SAWMILL RIVER CULVERT/FLUME INSPECTION Yonkers, New York

McLaren Engineering Group
100 Snake Hill Road
West Nyack, NY 10994

August 2006
Revised December 2007

MEG Job No. 106100.01

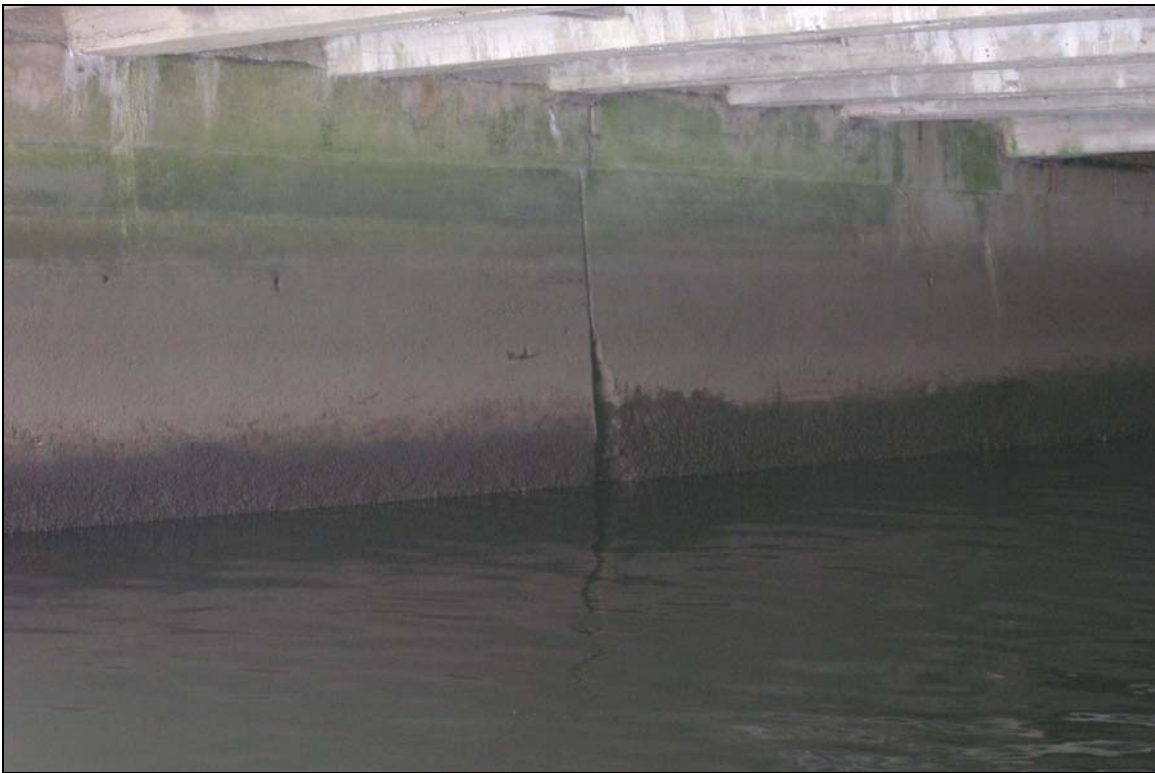
The bridge abutments and wingwalls typically exhibit moderate to heavy concrete scale within the tidal zone, see Photo 7. A layer of silt and fine stone covers the 12 in. by 4 in. timber cribbing/matting foundation of the north and south abutments. Overall, the construction joints exhibit areas of chamfer spalls and erosion in the tidal zone. Photo 8 provides a general view of typical construction joint located at the North Abutment. At the South Abutment, a 2' high by 1' wide by 3" deep spall is located at the construction joint at Station 9+43.

Photo 7 Up to 1" deep concrete scale with exposed aggregate in tidal zone at southwest wingwall.

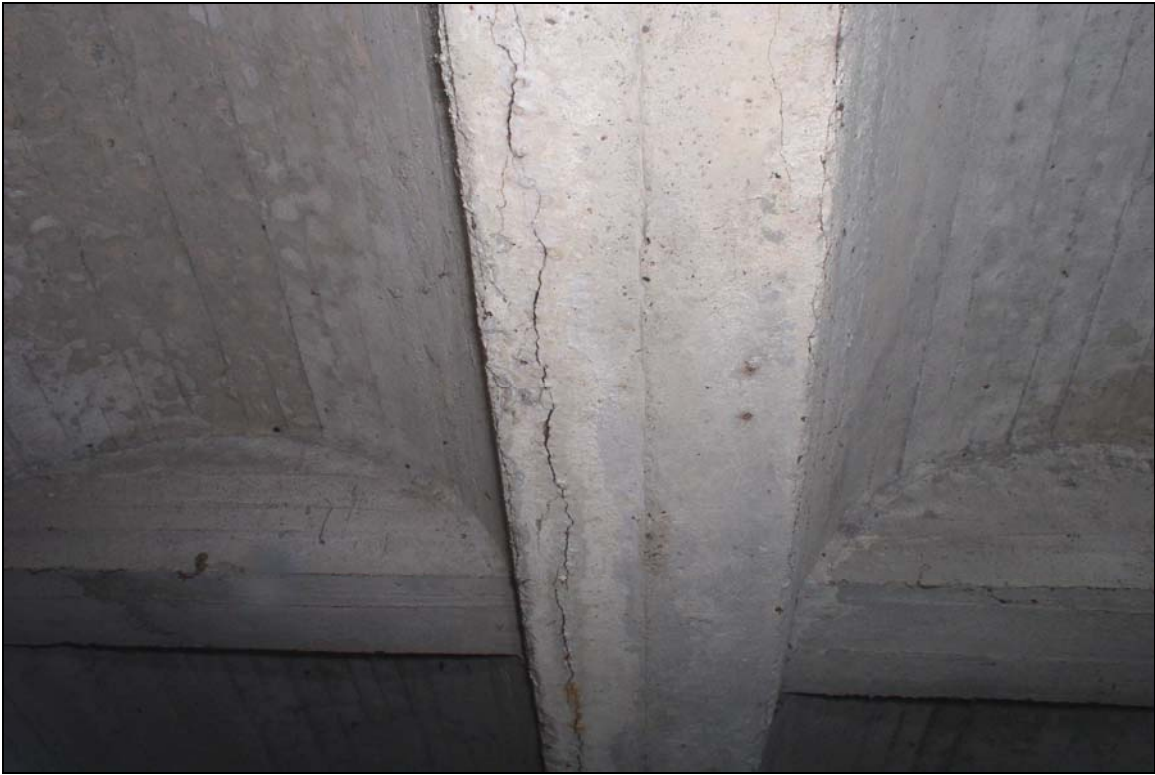
A general view of the underside of the bridge deck is shown in Photo 9. As depicted in Photos 10 through 11, the concrete beams typically exhibit multiple 1/8" to 1/4" wide cracks, spalls and areas of delamination along the bottom 6 inches of the concrete beams. These cracks vary in size, but are typically 6 ft in length. In addition, many of the concrete diaphragms have large spalls with exposed reinforcement (see Photo 12).

Photo 10 Wide cracks, delamination, and rust staining in bottom of concrete beam.

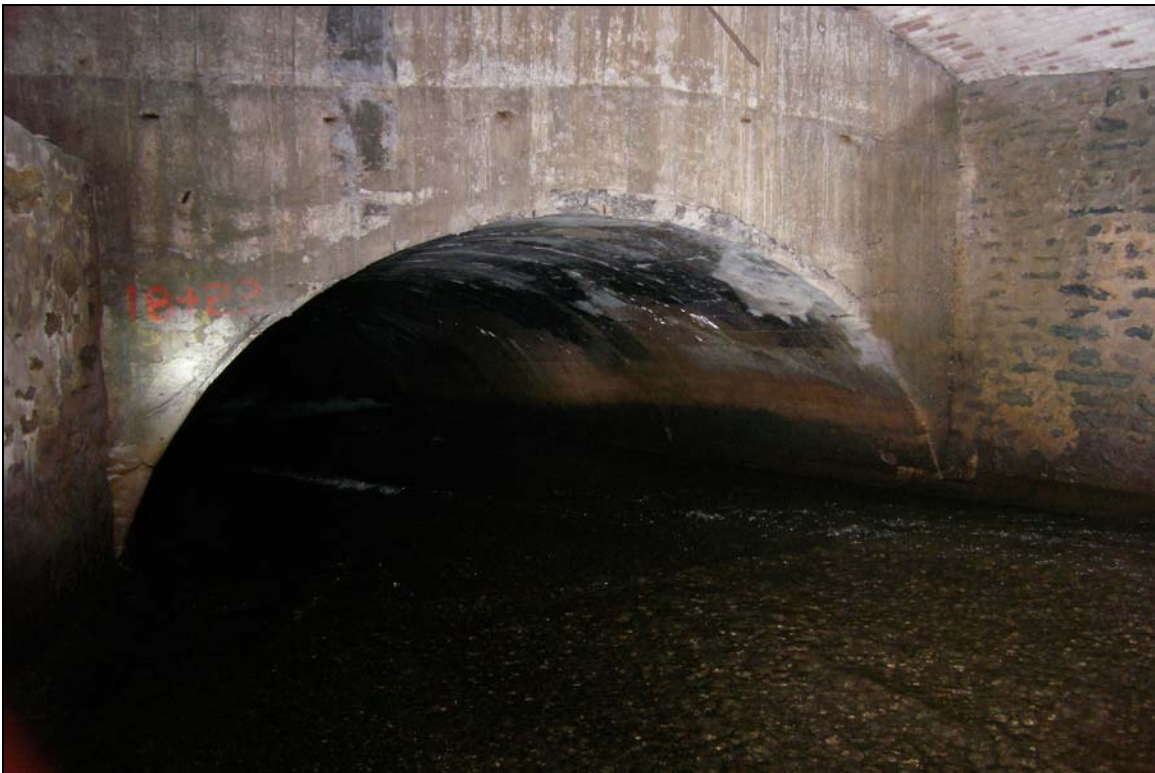
Photo 13 Western end of concrete arch culvert (Sta 10+50) at mean high tide. Note cracks with efflorescence in concrete headwall.

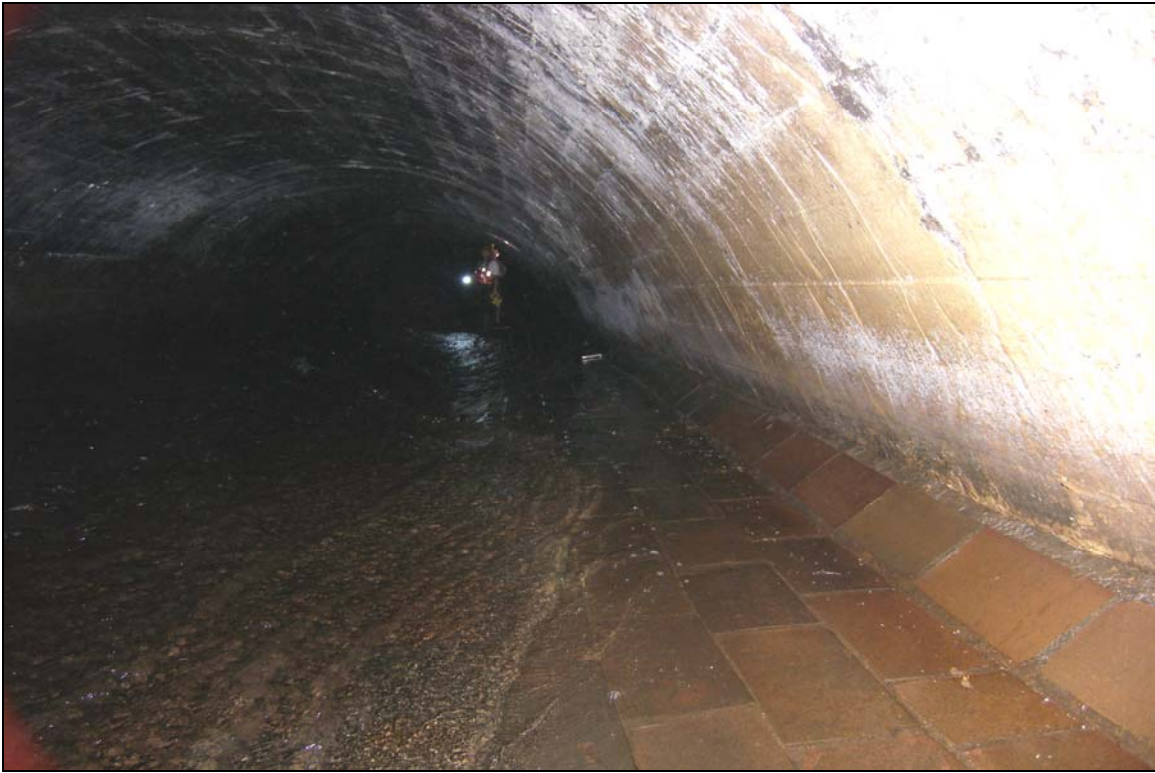
Overall the concrete arch culvert is in fair condition. The concrete arch typically exhibits localized areas of minor map cracking with efflorescence (see Photo 16). Upstream of Station 14+50, the culvert floor is lined with masonry pavers. As seen in Photo 17, many of the pavers are severely deteriorated as a result of excessive flow. The construction joints between sections of culvert typically exhibit minor chamfer spalls and loss of joint filler.

Photo 16 Minor map cracking with efflorescence in concrete arch.

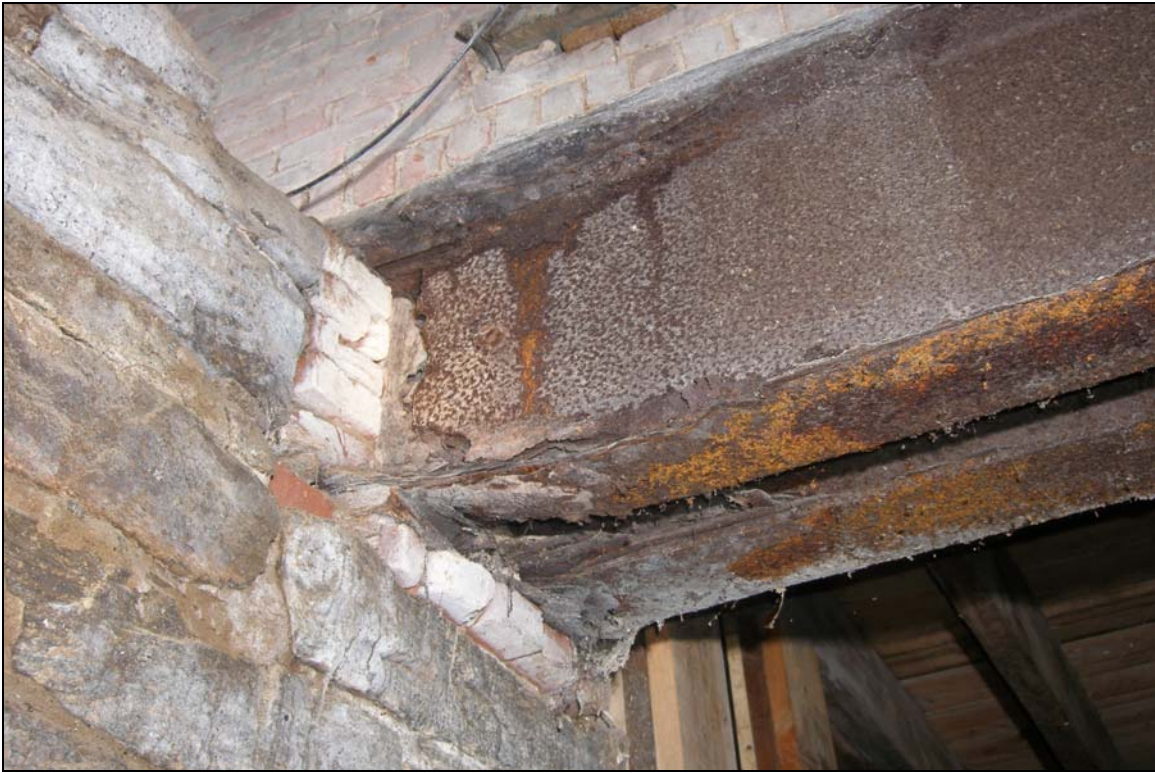
Photo 23 provides a general view of the brick building fascia and steel girders which span the river at the transition to the Warburton Ave. Bridge. As seen in Photos 24 and 25, the south end of the steel girders exhibit moderate corrosion while the north end is severely deteriorated with corrosion holes throughout the web. Photo 26 provides a general view of the severely corroded bottom flanges of the steel members.

Photo 24 Moderate corrosion at the south end of above-noted steel beams.

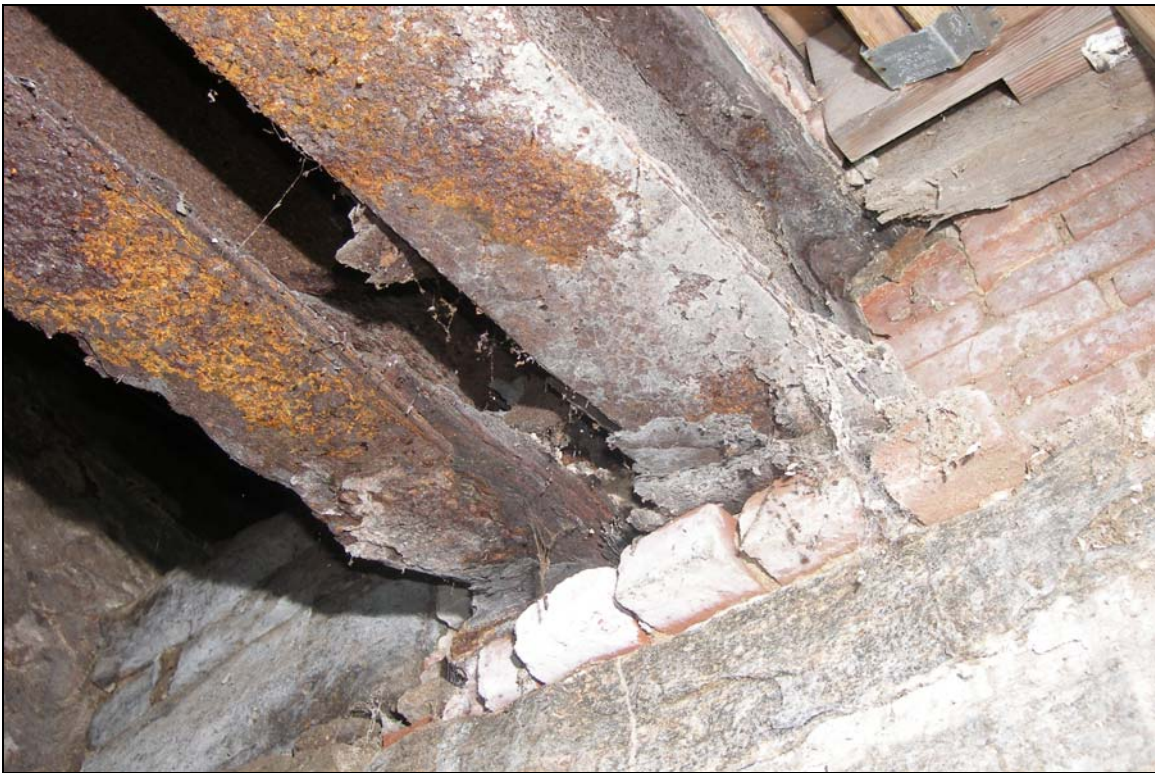
This corroded and deteriorated condition was previously noted in the prior Flume Report. In addition, the prior Flume Report noted water infiltration through the north wall in the vicinity of the girder. No active water infiltration was observed during this inspection.

Photo 25 North end of steel beam located at Station 18+75 exhibits one hundred percent deterioration of web due to corrosion.

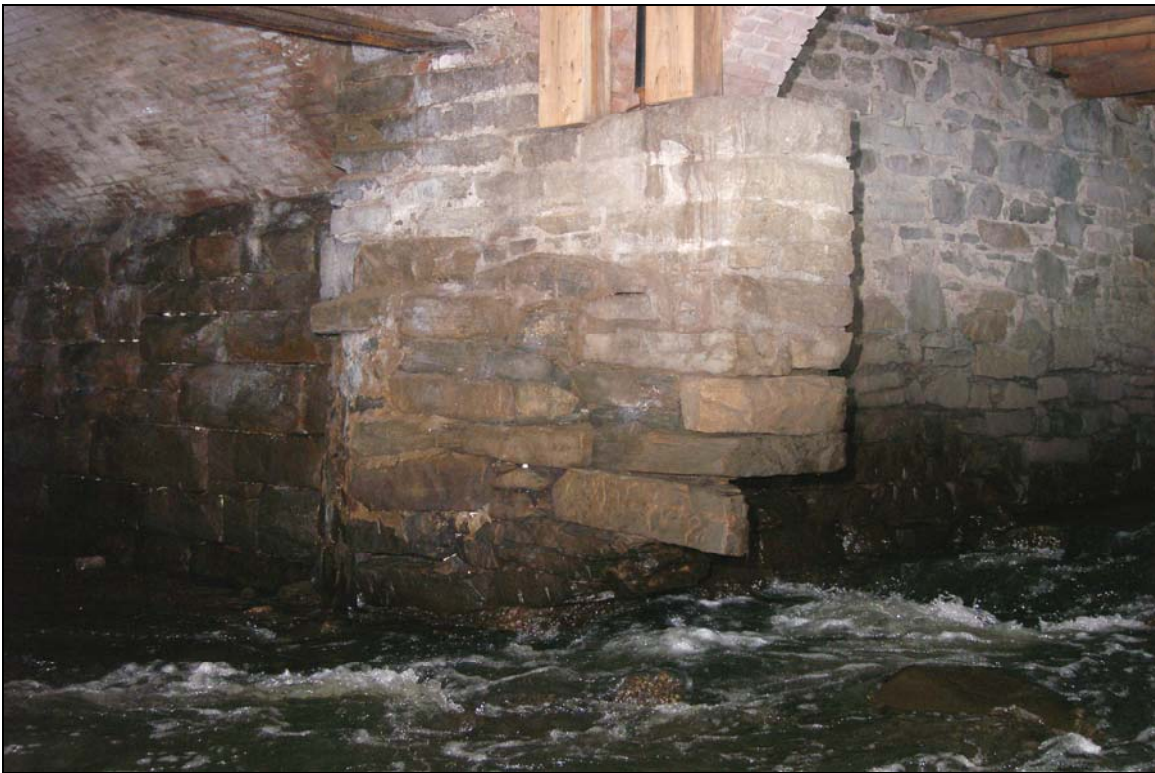
Repairs to the timber beams located directly east of the severely corroded steel girders were observed during the inspection. As seen in Photos 27 and 28, the timber joists adjacent to the north end of the steel beams have been jacked-up and supported with built-up timber members. The timber support members have been installed atop a section of severely deteriorated stone masonry pier.

Photo 27 Repair to support timber beams directly east of severely corroded steel beam noted in Photos 25 and 26.

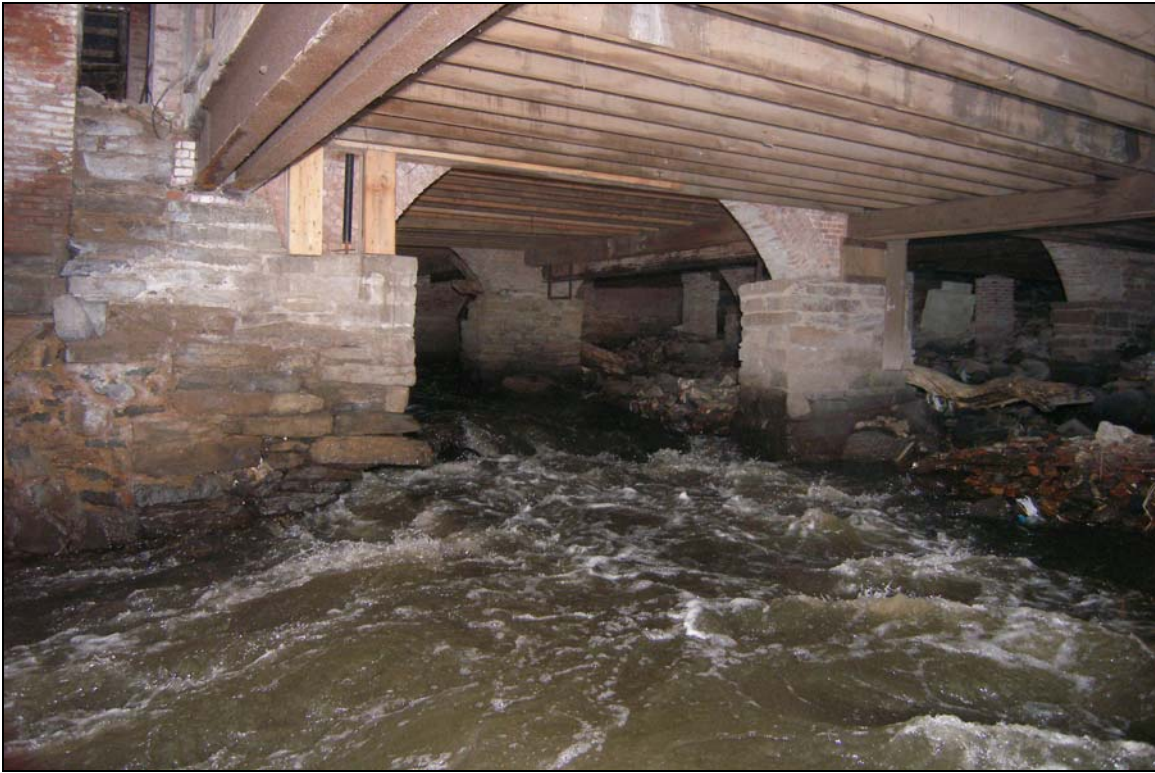
Photo 28 Above timber beam repair installed atop severely deteriorated stone masonry pier.

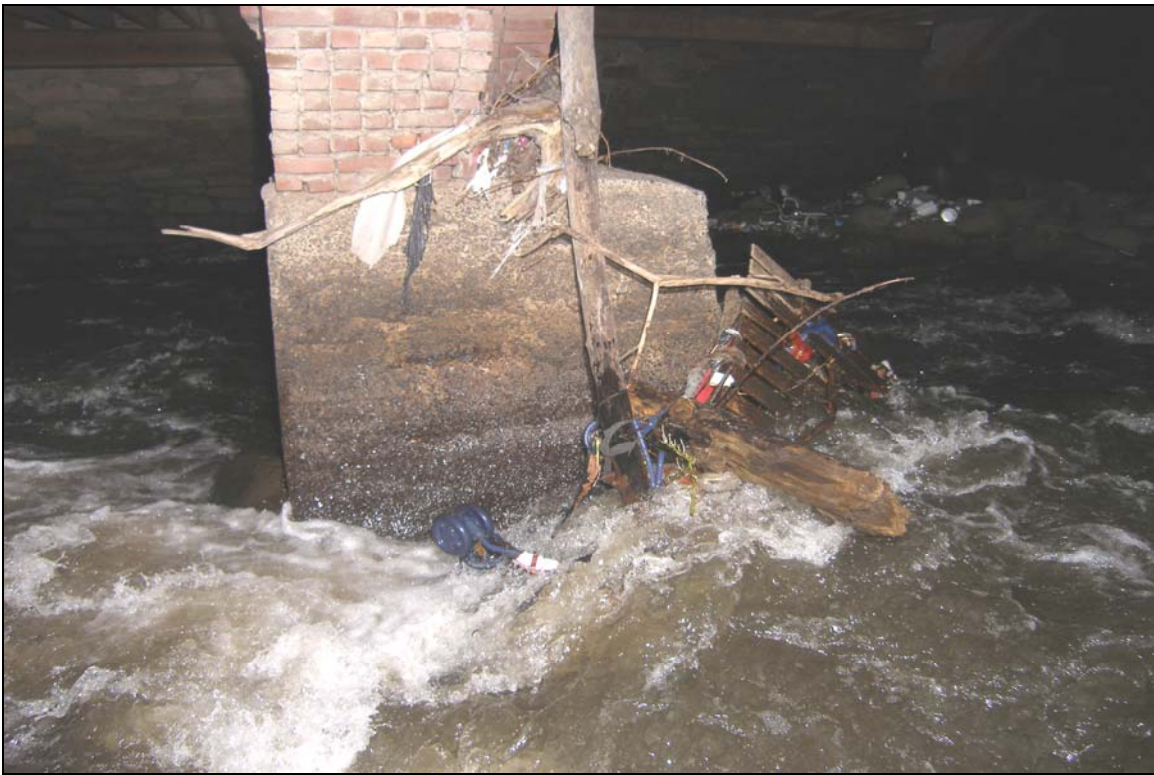
Photo 41 Severely deteriorated north and west faces of masonry pier which has been encased in concrete as a repair.

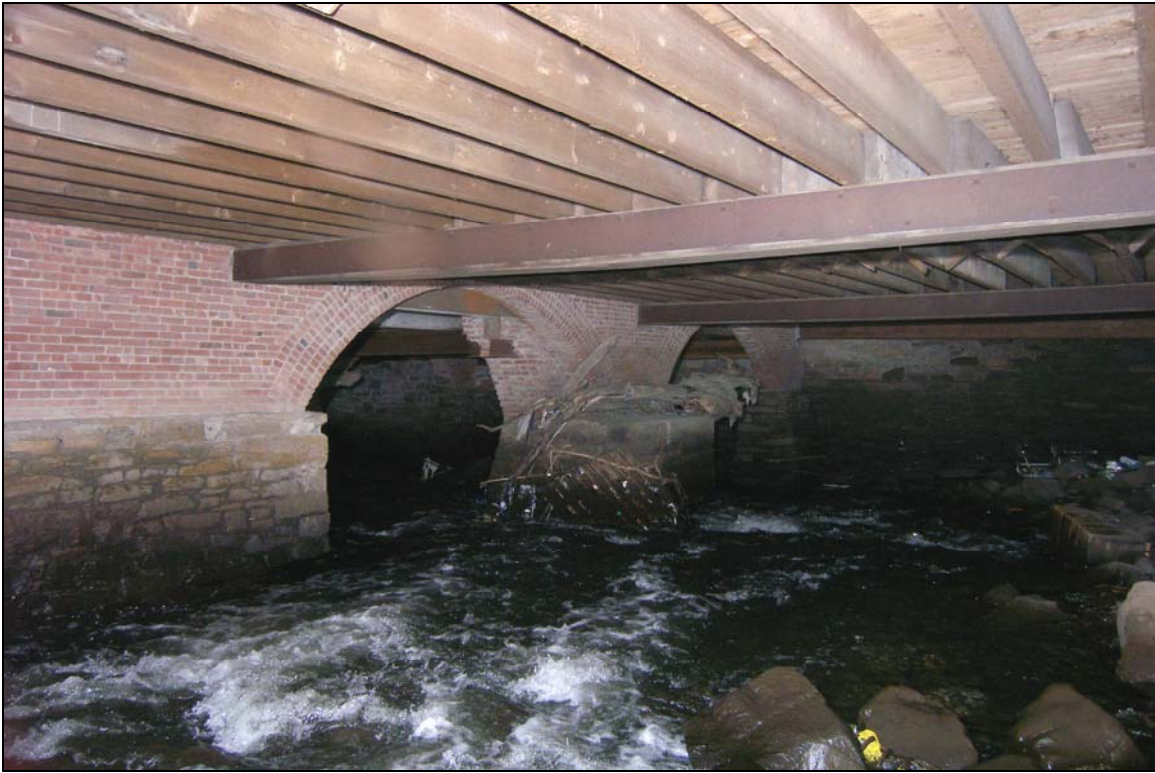
Photo 43 provides a general view of the area of the flume located directly beneath Manor House Square. This area is constructed of steel beams and brick arches, which are supported by stone masonry walls along the north end and stone masonry piers and brick arches at the south end. In addition, in this area the flume has a concrete floor located approximately 3' above the observed water level. Although this section of the flume does not convey normal/low flows, larger storm events have deposited large stones, scattered debris and a 2' diameter section of tree stump atop the concrete floor (see Photo 44).

Photo 44 Brick jack-arch construction looking east beneath Manor House Square. Note general efflorescence in concrete arches and rust stains on masonry walls.

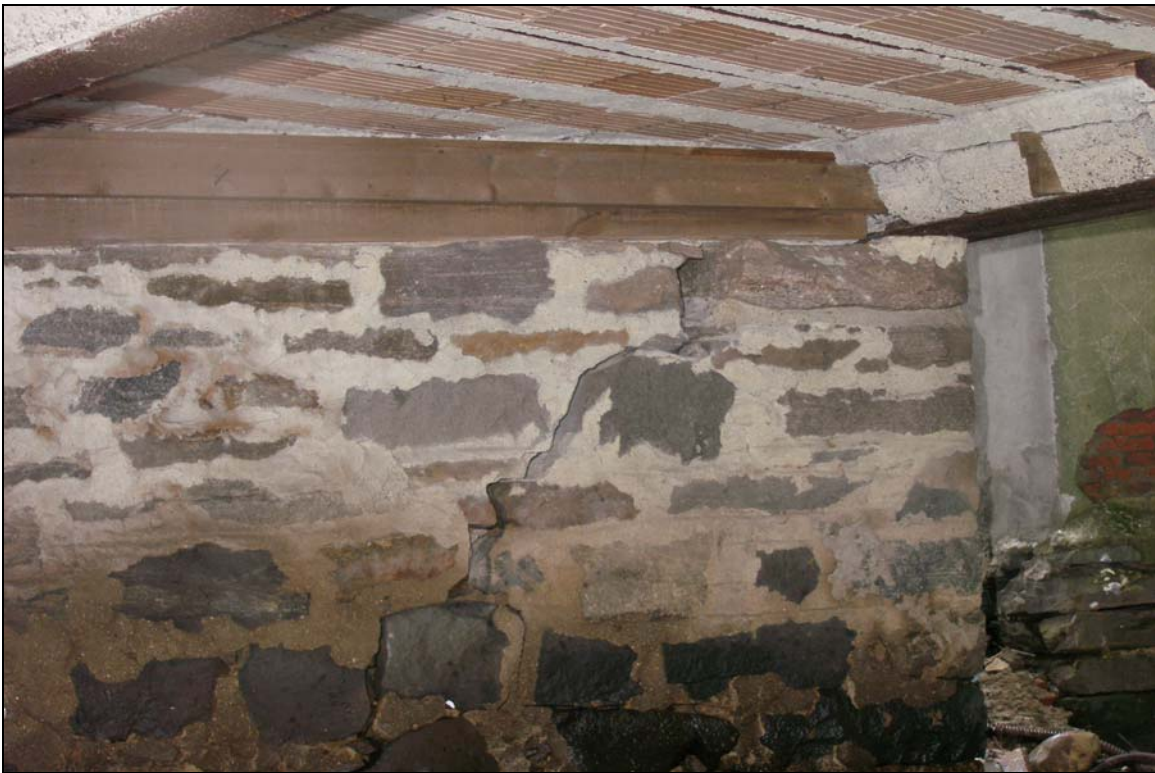
in Photos 53 and 54, a wide diagonal crack exists in the corner of the building located directly upstream of the Mill Street opening. The crack is approximately 8' long and up to 1" wide and translates from the north to the west face of the structure. The section of the crack along the west face has been repaired by epoxy injection.

Photo 53 Stone masonry foundation along south face of river channel. Note diagonal crack in corner of building foundation.

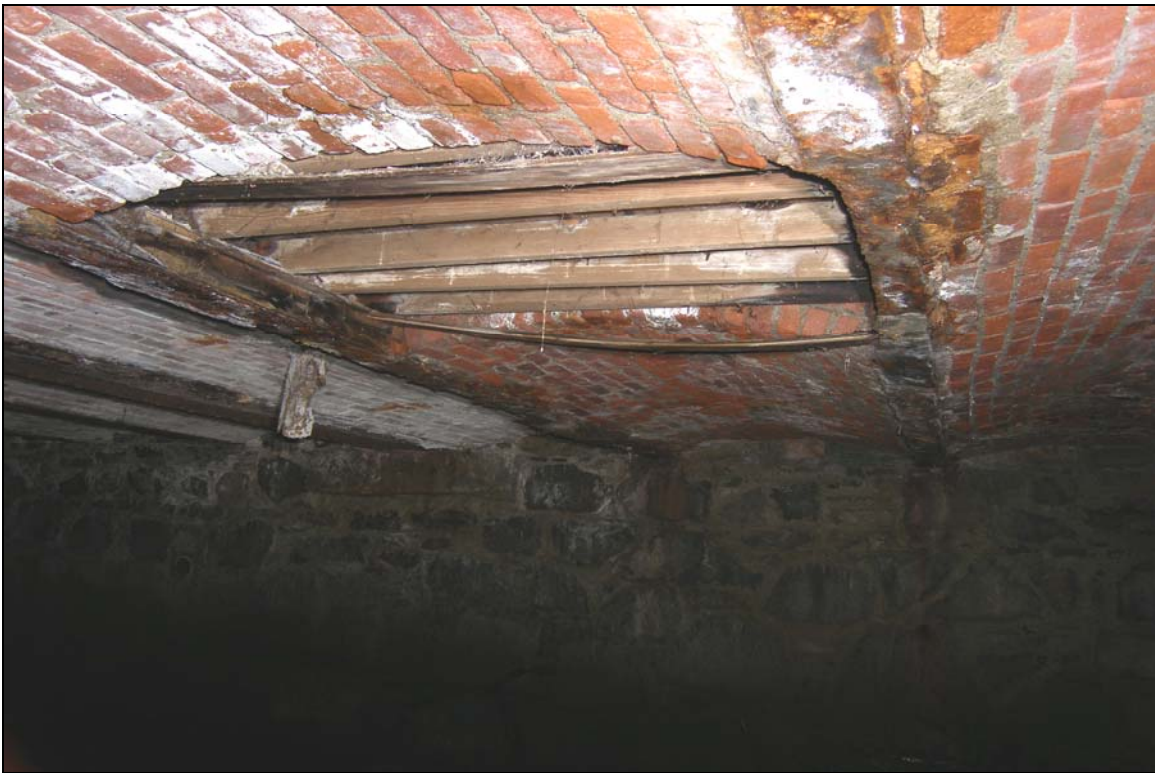
Photo 69 Heavy corrosion of bottom flange of steel beam.

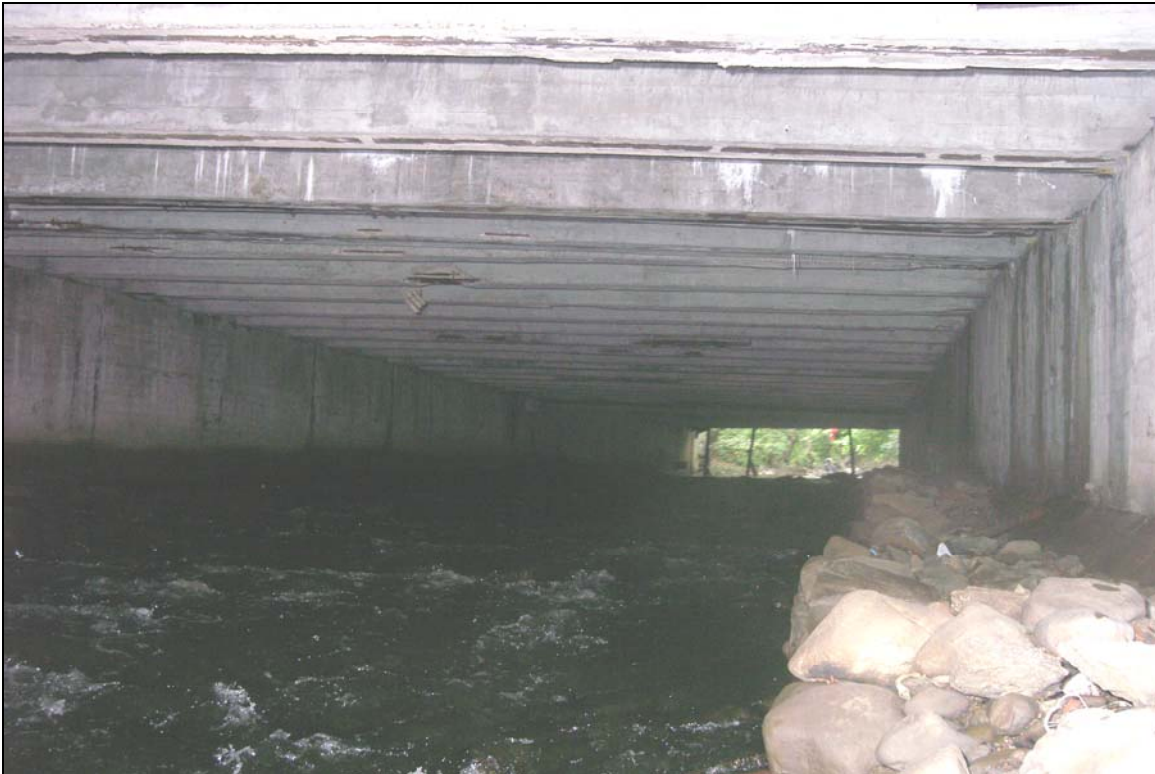
Photo 103 Construction transition at Sta 28+94. Note sections of missing insulation exposing concrete beam.

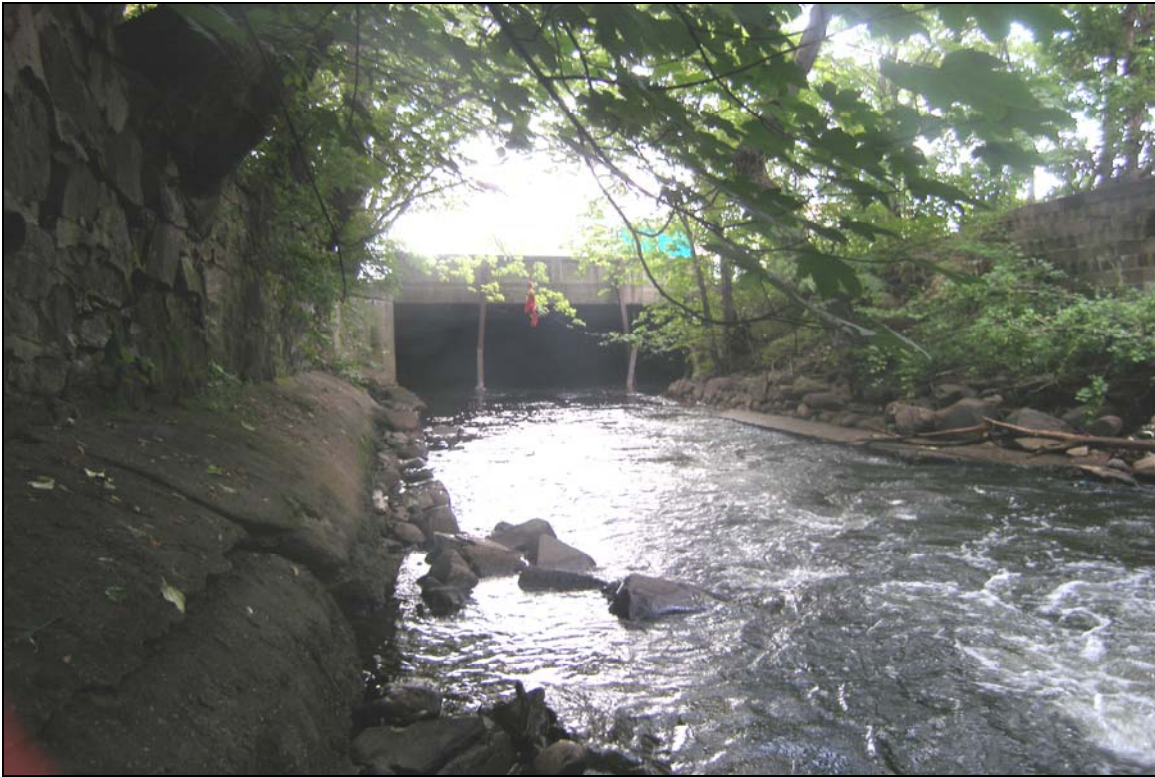
Photo 110 Left embankment, Station 32+00 to 32+15. 2.5' high by 2.0' deep undermining and 1" wide vertical cracks in stone masonry wall.

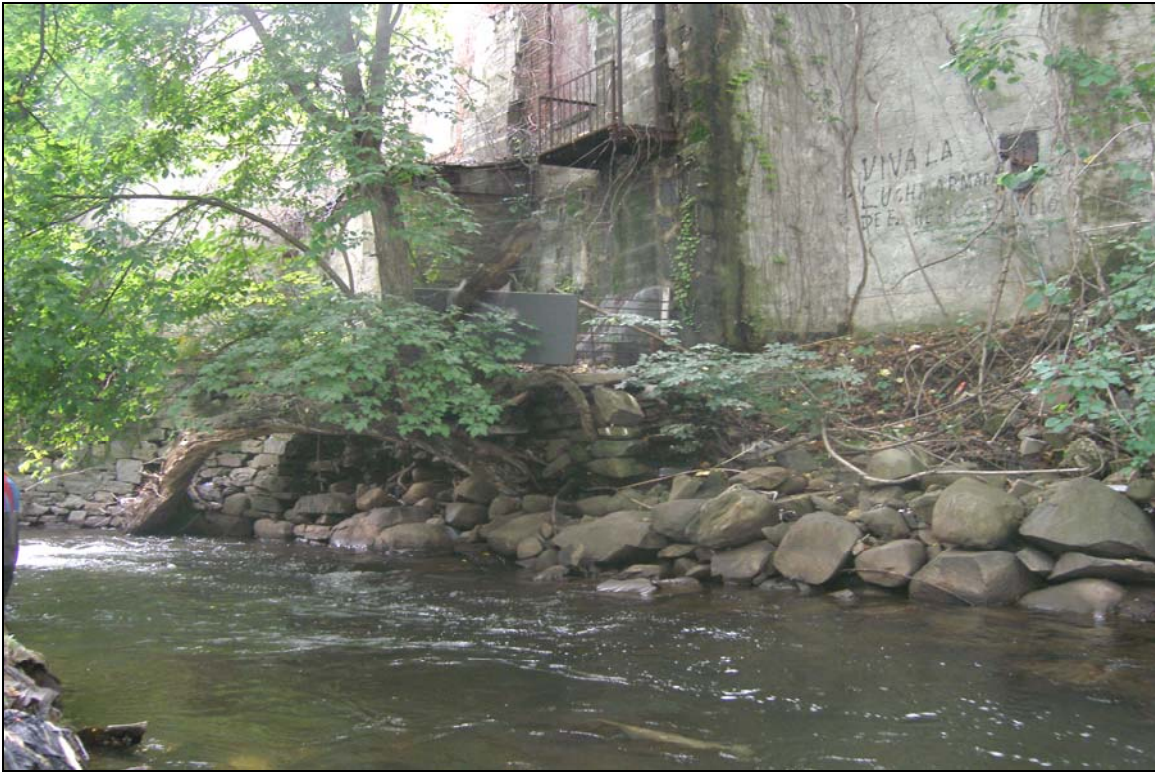
Photo 112 Right embankment, upstream of Ann Street bridge. Concrete repair is undermined up to 1' high by 2' deep from Station 31+03 to 32+10.

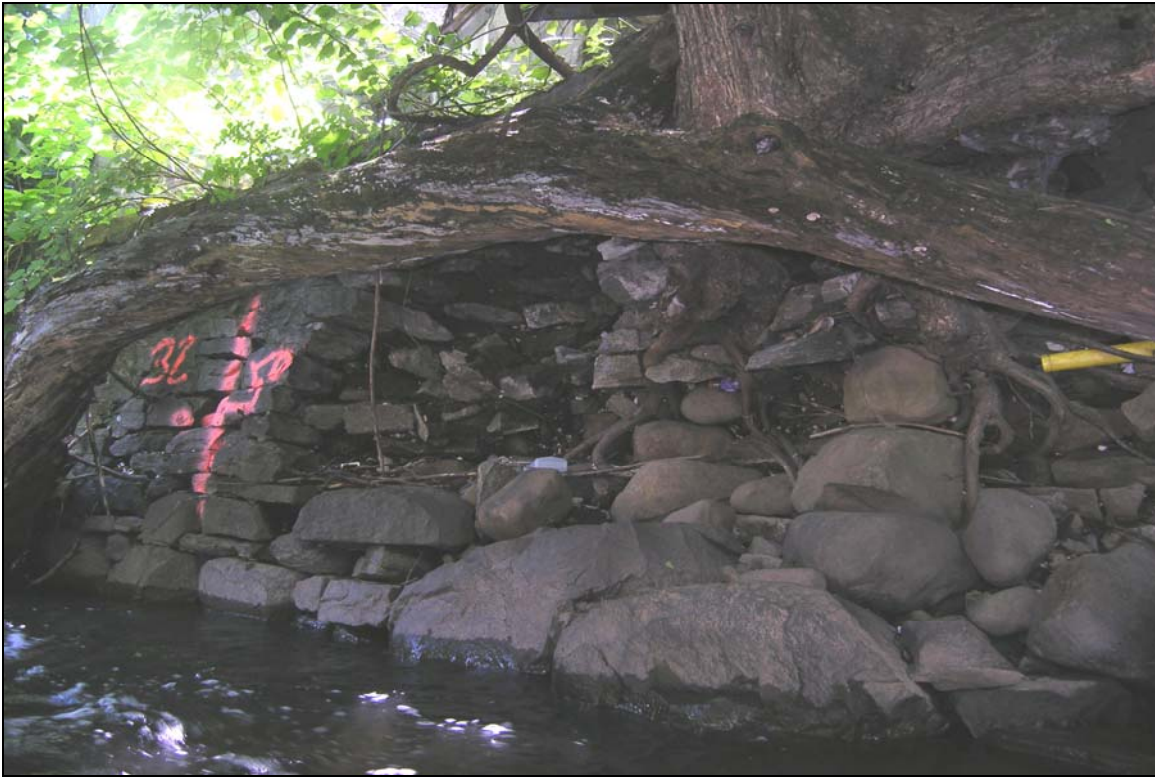
Photo 114 Right retaining wall, upstream of the Ann St. Bridge. Typical condition whereby vegetation and missing chink stones are compromising the integrity of the retaining wall.

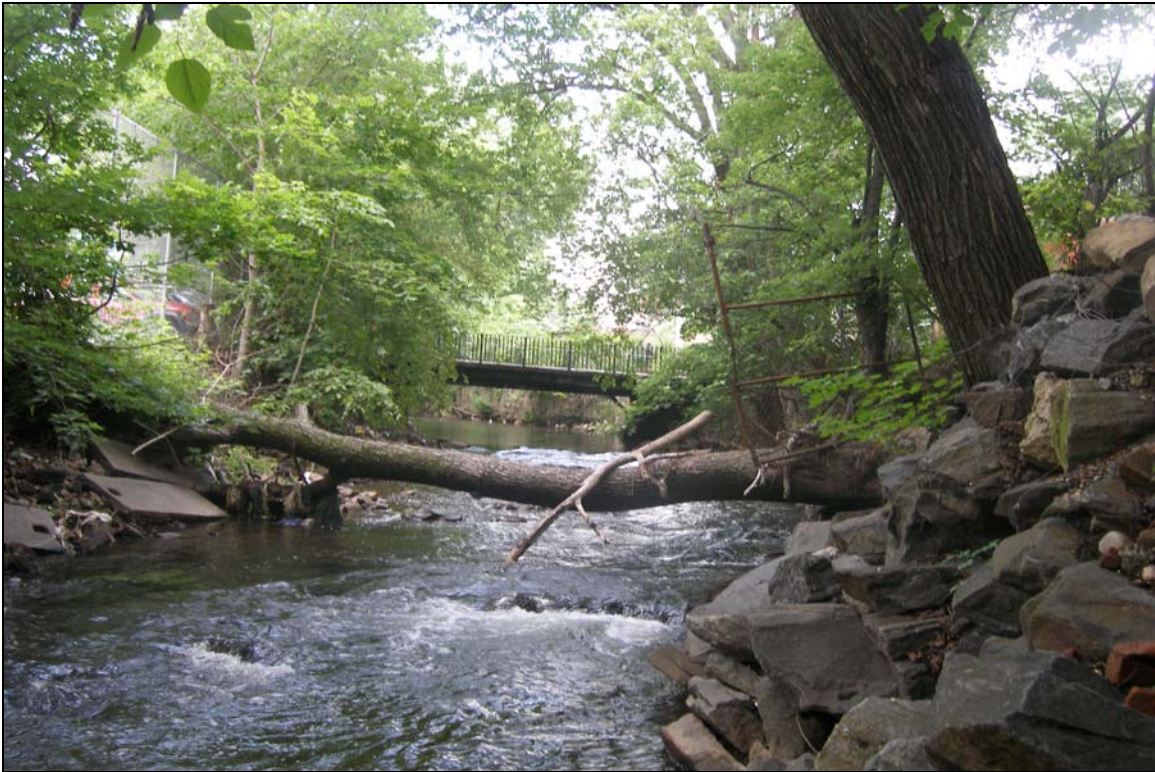
Photo 124 Left embankment. Deteriorated stone masonry wall located between Stations 37+00 and 37+50. Note accumulation of debris along edge of river.

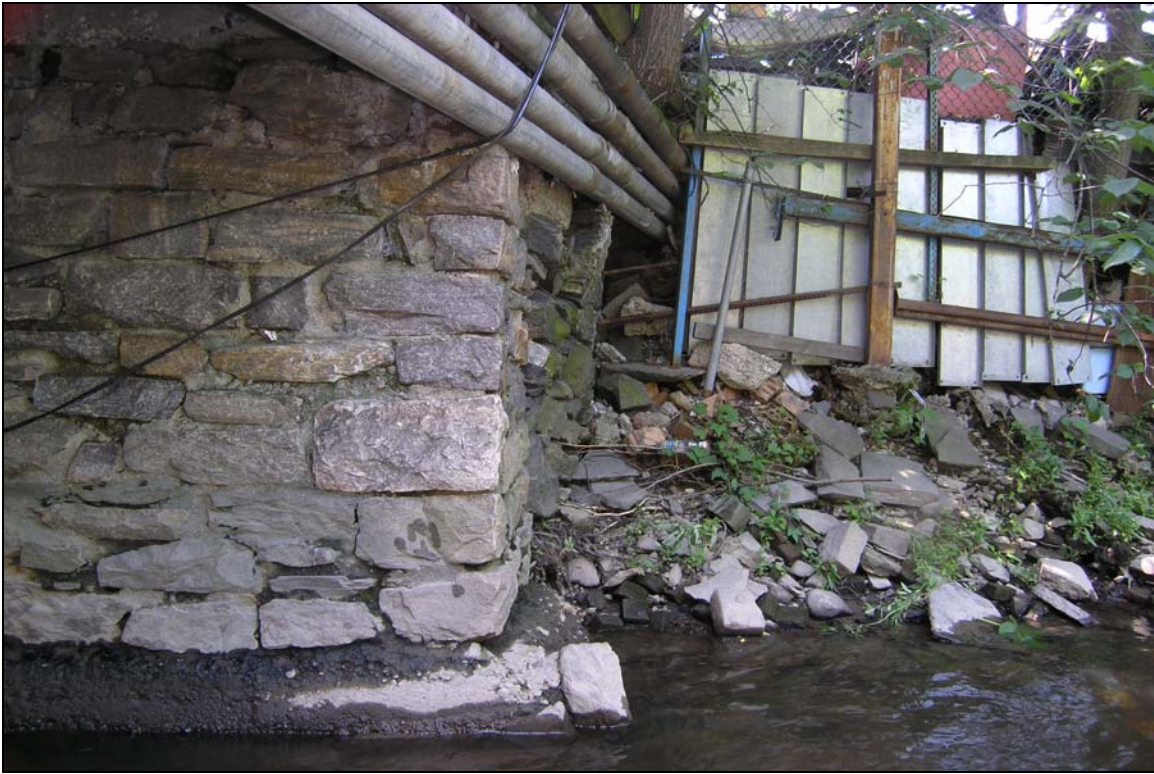
Photo 126 John Street Alley Bridge, East Abutment. 10' long by 5' high by 3' deep void in stone masonry abutment at Station 39+36. Note severely deteriorated timber fascia beam.

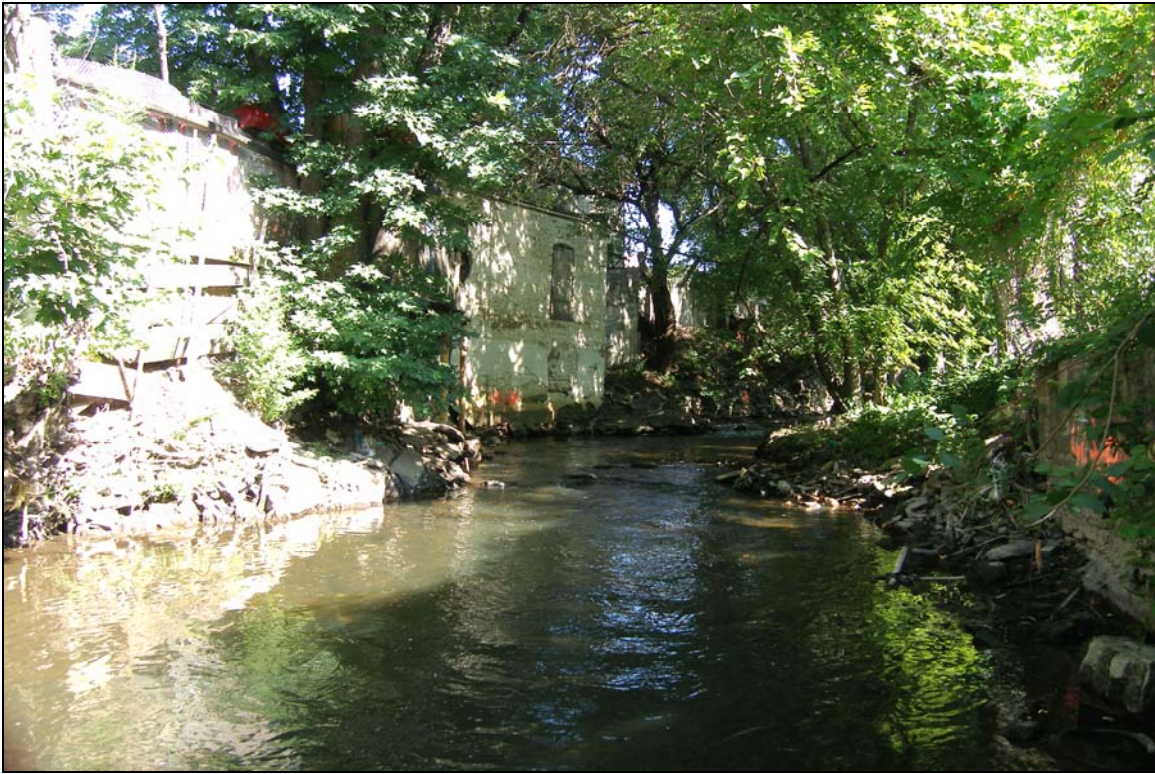
Photo 130 Typical undermining and cracks in stone masonry wall. Wall exhibits intermittent undermining up to 1' high by 1' deep.

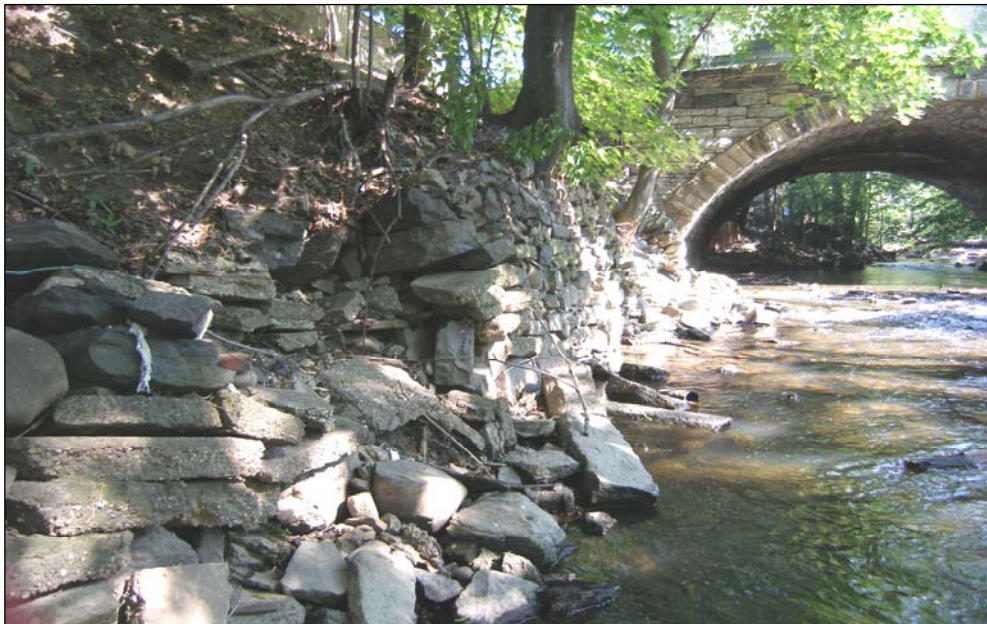
Photo 133 Left embankment, upstream of John Street Alley Bridge. Scrap metal and concrete retaining wall from Station 39+50 to 40+40. Masonry building foundation from Sta 40+40 to Sta 40+67 exhibits intermittent 1' high by 1.5' deep areas of undermining.

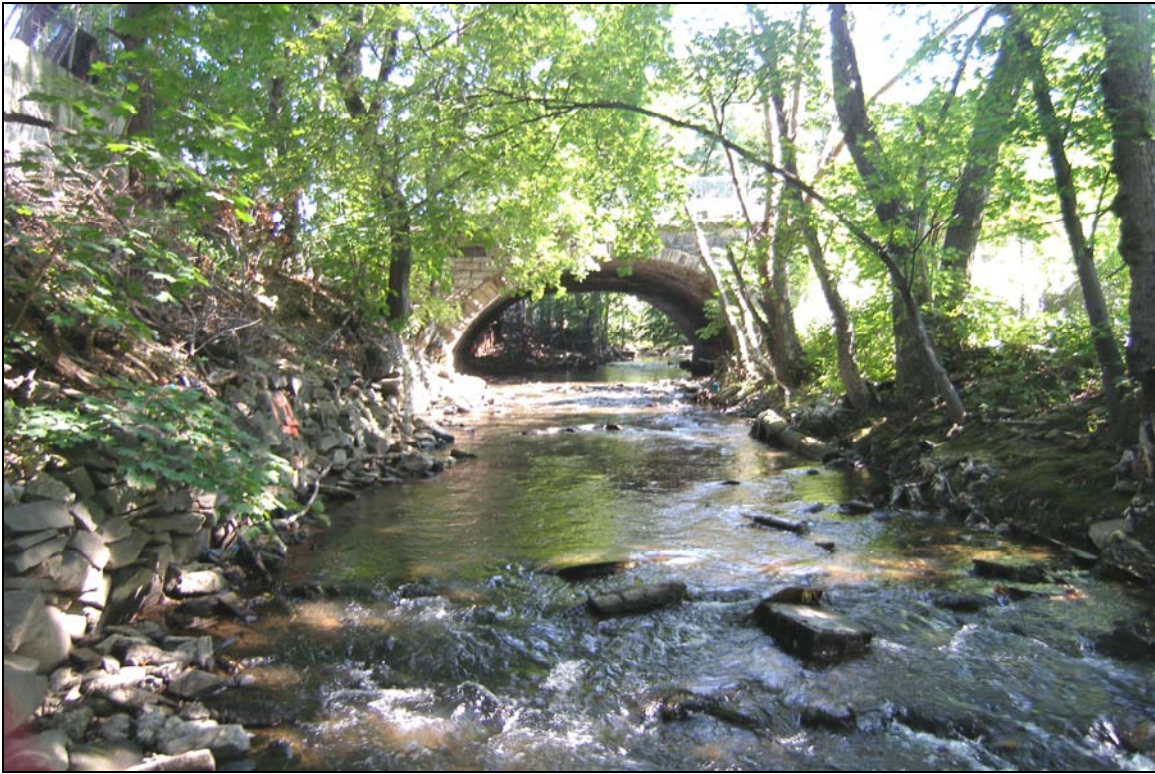
Photo 134 Left embankment. Deteriorated stone masonry wall located downstream of Elm Street Bridge between Stations 40+85 and 41+71.

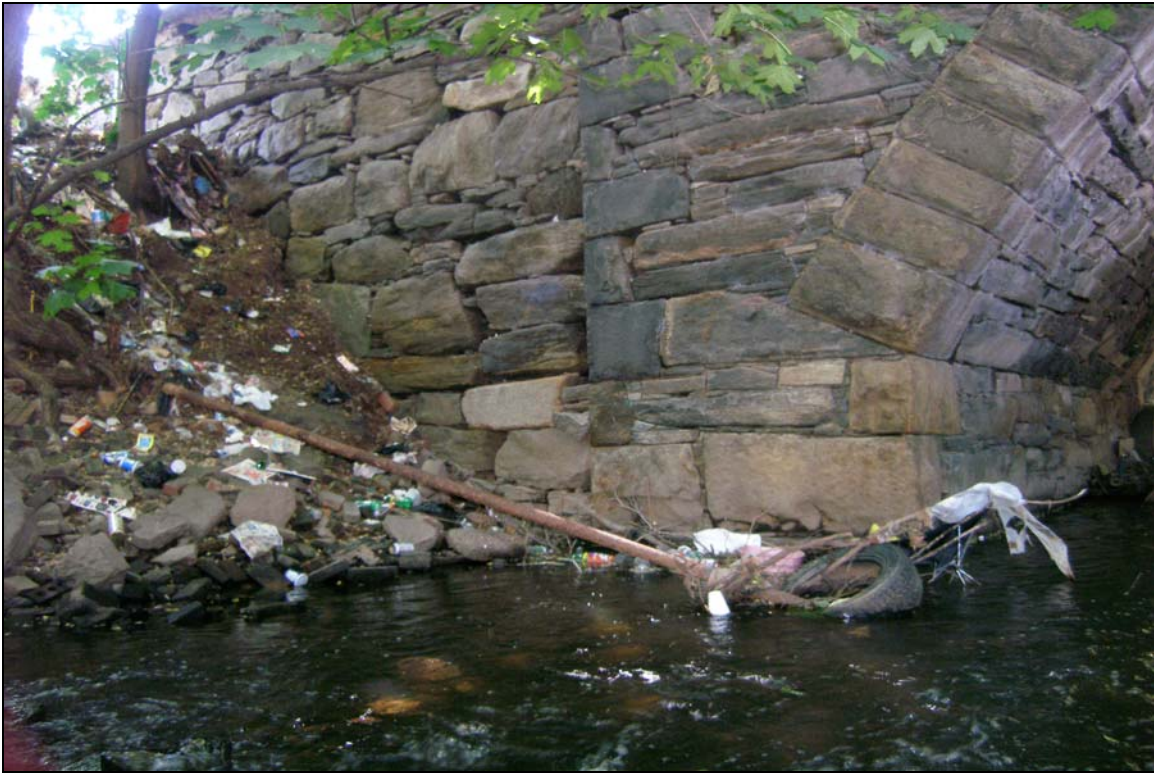
Photo 136 Underside of Elm Street Bridge stone masonry arch (looking downstream). Note areas of missing grout and overall efflorescence in joints.

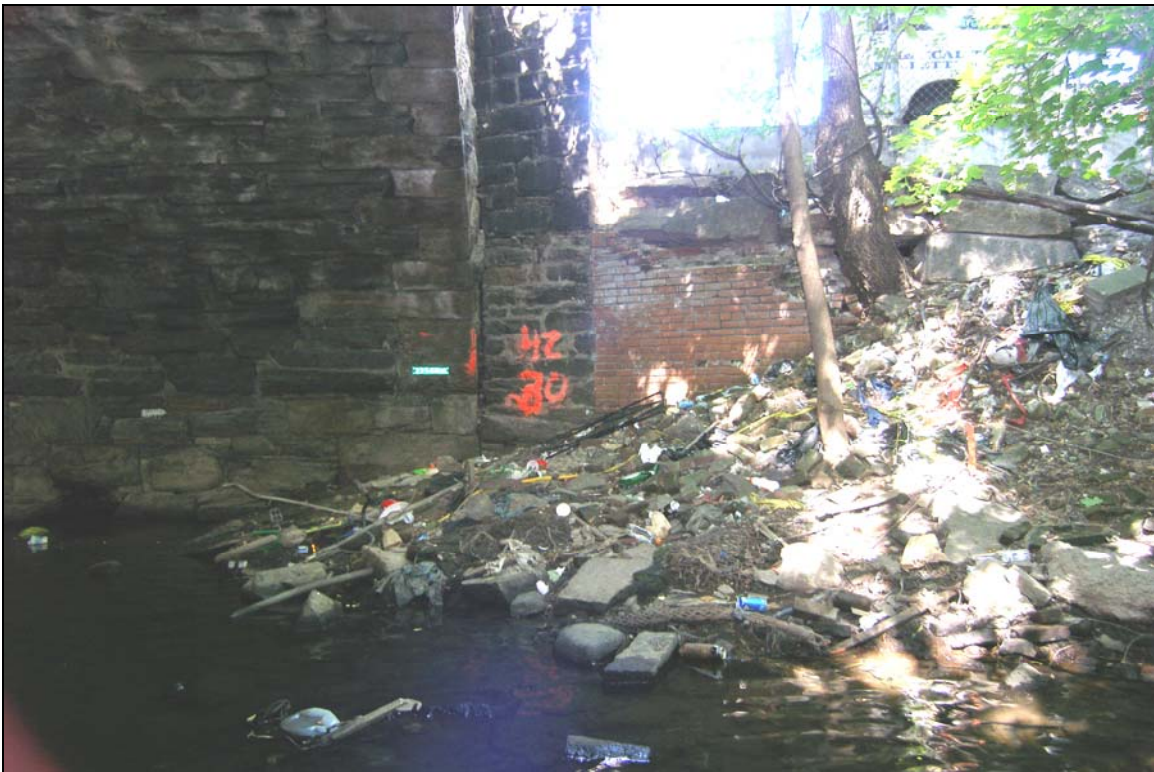
Photo 137 Missing chink stones at the northeast wingwall of the Elm Street Bridge, Station 42 + 30.
