PHOTOGRAPHS

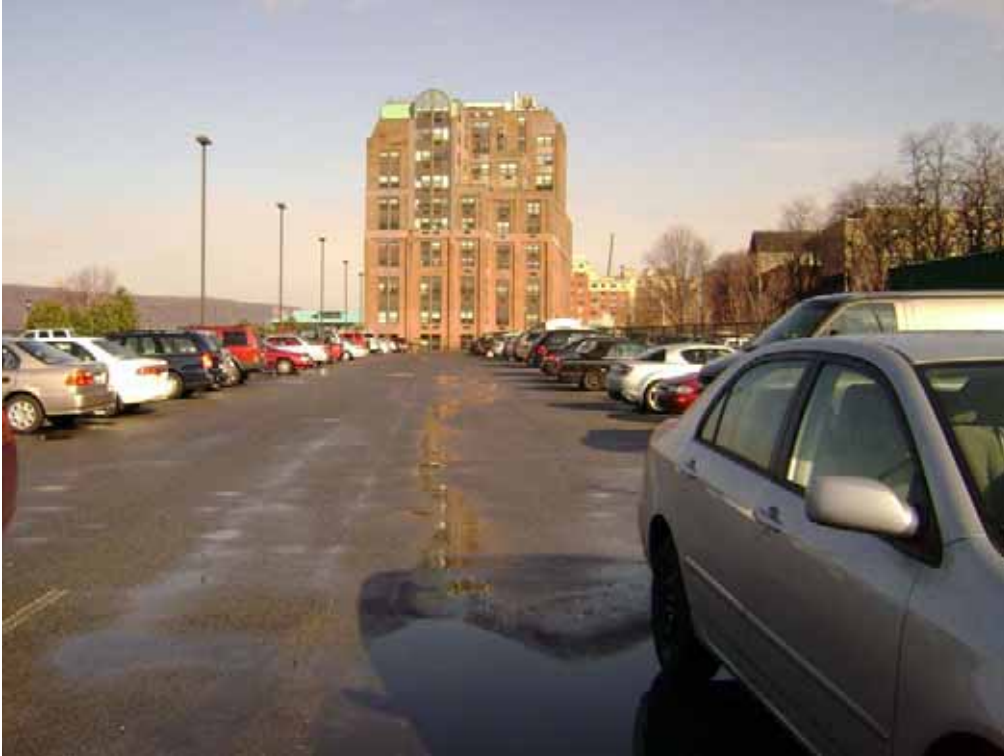
Photo 1. View north showing the paved parking lot located in the northeast section of the Palisade Point project area (Block A).

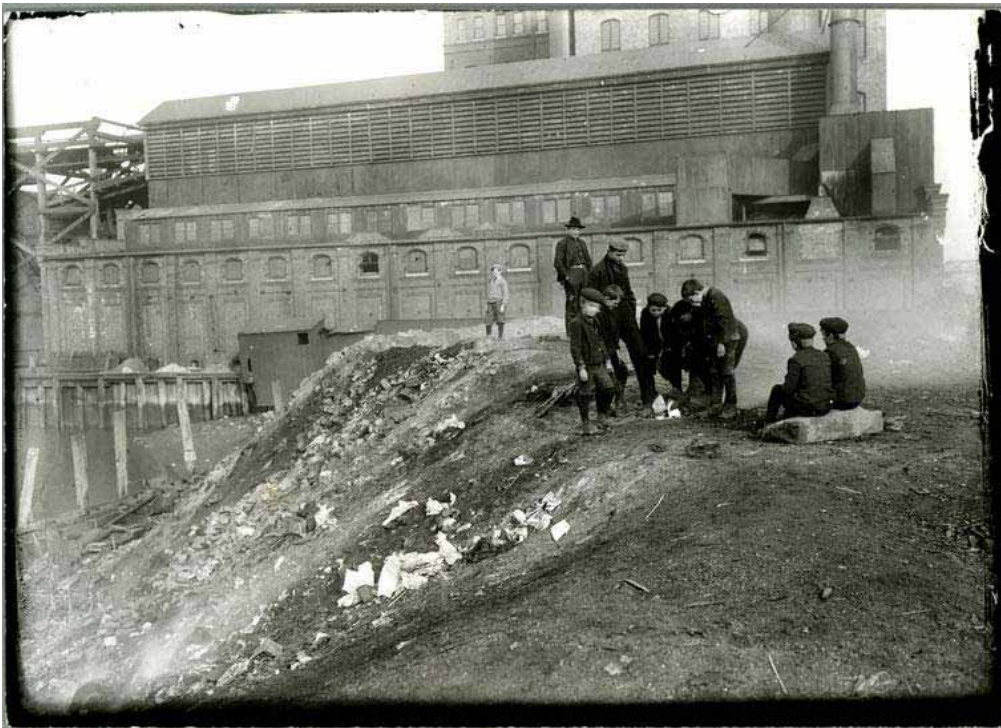
Photo 2. Historic view c. 1906 of sugar refining mill and steep bank along Hudson River prior to modern filling near Block A facing north. Photo from the New York Public Library Digital Gallery.

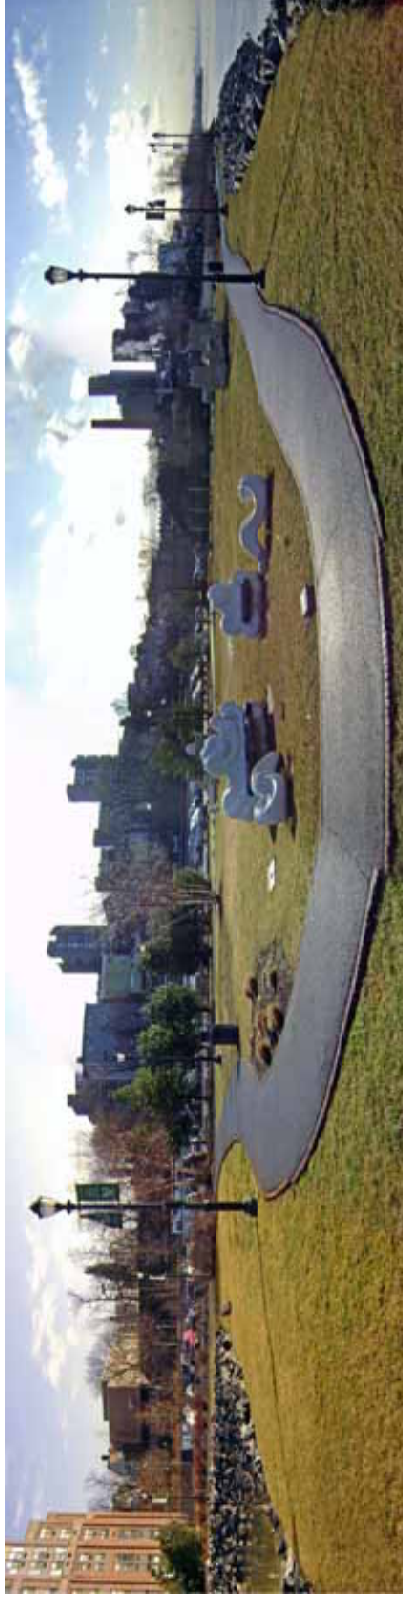
Photo 3. View from the northwest corner of Block A facing southeast along the statue garden and path located between the paved parking lot and the Hudson River within Block A. Modern riprap lines the shore along the park.

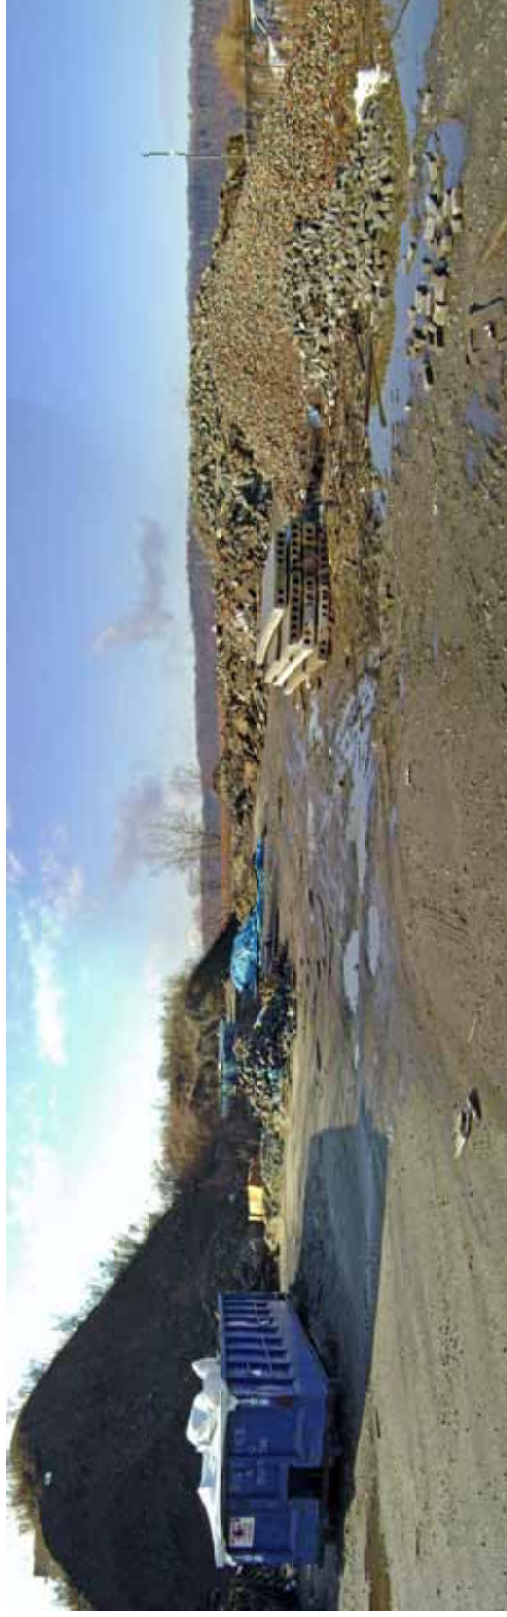
Photo 4. View southwest from the southern end of the paved parking lot within Block A showing mounds of rubble. The entire southern portion of the block contains mounds of rubble, which might have been pushed to the end of the block when the northern portion was remediated.

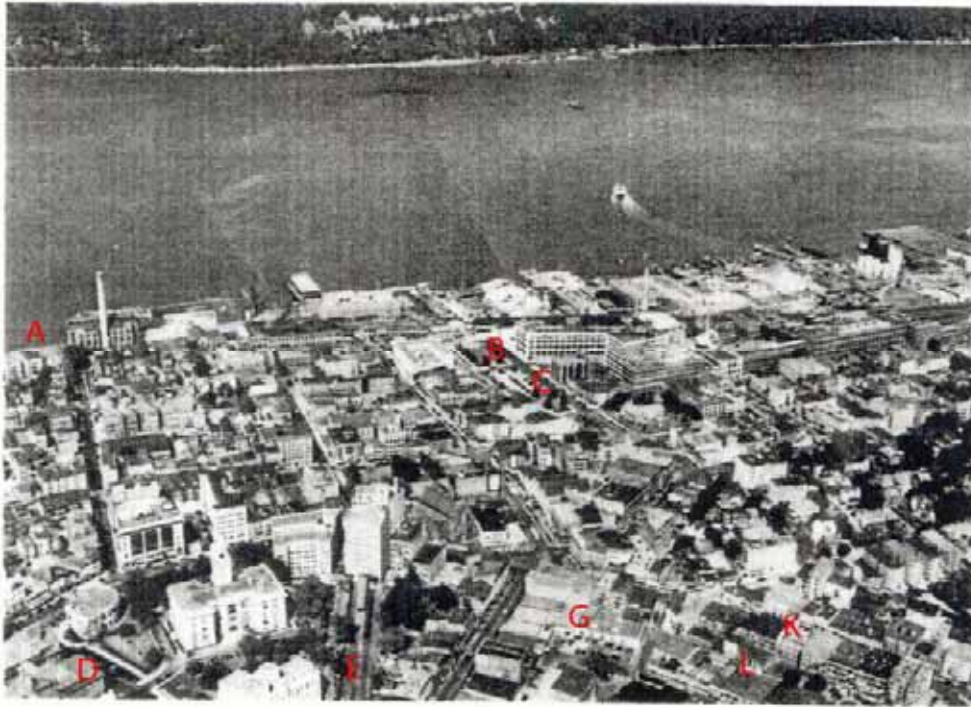
Photo 5. Circa 1946 aerial image of the City of Yonkers facing west. All or part of blocks A-E, G, L, and K are visible. Photo from Central National Bank of Yonkers 1946, end page.

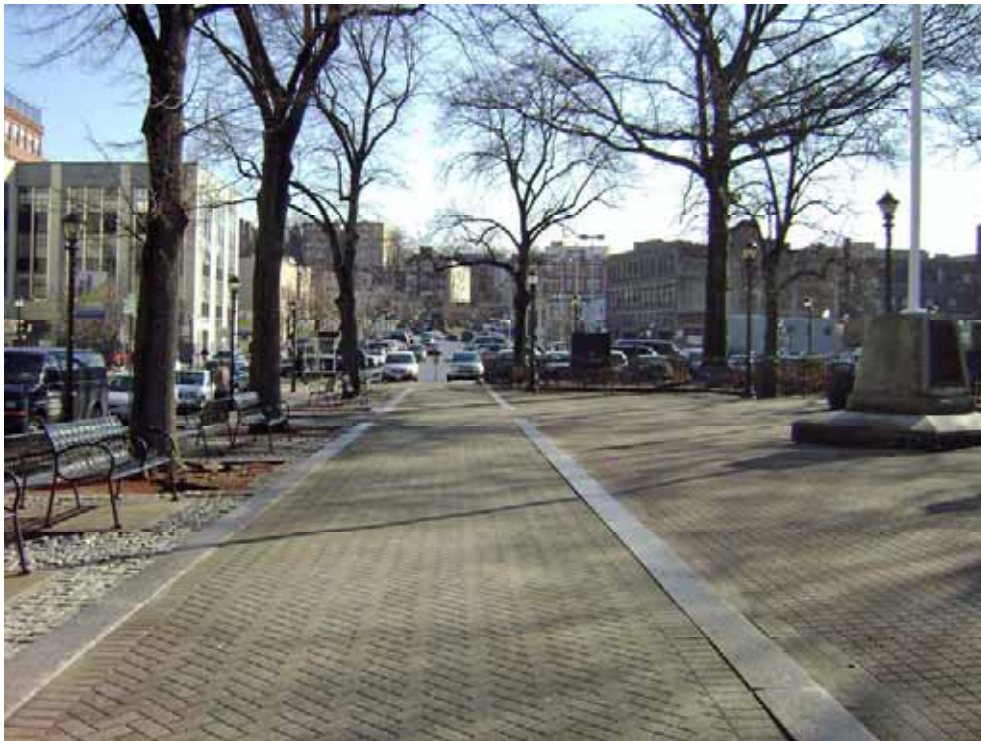
Photo 6. View from the northwestern end of Block B looking east toward Block C along the covered location of the Saw Mill River. Larkin Plaza Park occupies the western end of Block C, while a paved parking lot, seen in the background, occupies the eastern end of Block B.

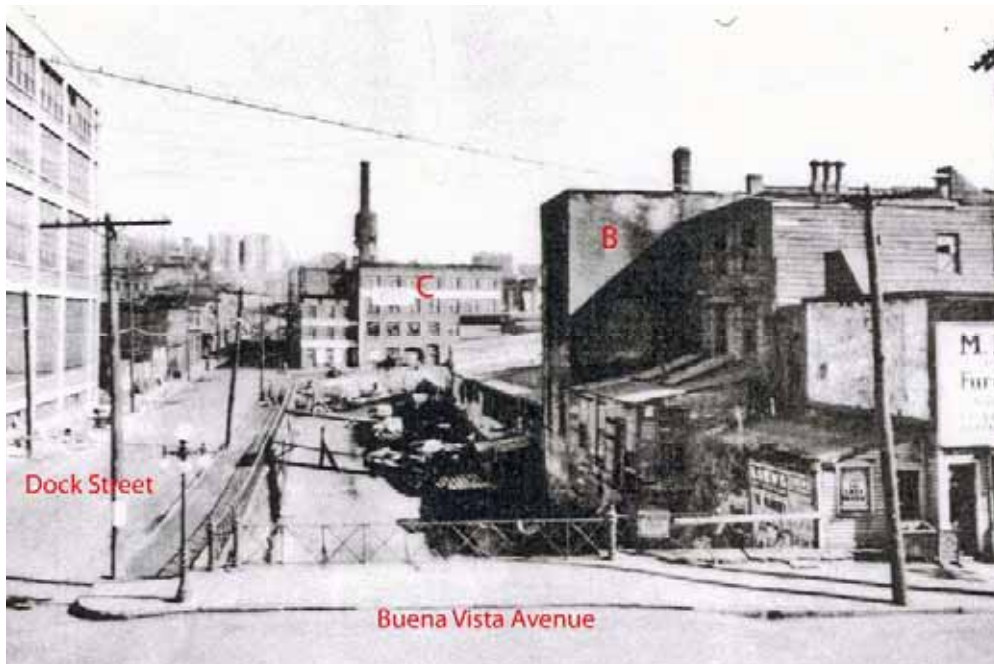
Photo 7. Circa 1900 view of Larkin Plaza from Buena Vista Avenue looking east toward Block C. The Saw Mill River is visible in the northern portion of Block B. This photograph was taken in the same approximate location as Photo 6. Photo from Crandell 1954, pg. 59.

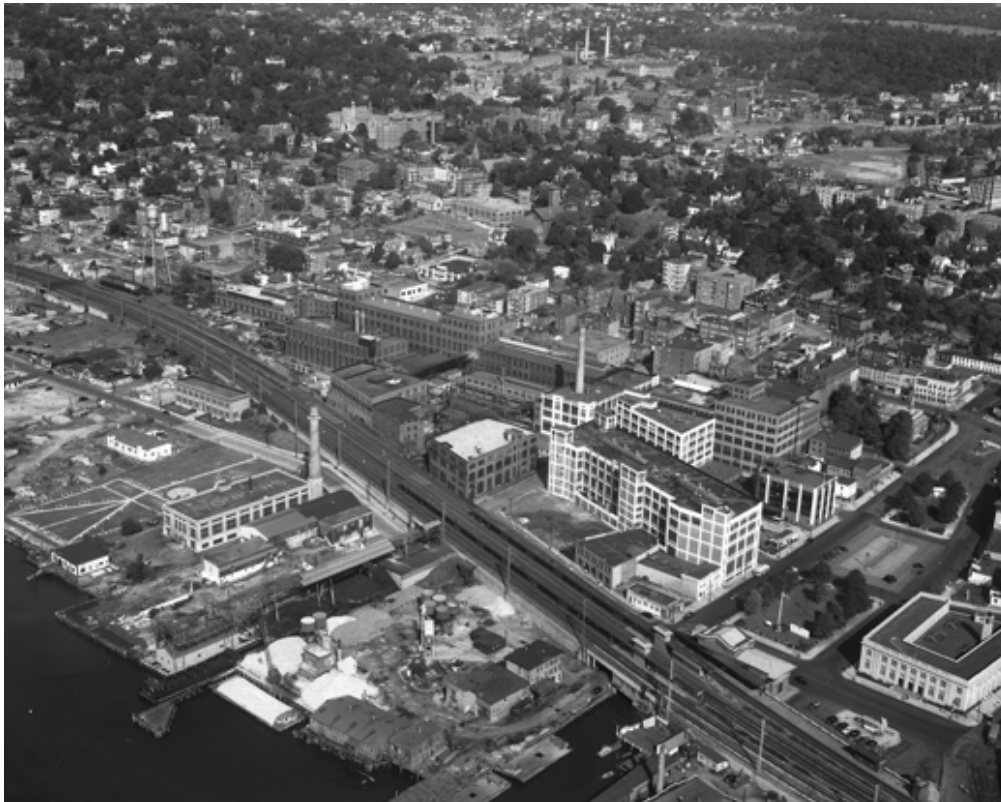
Photo 8. 1946 Fairchild Aerial Survey of Yonkers. Larkin Plaza (Blocks B and C) is in the lower right corner. From the New York State Archives Digital Collections.

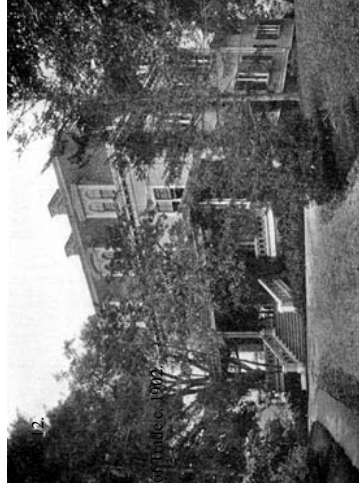
Photo 12. Circa 1902 view of the Baldwin/Waring estate house located on South Broadway, within Block D. From Yonkers Board of Trade, c. 1902.

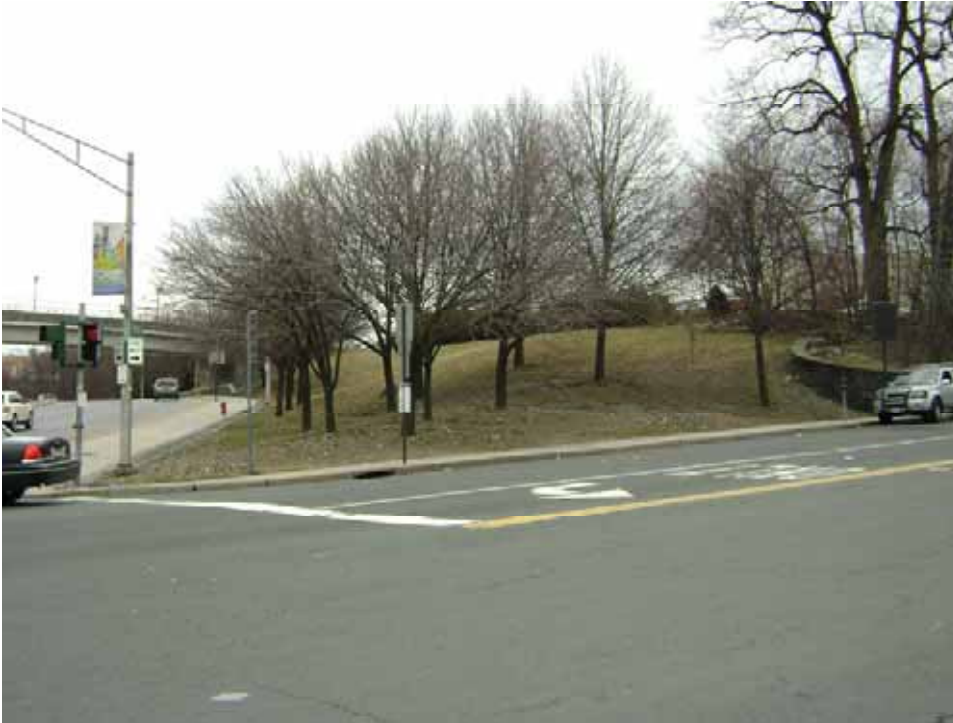
Photo 13. View of the northwest corner of the Block D at the corner of Nepperhan Avenue and South Broadway. Nepperhan Avenue was originally straight and extended through this section. Remains of the stone retaining wall are still visible (right side of photo) within this portion of the project area (Maps 10 and 11).

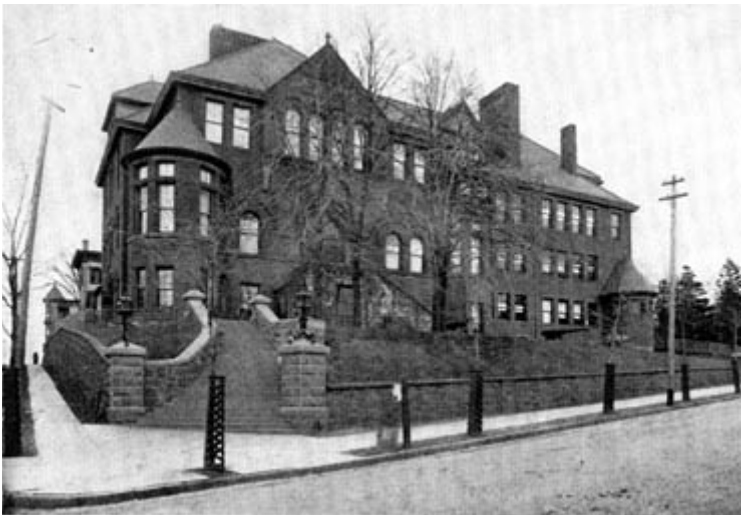
Photo 14. Circa 1902 view of Yonkers High School at the southeast corner of Nepperhan Avenue and South Broadway in Block D. From Yonkers Board of Trade c. 1902.

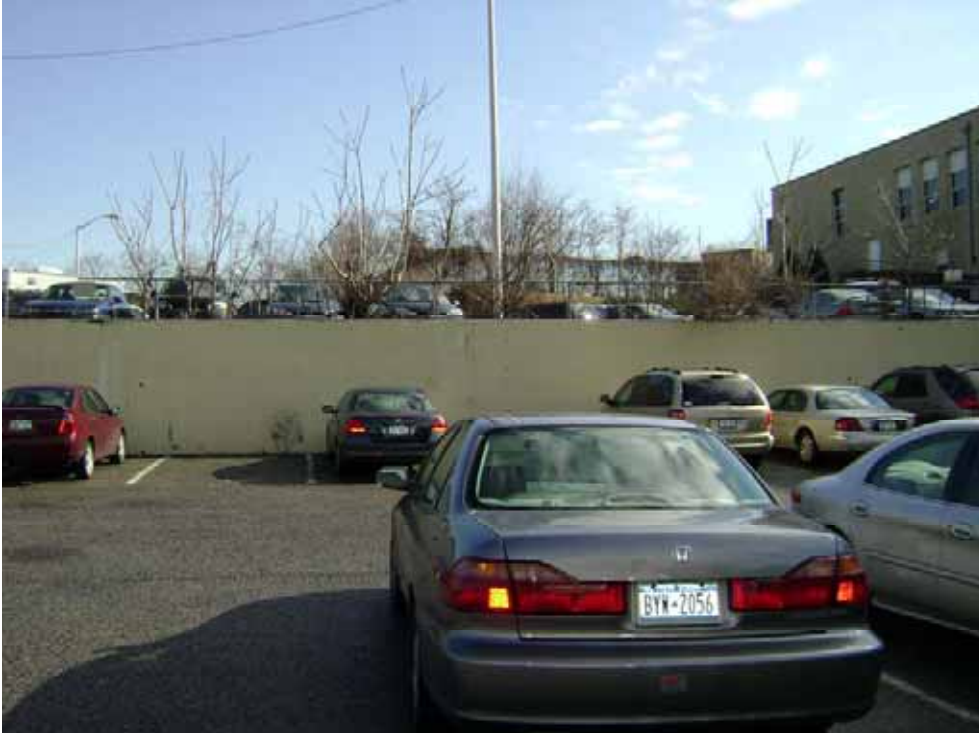
Photo 15. East view of the southern portion of Block D from within the terraced parking lot. The northern portion of Block D appears terraced on the 1898 Sanborn map. While it is not clear when terracing occurred within the southern portion of the block, the eastern end of the parking lot seems to follow a natural slope.

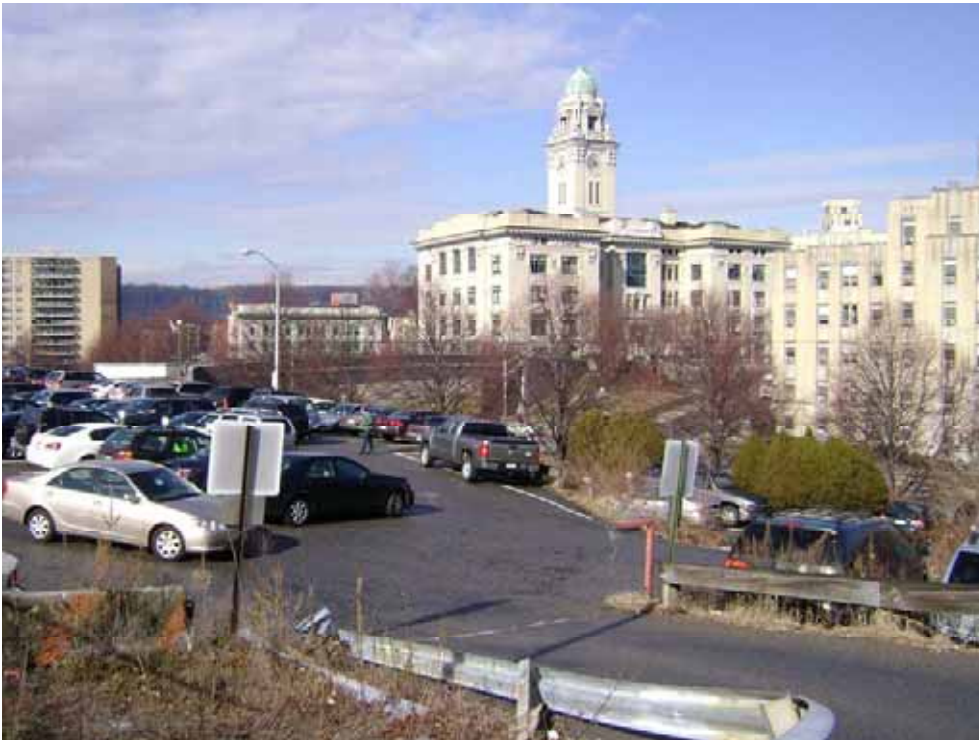
Photo 16. Northwestern view of the terraced parking lot within the northern section of Block D. City Hall, located across Nepperhan Avenue from the Cacace Center project area, is visible in the background.

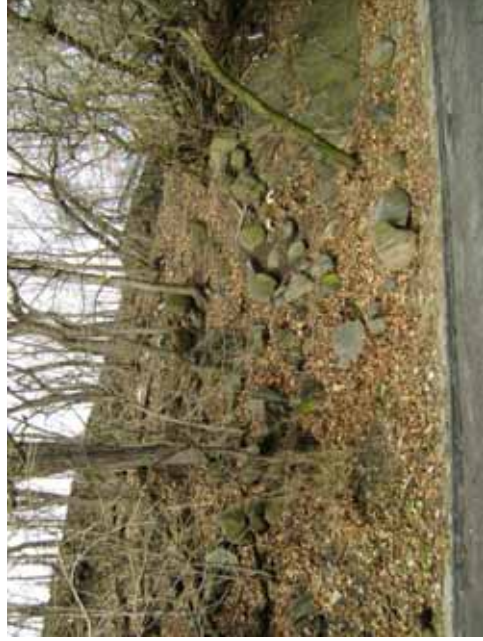
Photo 17. View west toward the steep slope and bedrock outcroppings located along the eastern end of Block D along Guion Street.

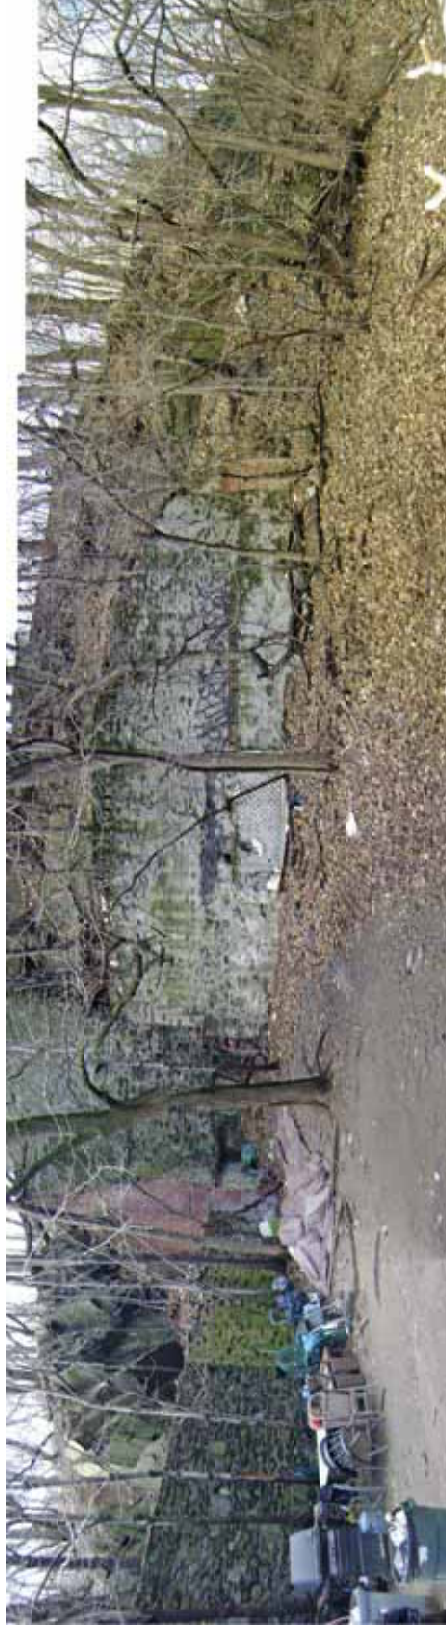
Photo 18. View toward the remains of foundation walls located along the northeastern portion of Block D at the corner of Nepperhan Avenue and New Main/Guion Street. A series of two-story structures was constructed into the steep slope during the late-19th century (Maps 9-12). These structures, utilized at least until the mid-20th century, contained small businesses on the ground floors as well as upper-level apartments.

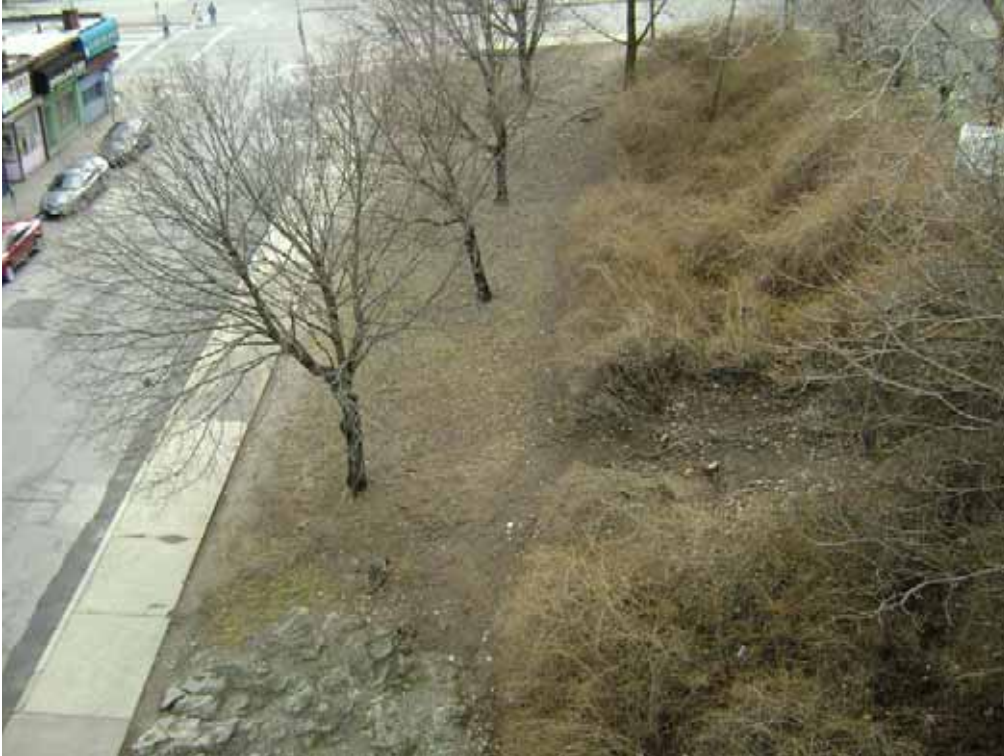
Photo 19. View of the southeastern corner of Block E from the roof of a six-story parking garage located within the center of the block. This photograph shows one of the only unoccupied areas within the block.

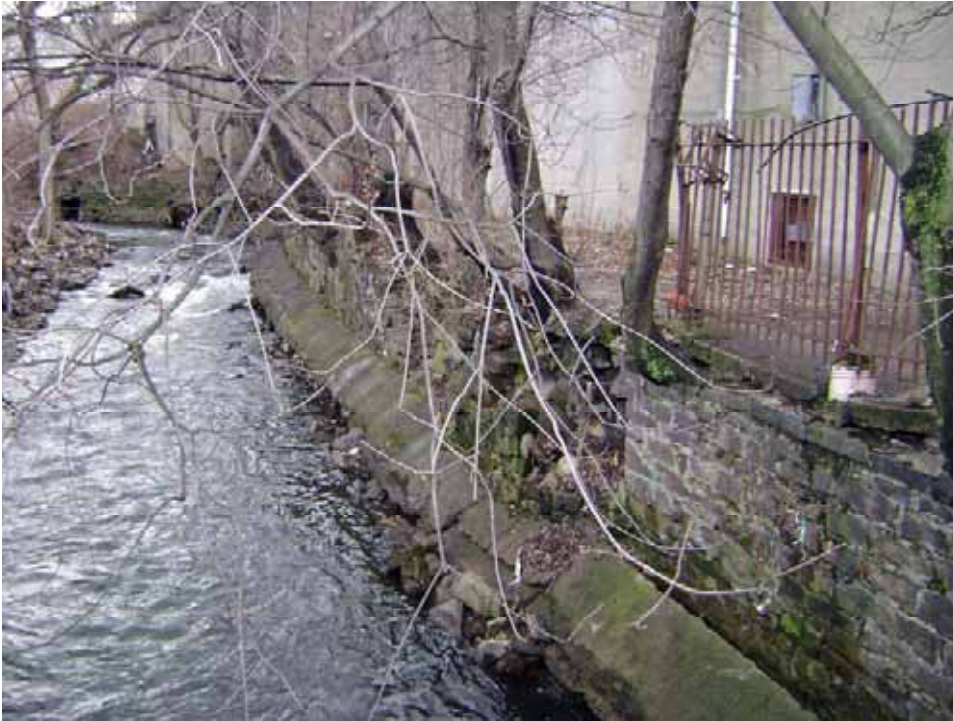
Photo 28. View southeast along the uncovered Saw Mill River within Block I from the Ann Street bridge. Nineteenth century walls, possibly retaining walls or building foundation remains, are visible lining the river.

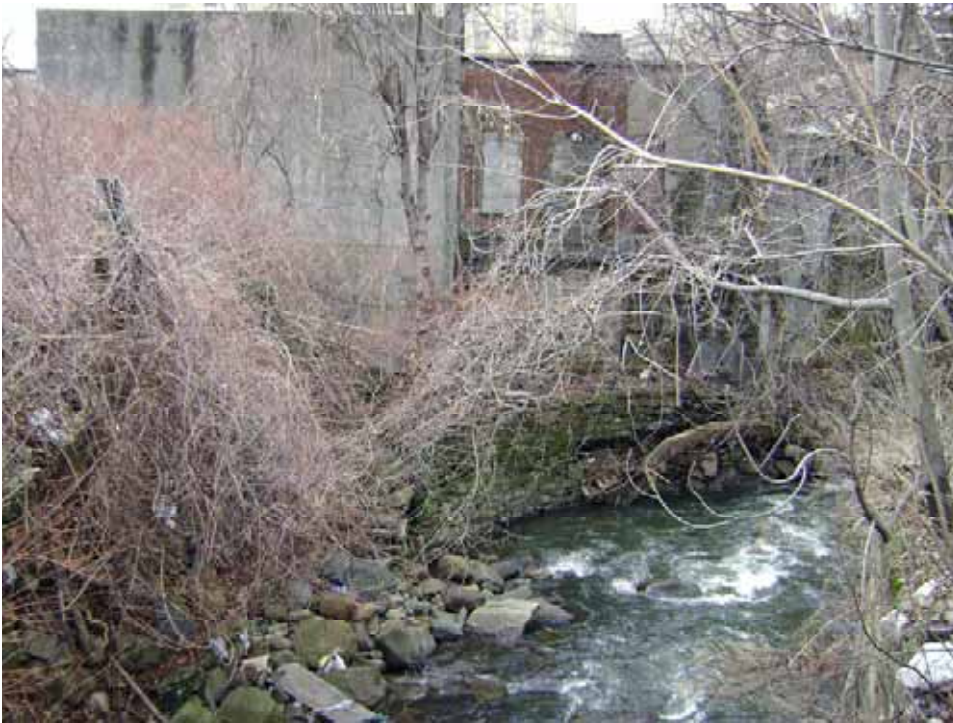
Photo 29. View west showing the curve of the Saw Mill River and 19th century retaining wall west of Henry Herz Street. A livery and morocco leather factory were located within this area south of the river bend (left side of photo) during the 19th century (Maps 8-10).

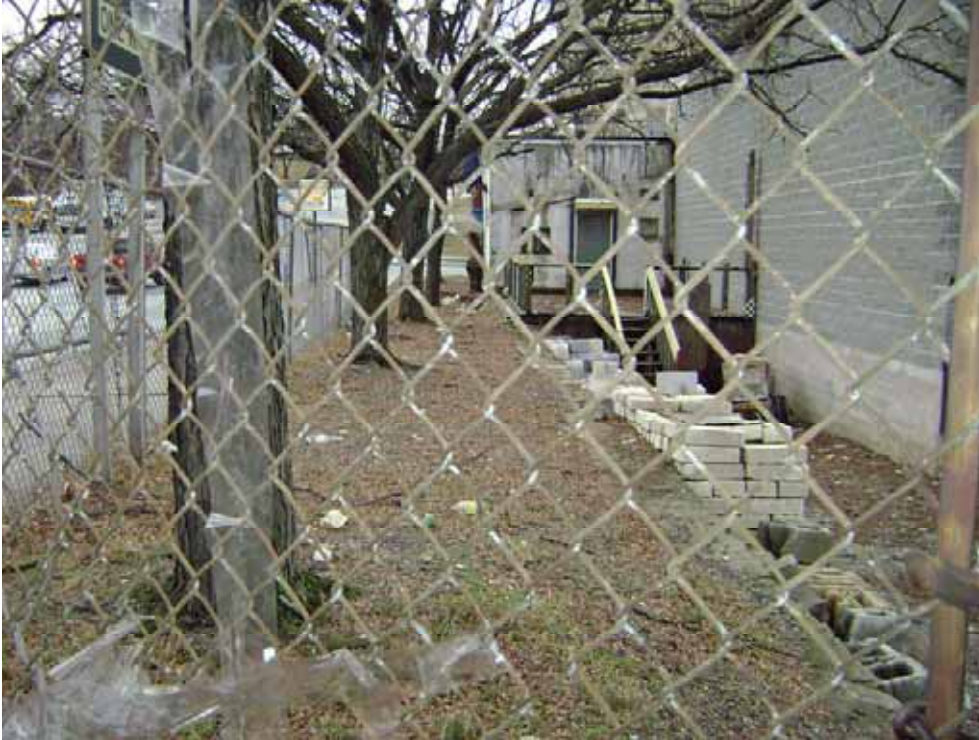
Photo 30. View southwest along the northern side of Nepperhan Avenue from Henry Herz Street. Nepperhan Avenue was extended north into the footprints of the late-19th and early-20th century commercial/residential structures fronting Nepperhan Avenue. The rear foundation walls of these structures are currently visible along the right side of the photo.

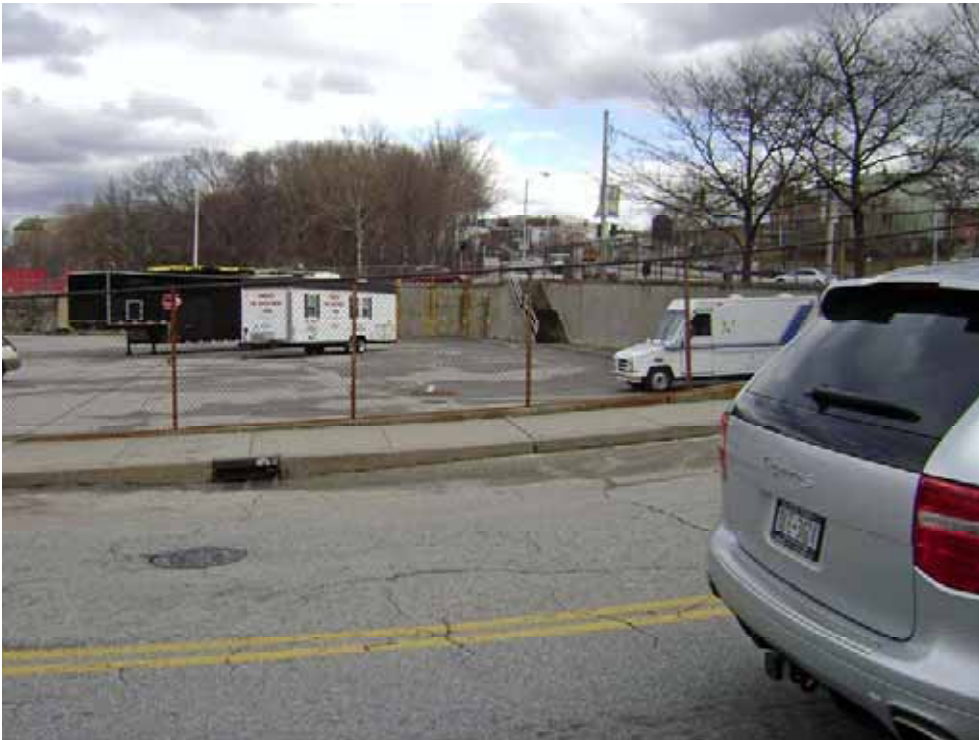
Photo 31. View northeast toward the center of Block I, located within the Chicken Island parking lot. Nepperhan Avenue (right) and New School Street (background) are elevated above the block within this area.

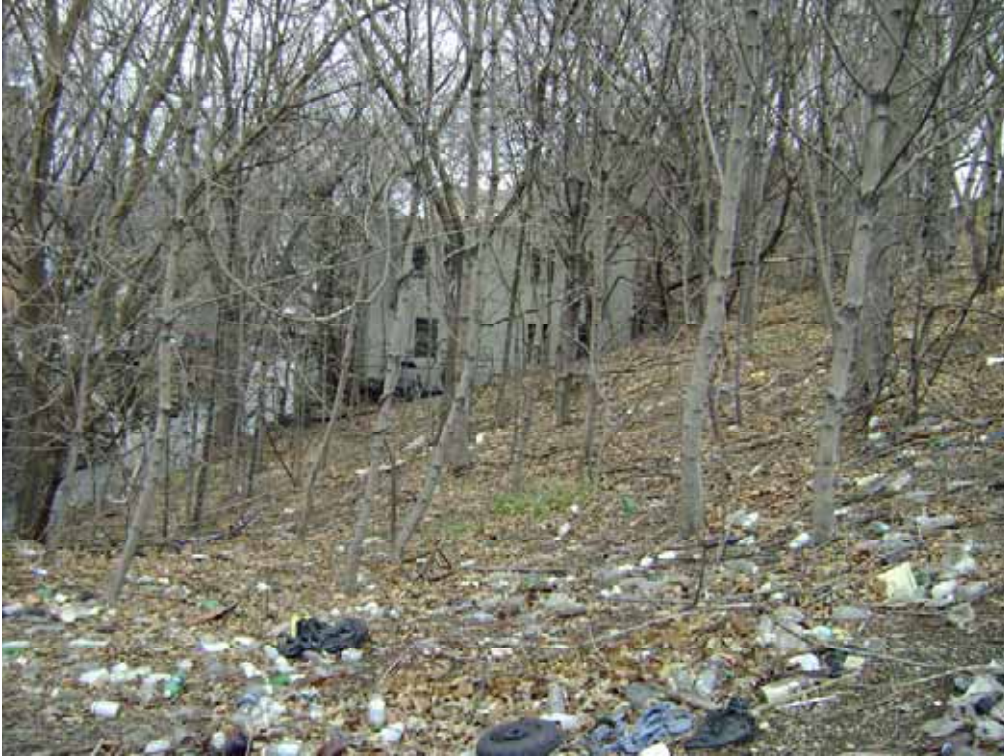
Photo 32. Eastern view of the northern portion of Block I from New School Street. Single-family homes, tenements, and small businesses once fronted Nepperhan Avenue at the top of the steep slope, while the rear yards were located along the slope. The structure in the background is located at the southern end of Block N.

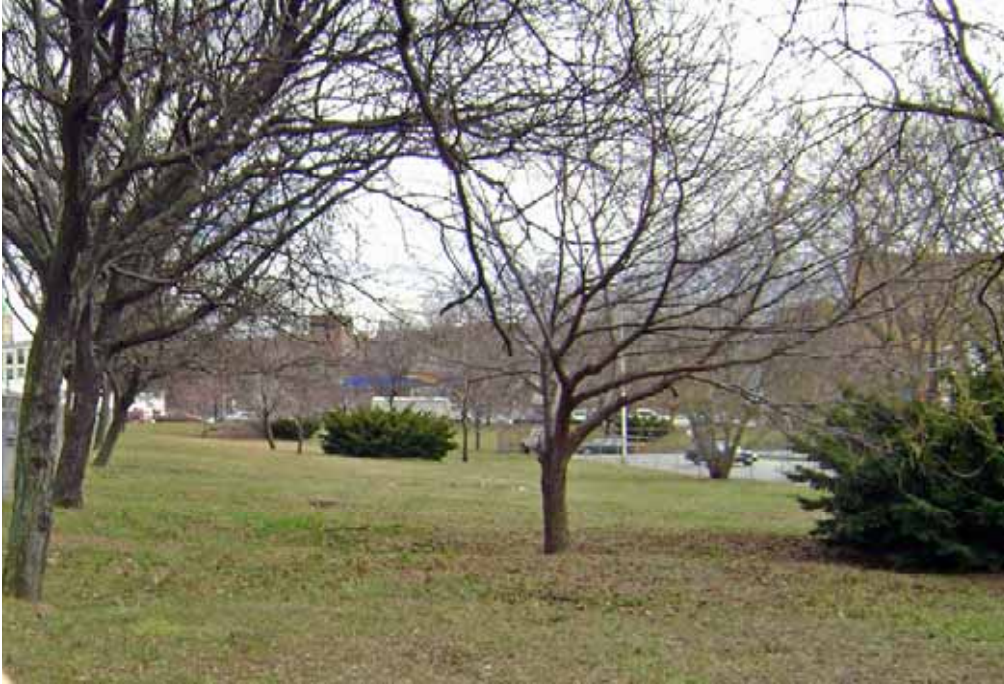
Photo 36. View east of Block K from the corner of James Street and Palisade Avenue. Cellar holes and foundation remains are visible on the surface along the entire northern end of this block.

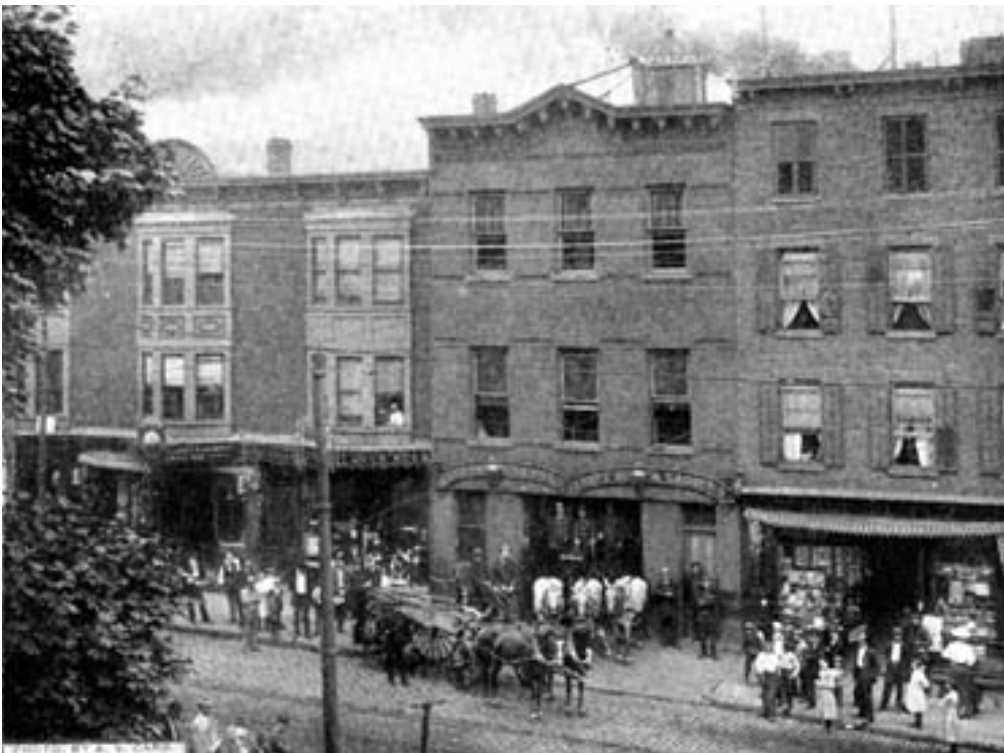
Photo 37. Circa 1902 view south of the fire station at 18 Palisades Avenue, located within Block K. The fire station is in the center of the photo. From Yonkers Board of Trade c. 1902, pg. 141.

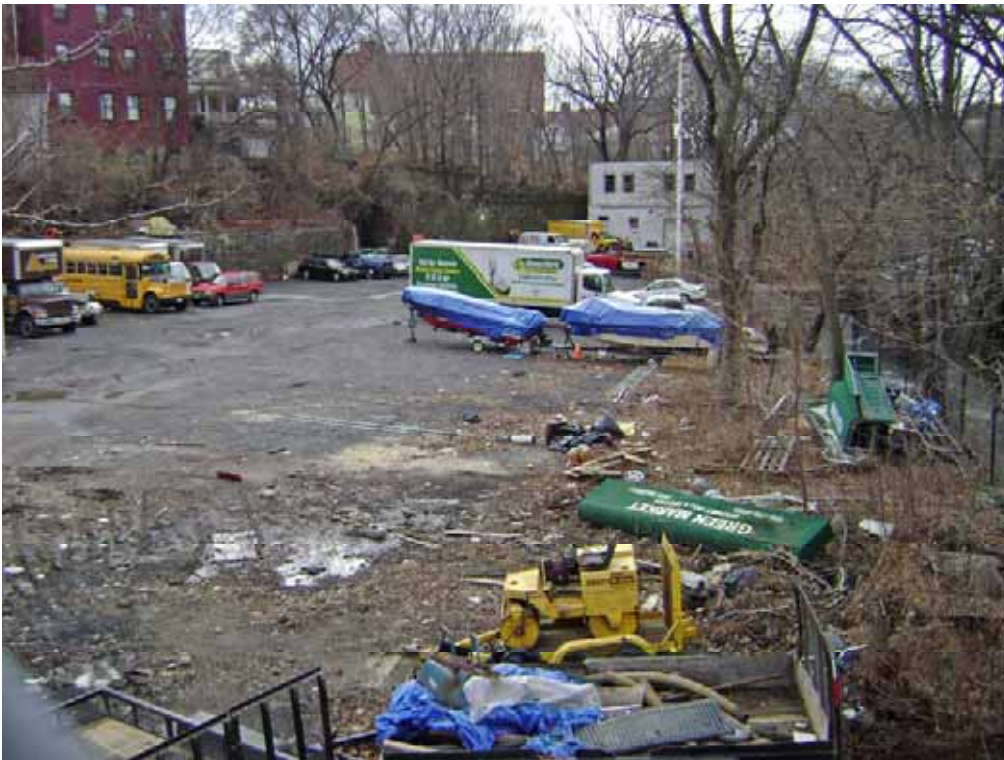
Photo 39. Southern view of the western end of Block N from Elm Street. The Rose, McAlpin and Company leather factory occupied this area from at least 1886 until at least the mid-20th century. The Saw Mill River is visible on the right side of the photo, while a 19th century stone retaining wall is visible on the left.

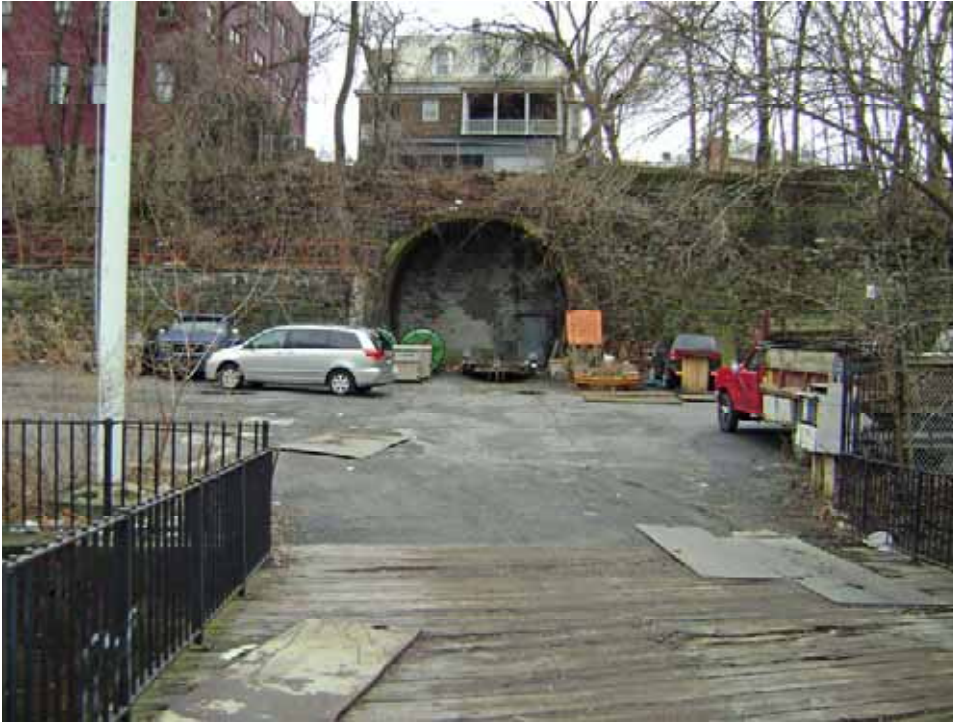
Photo 40. View east toward an underground vault located along the eastern edge of Block N. The vault is depicted on the 1886 Sanborn map (Map 9) and is surrounded by a 19th century retaining wall.

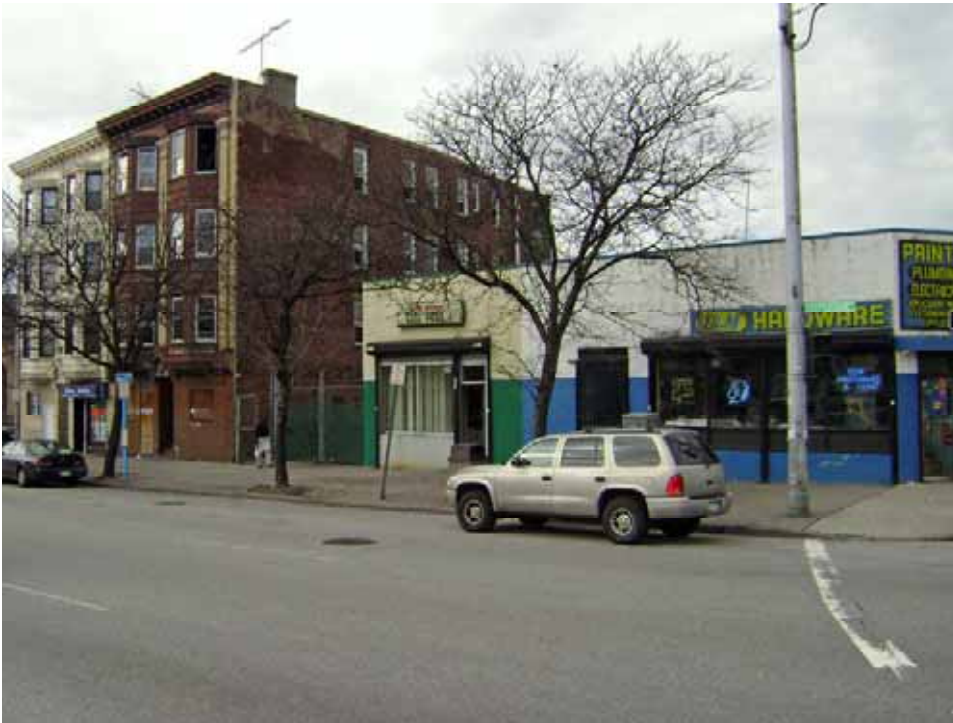
Photo 41. View west toward the northeastern end of Block N from the Nepperhan Avenue median. The four-story tenement building dates to the late-19th or early-20th centuries, while the single-story commercial structure possibly dates to the mid-19th century.
