## **PHASE I ENVIRONMENTAL SITE ASSESSMENT**

**33 John Street  
Yonkers, New York 10701**

**April 10, 2006**

**ACT File #: 5435-YONY**

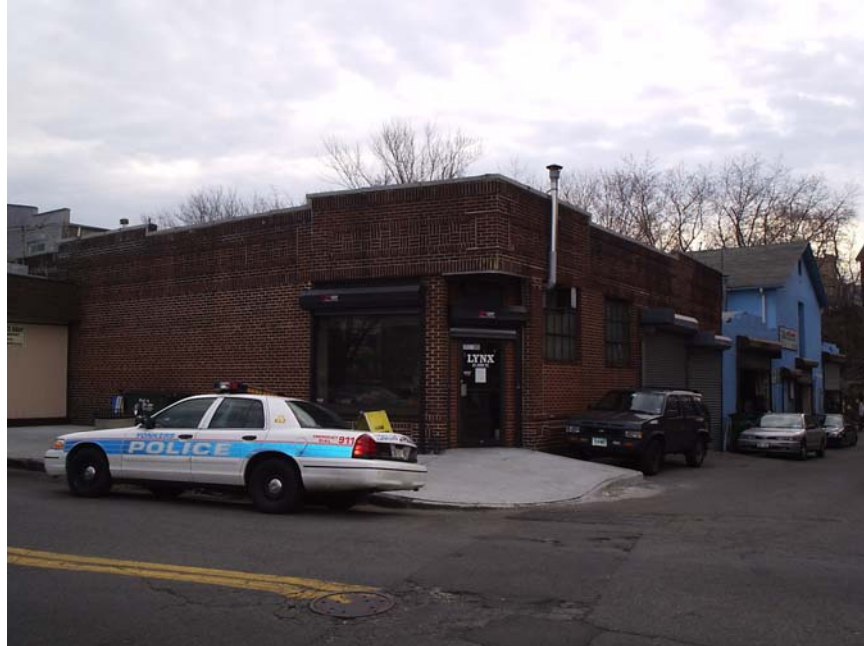
Photograph 1: 33 John Street, Yonkers, New York

The subject property consists of a one-story commercial building (Photographs 1 through 6). The building contains a full basement. The footprint of the building is approximately 2,800 square feet in area and encompasses the entire property. A Site Diagram is provided as Figure 2.

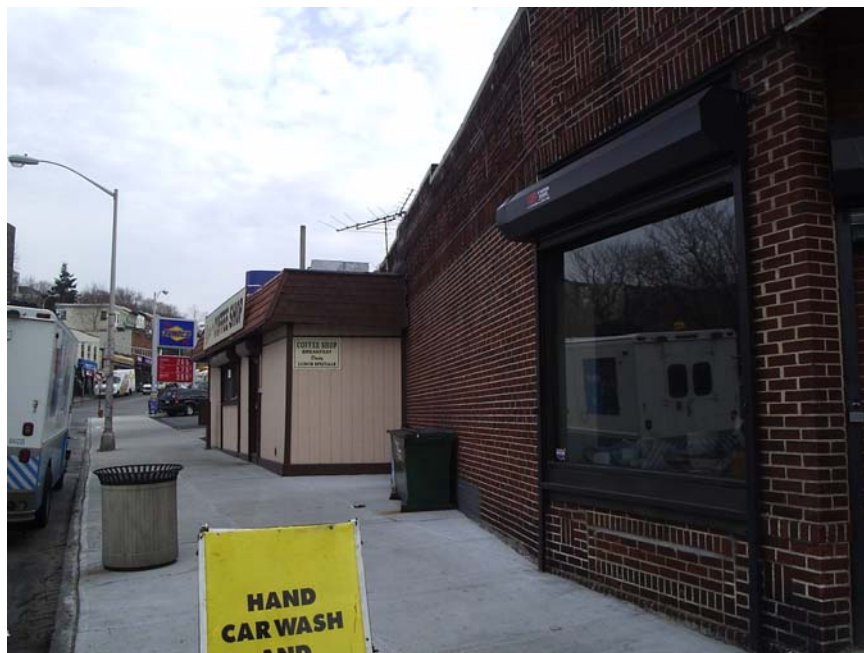
Photograph 2: Subject Property, Coffee Shop

The commercial building contains two commercial units and no residential apartments. The commercial units consist of an air conditioning company, Lynx Air Conditioning, and Lisa's Coffee Shop. The northwest portion of the building contains the coffee shop. The coffee shop contains a seating and counter area and a kitchen. The remainder of the building is utilized by Lynx Air Conditioning. The first floor contains storage areas for air conditioning materials, tools and equipment and an office area. A roll up door accesses the first floor. Two vehicles were also identified on the first floor. The interior of the building consists of concrete floors and painted drywall and concrete block walls. Ceilings consist of drywall and suspended ceiling tiles.

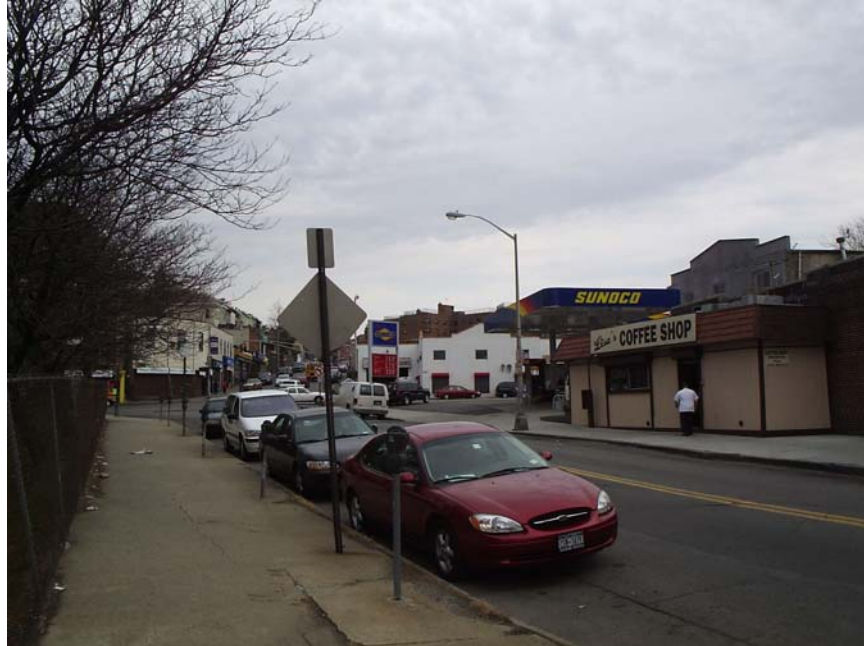
Photograph 3: View of Gasoline Station located to the north of the Subject Property

A gasoline station has been located adjacent to the north of the subject property since prior to 1951. This gasoline station is associated with numerous closed spills, mentioned in Section 5.0 of this report, and may be impacting the environmental quality of the subject property.

The NYSDEC Spills and Leaking Underground Storage Tank (LUST) lists were searched for all reported spills within ½ mile of the subject property. The subject property is not listed in the databases as containing a Spill or LUST. A total of 160 Spills or LUSTs have occurred within ½ mile of the property. The closest active site is located approximately 586 feet south of the subject property. This site and the remaining active sites should not impact upon the environmental quality of the subject property. A total of five closed spills are identified at the gasoline station located adjacent to the north of the subject property. This gasoline station may be impacting the environmental quality of the subject property.

The soil and groundwater quality beneath the subject property should be evaluated to determine if the adjacent gasoline station has impacted the environmental quality of the subject property. This can be accomplished by the installation, sampling and analysis of soil borings and temporary groundwater monitoring wells throughout the subject property. The results of the above evaluation should be presented in a formal Phase II Environmental Site Assessment Report. The Phase II Environmental Site Assessment can be accomplished for approximately \$6,000.00.

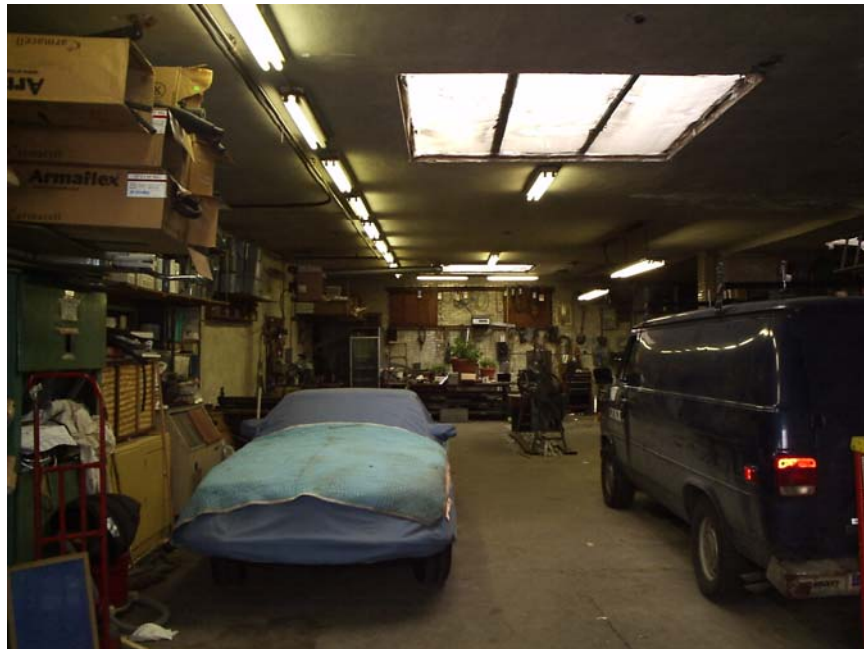
Photograph 4: First Floor Interior

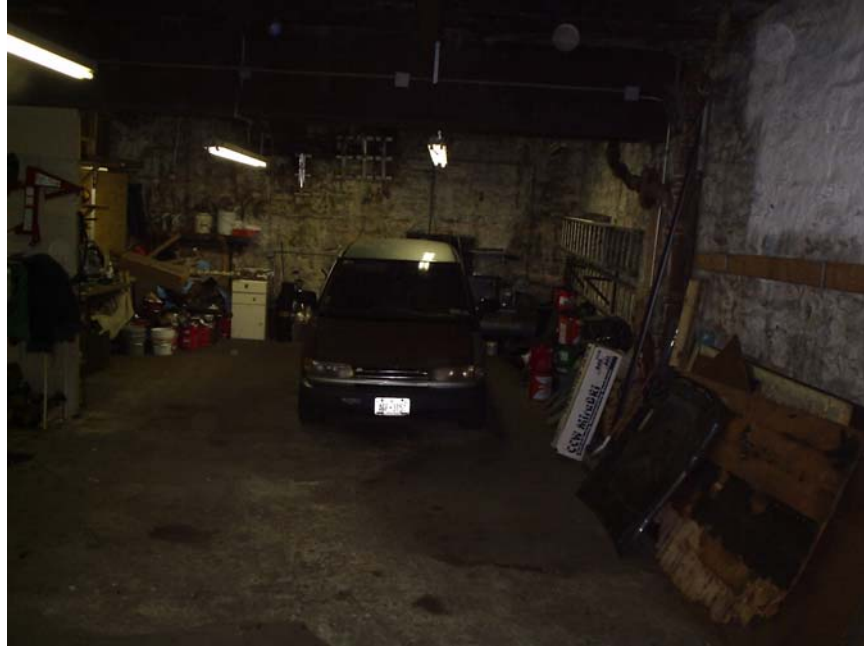
Photograph 5: Basement Interior

The basement can be accessed from a roll up door at street level and a concrete ramp which leads to the basement. An automobile is located in the basement. The basement of the building also contains the utility meters and storage areas. Two floor drains were identified in the basement of the building. No stains, odors or evidence of spills were identified in the vicinity of the floor drains or throughout the building.

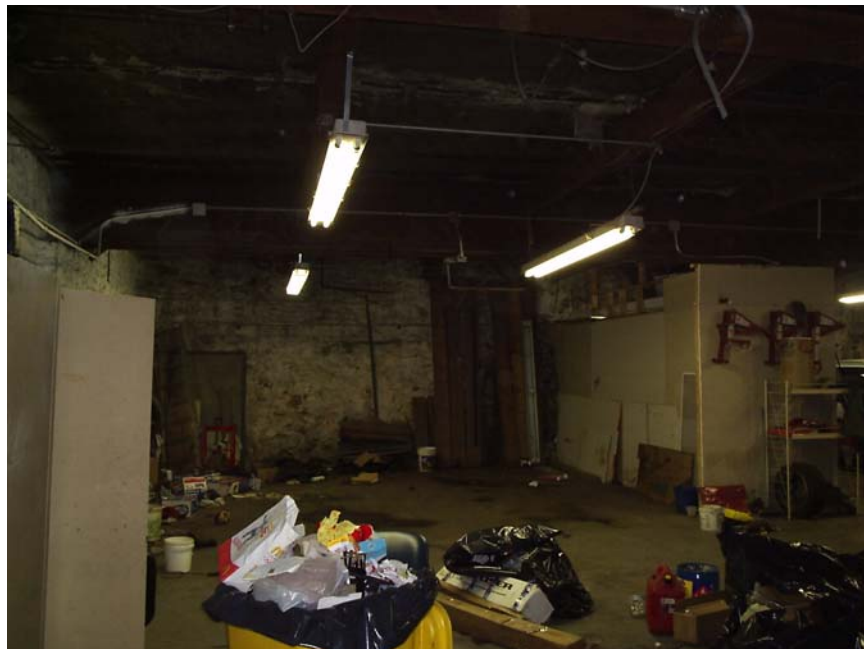
Photograph 6: Basement Interior

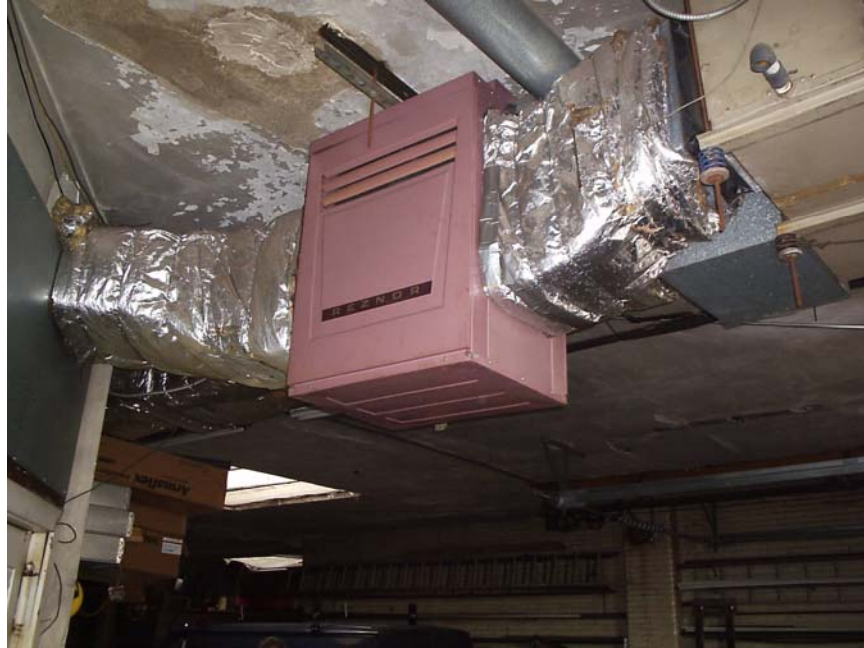
The electrical, natural gas and water services enter the building underground along the southern property boundary. The utility meters are located in the basement of the building. The property is connected to the municipal sewer system. The building is provided heat via natural gas-fired overhead heating equipment located throughout the building (Photograph 7). The building is provided hot water via natural gas-fired heating equipment. No stains, odors or evidence of spills were identified in the vicinity of the heating equipment.

Photograph 7: Overhead Natural Gas Fired Heating Equipment
