SAWMILL RIVER CULVERT/FLUME INSPECTION Yonkers, New York

McLaren Engineering Group
100 Snake Hill Road
West Nyack, NY 10994

August 2006
Revised December 2007

MEG Job No. 106100.01

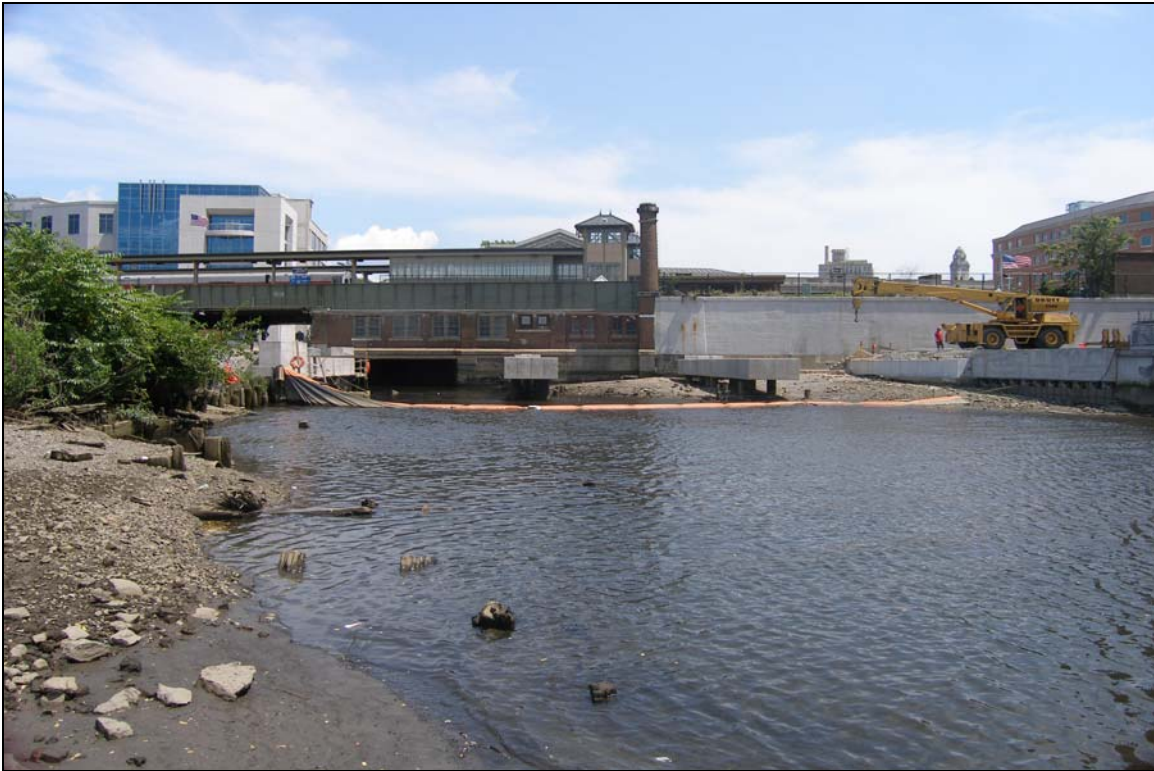
The Saw Mill River is a tributary of the Hudson River. As seen in Photos 1 and 2, the river flume discharges from beneath the Metro North Train Station into a 400' long by 100' wide tidal basin before it eventually reaches the Hudson. A concrete seawall has been constructed along the southern shoreline of the basin, and the northern shoreline is currently in the process of being developed (see Photo 3).

Photo 1 General view of Yonkers Metro North Train Station from Hudson River. Note construction of new bridge pier in front of station.

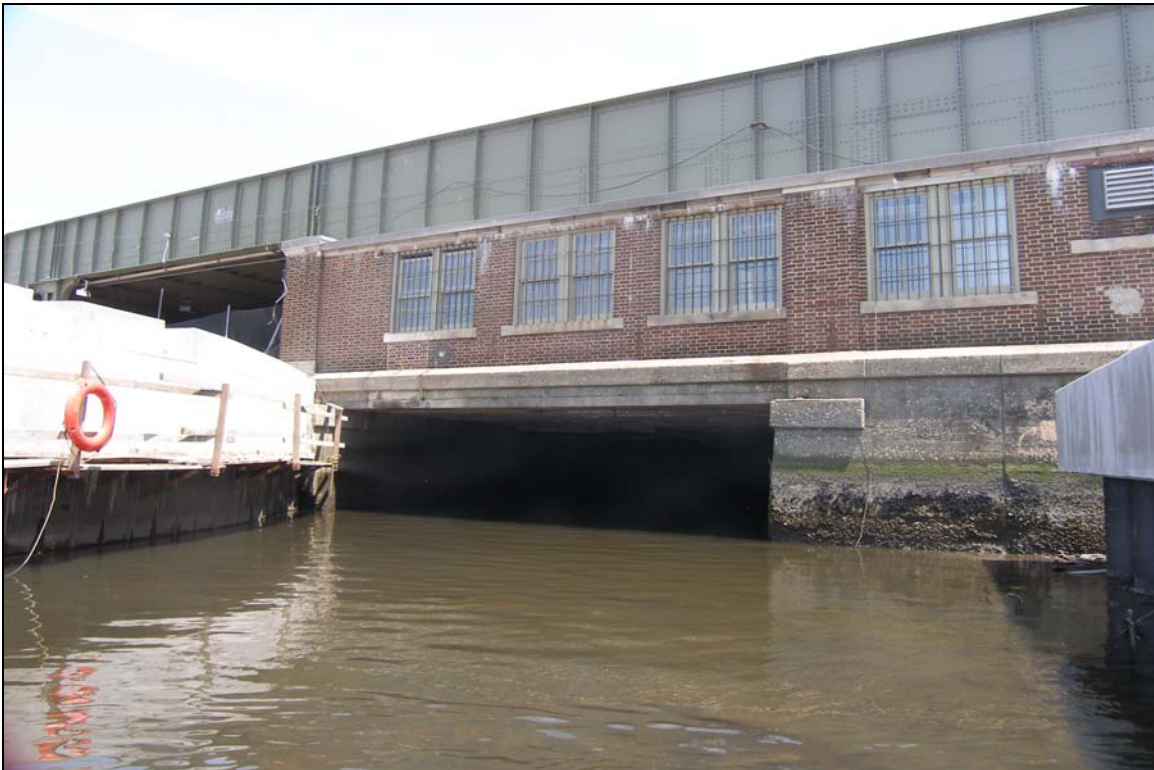
Photo 2 West elevation of Yonkers Metro North Train Station at Saw Mill River outfall.

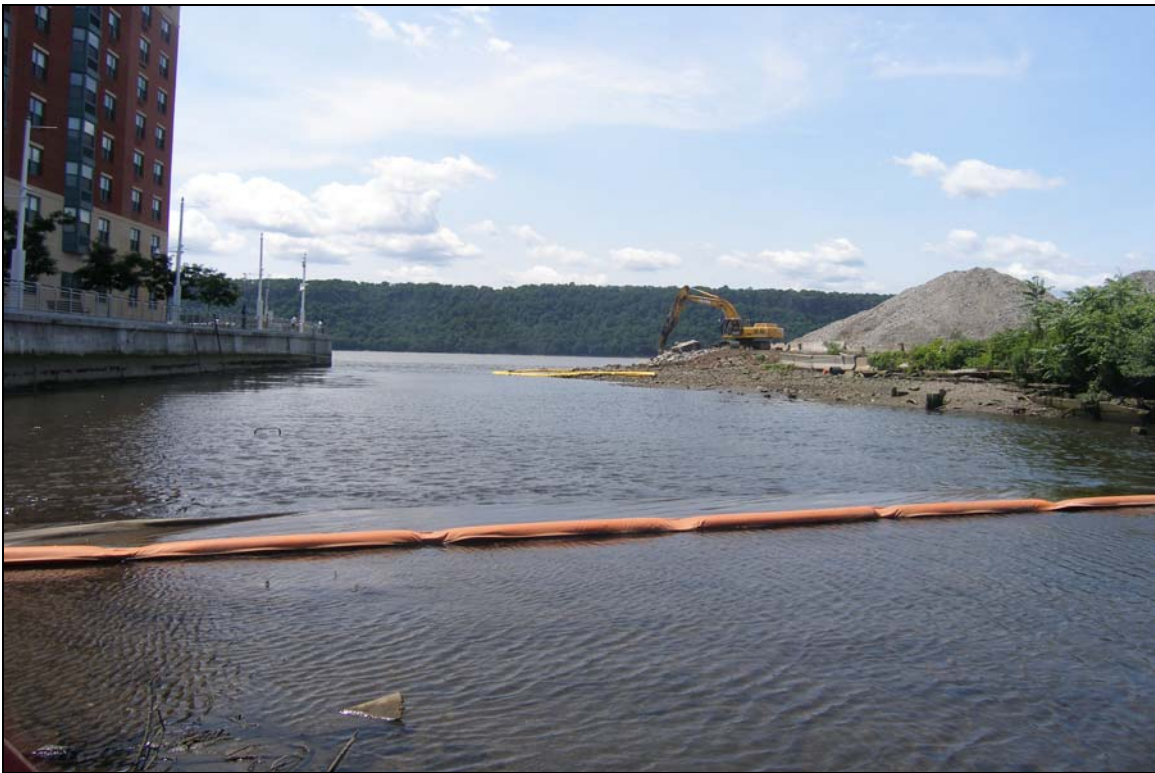
PHOTO 3 General view of western terminus of Saw Mill River. Note Hudson River in background.

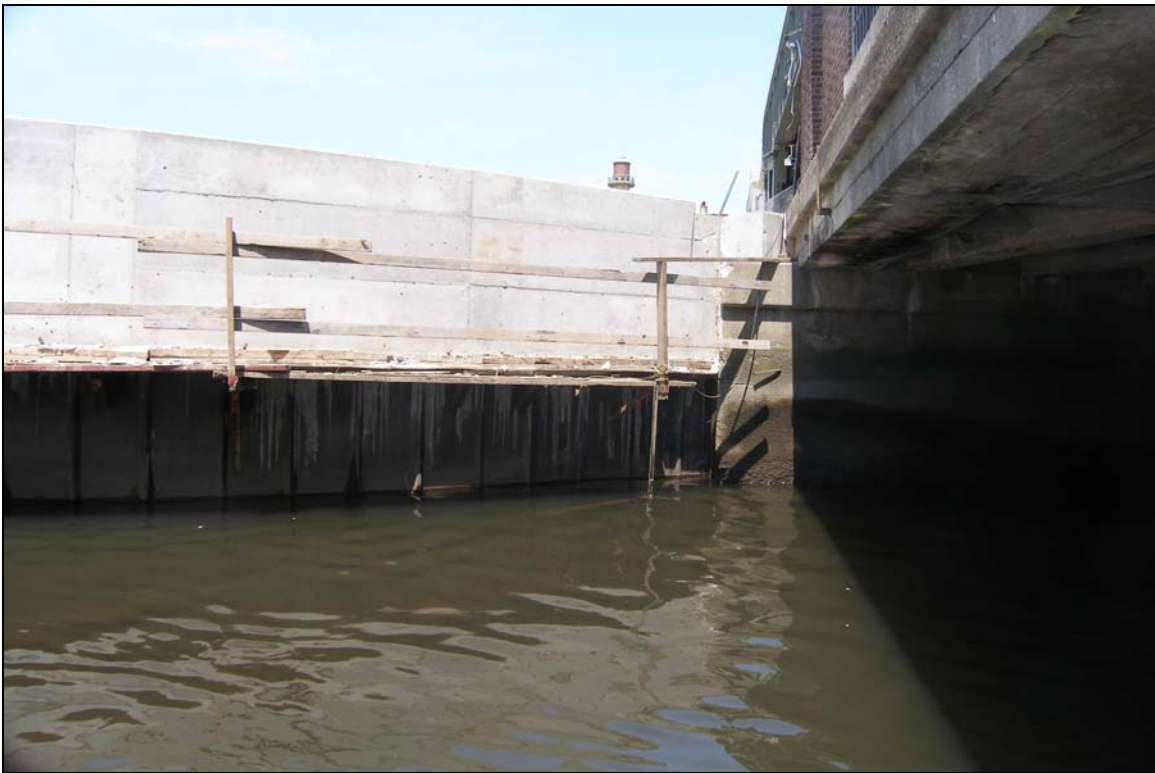
In addition, construction of a new roadway bridge is underway just west of the Metro North Train Station. As seen in Photo 4, a new steel sheet pile bulkhead has been installed adjacent to the north abutment of the bridge which supports the Metro North Train Station.

PHOTO 4 New steel sheet pile bulkhead located adjacent to western end of north bridge abutment.

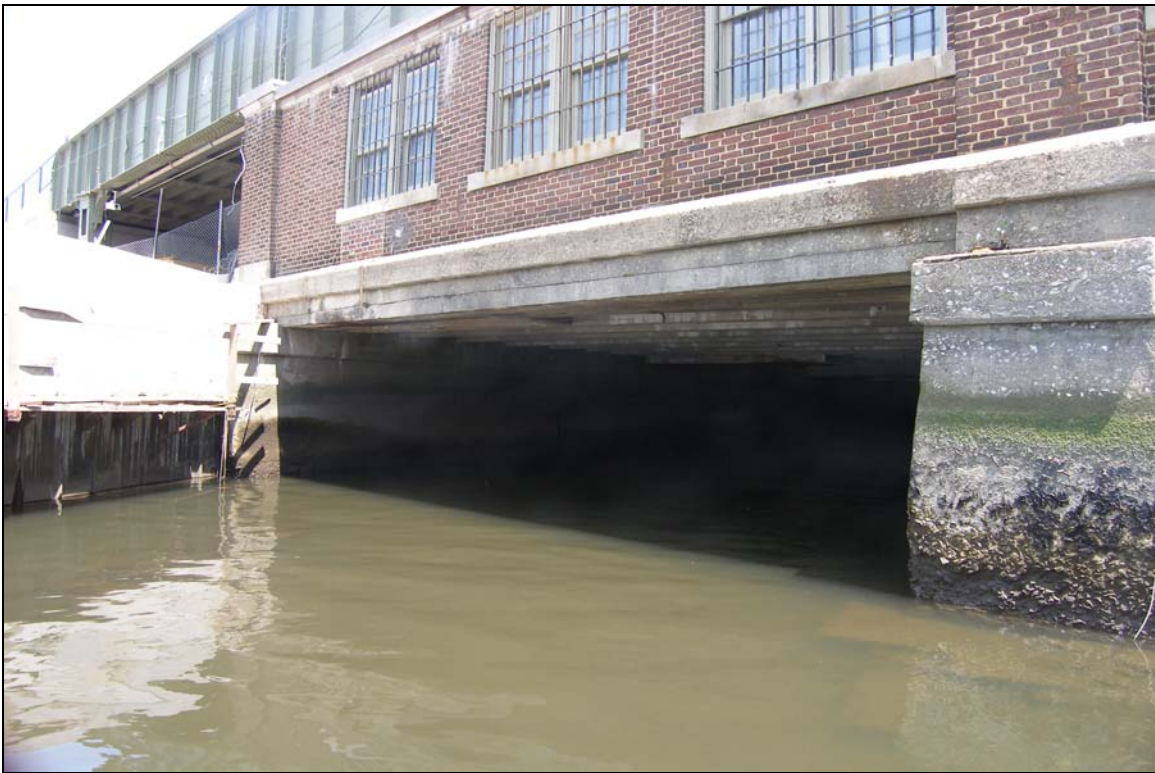
Bridge No. HU 15.25 extends under the Hudson line of the Metro-North Railroad. The bridge is approximately 29.5 feet wide by 10 feet high and is approximately 188 feet long. A general view of the west fascia of the bridge is provided in Photo 5. Overall, the bridge is in fair condition.

Photo 5 West fascia of 29.5' wide bridge which carries the Hudson Line of the Metro North Railroad.

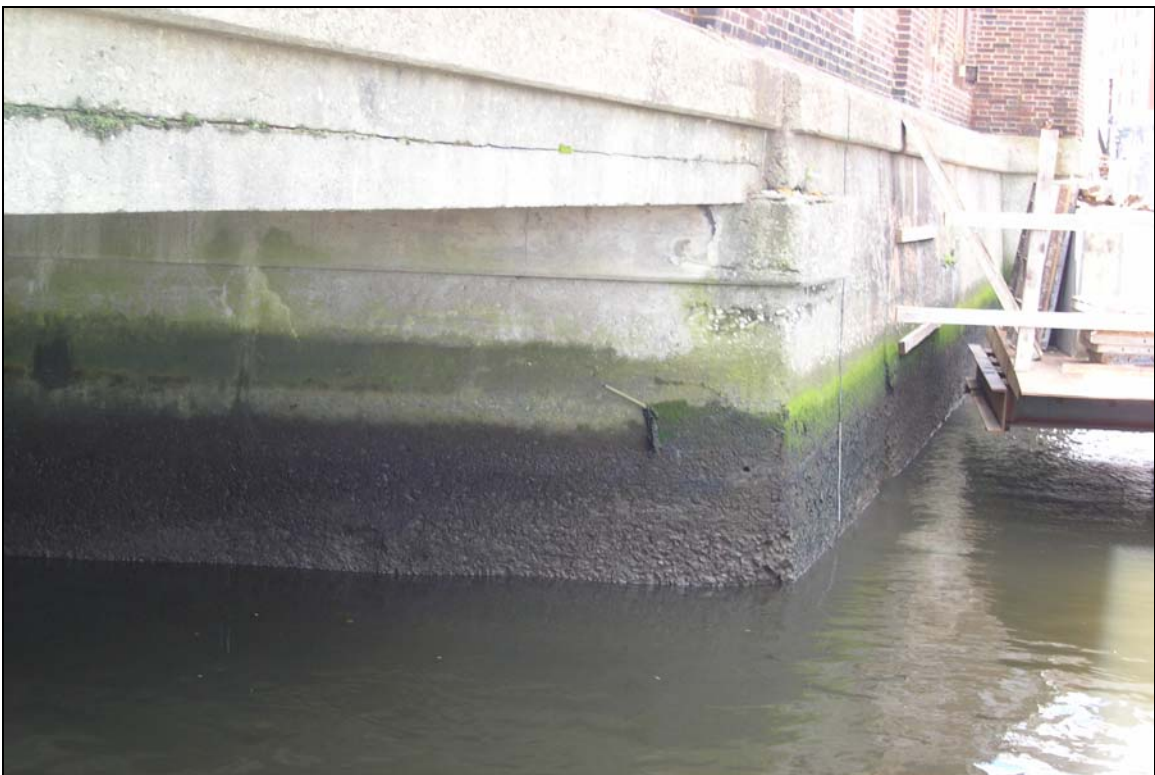
Photo 6 General view of western end of south bridge abutment and southwest wingwall.

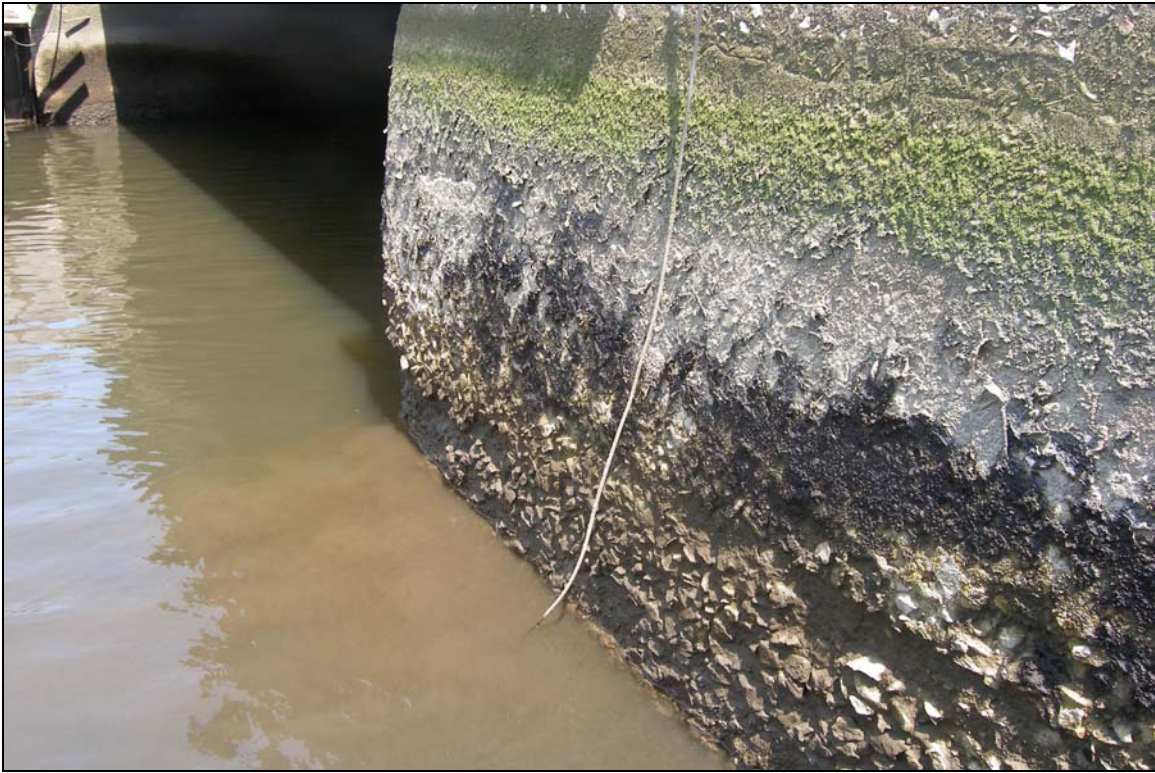
The bridge abutments and wingwalls typically exhibit moderate to heavy concrete scale within the tidal zone, see Photo 7. A layer of silt and fine stone covers the 12 in. by 4 in. timber cribbing/matting foundation of the north and south abutments. Overall, the construction joints exhibit areas of chamfer spalls and erosion in the tidal zone. Photo 8 provides a general view of typical construction joint located at the North Abutment. At the South Abutment, a 2' high by 1' wide by 3" deep spall is located at the construction joint at Station 9+43.

Photo 7 Up to 1" deep concrete scale with exposed aggregate in tidal zone at southwest wingwall.

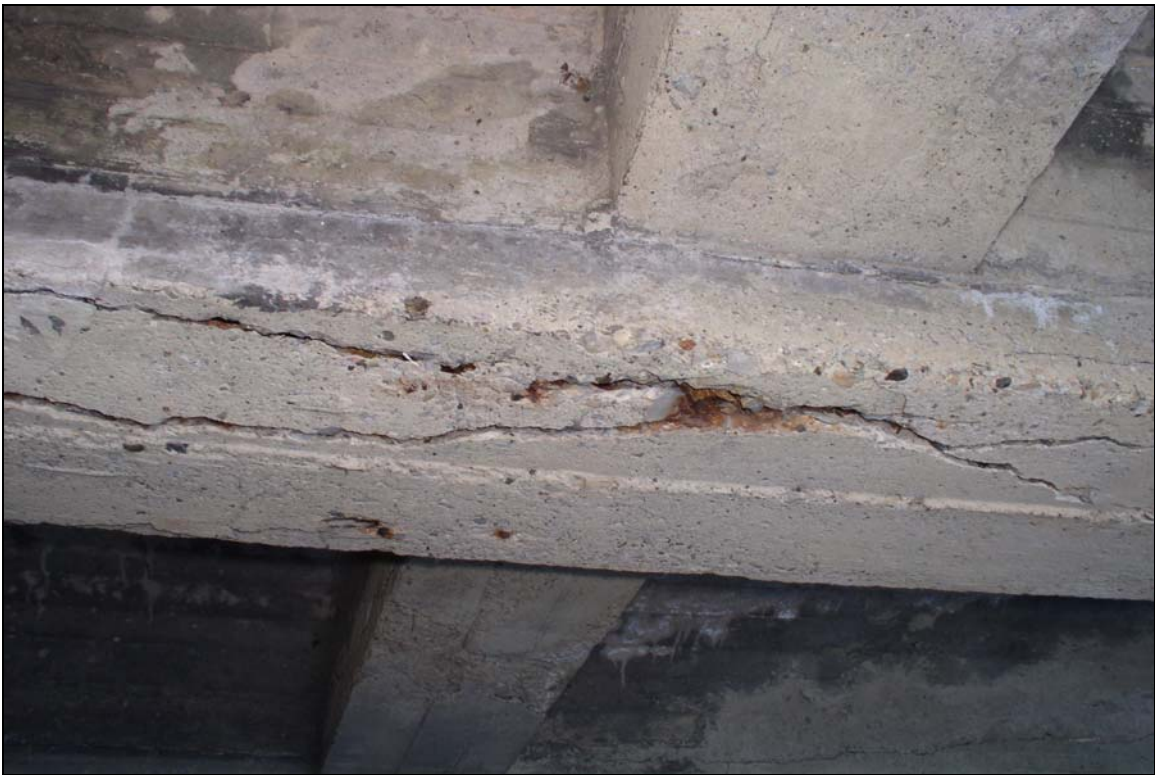
A general view of the underside of the bridge deck is shown in Photo 9. As depicted in Photos 10 through 11, the concrete beams typically exhibit multiple 1/8" to 1/4" wide cracks, spalls and areas of delamination along the bottom 6 inches of the concrete beams. These cracks vary in size, but are typically 6 ft in length. In addition, many of the concrete diaphragms have large spalls with exposed reinforcement (see Photo 12).

Photo 10 Wide cracks, delamination, and rust staining in bottom of concrete beam.

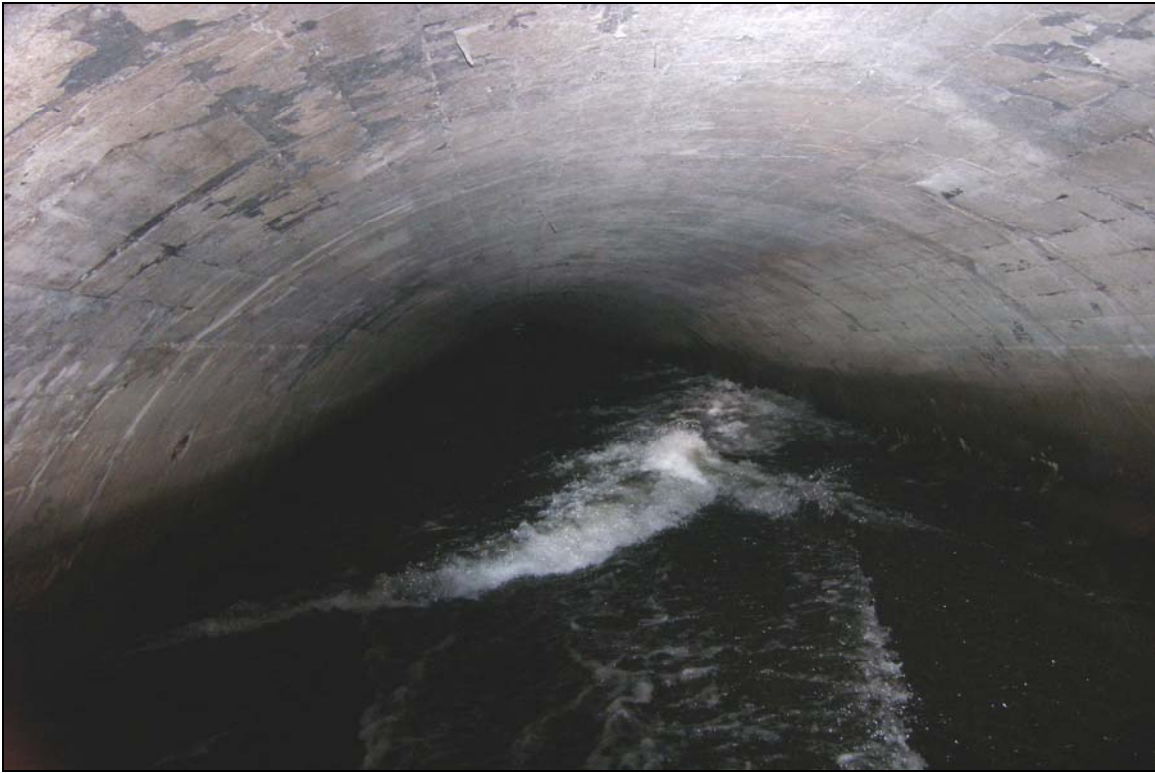
Photo 15 General view of concrete arch culvert interior. Note hydraulic jump in channel flow.

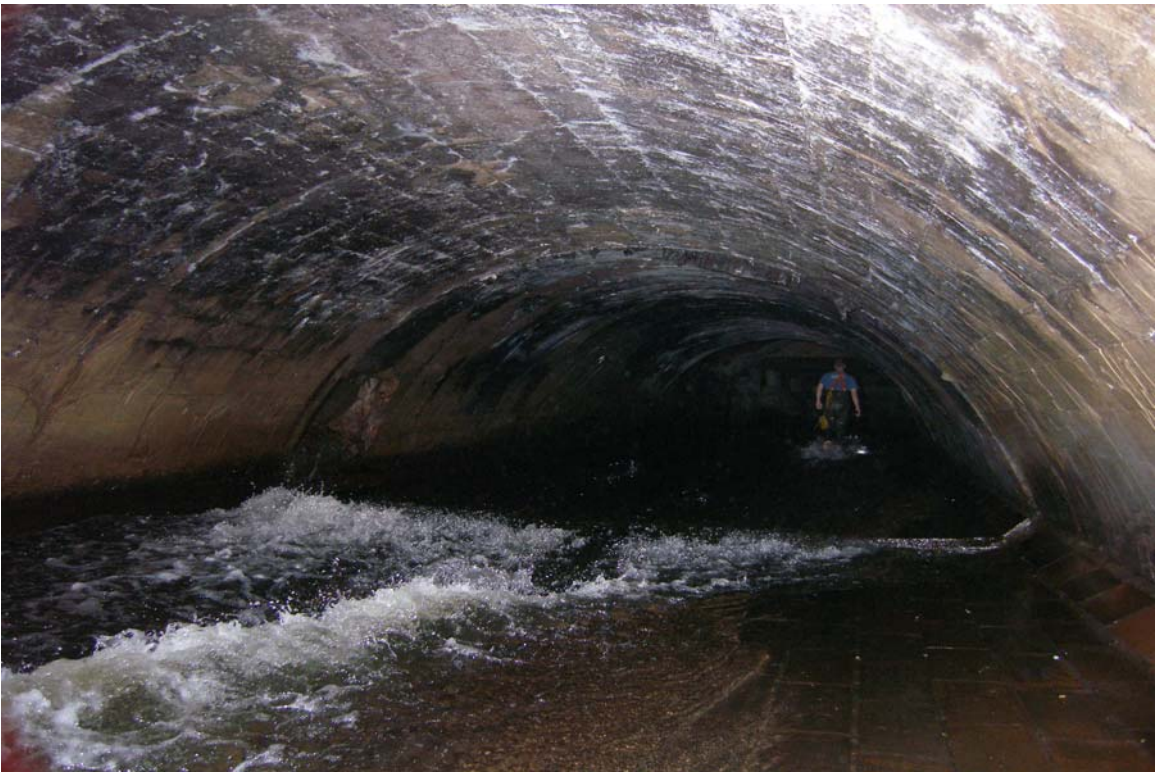
Overall the concrete arch culvert is in fair condition. The concrete arch typically exhibits localized areas of minor map cracking with efflorescence (see Photo 16). Upstream of Station 14+50, the culvert floor is lined with masonry pavers. As seen in Photo 17, many of the pavers are severely deteriorated as a result of excessive flow. The construction joints between sections of culvert typically exhibit minor chamfer spalls and loss of joint filler.

Photo 16 Minor map cracking with efflorescence in concrete arch.

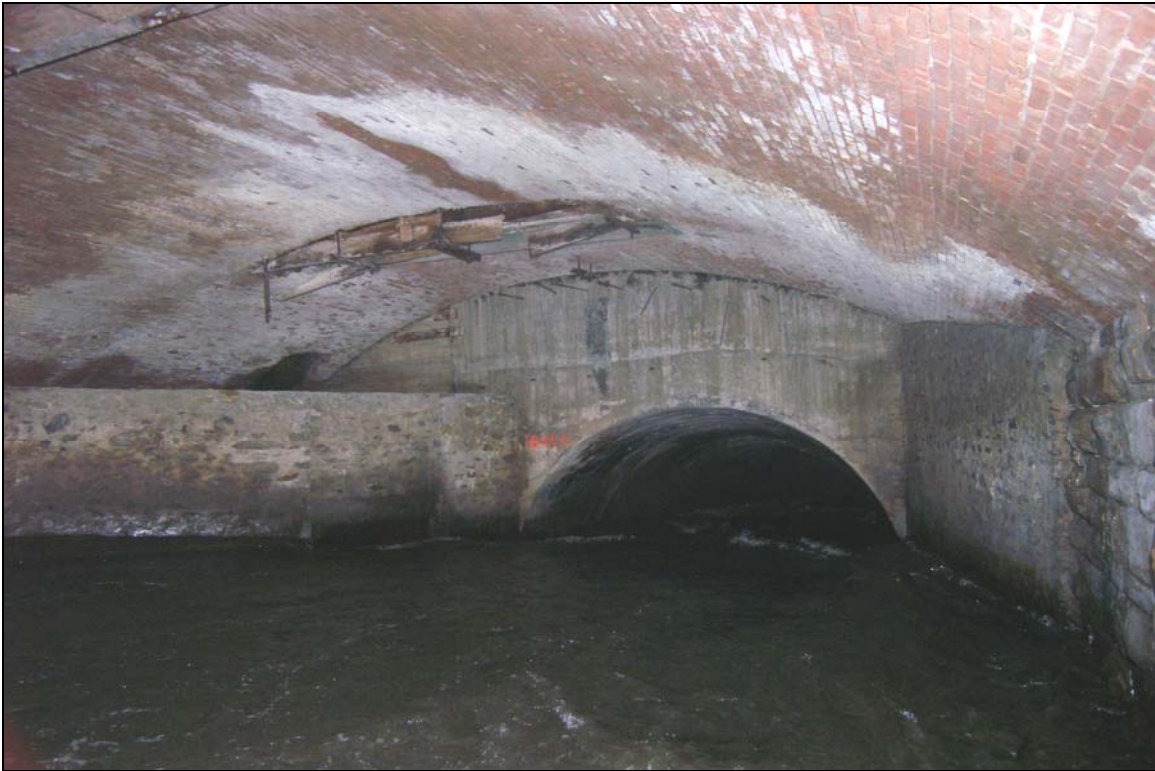
The brick arch bridge located beneath Warburton Avenue is approximately 39.5' wide by 51.5' long. A general view of the transition between the upstream concrete arch culvert headwall and the brick arch bridge is shown in Photo 19. The top of the brick arch, as measured from the concrete floor, is 16.4' and 15.6' at the downstream and upstream faces, respectively. The height of the stone abutments is approximately 9.6'.

Photo 19 General view of transition between upstream concrete arch headwall and brick arch bridge located beneath Warburton Avenue.

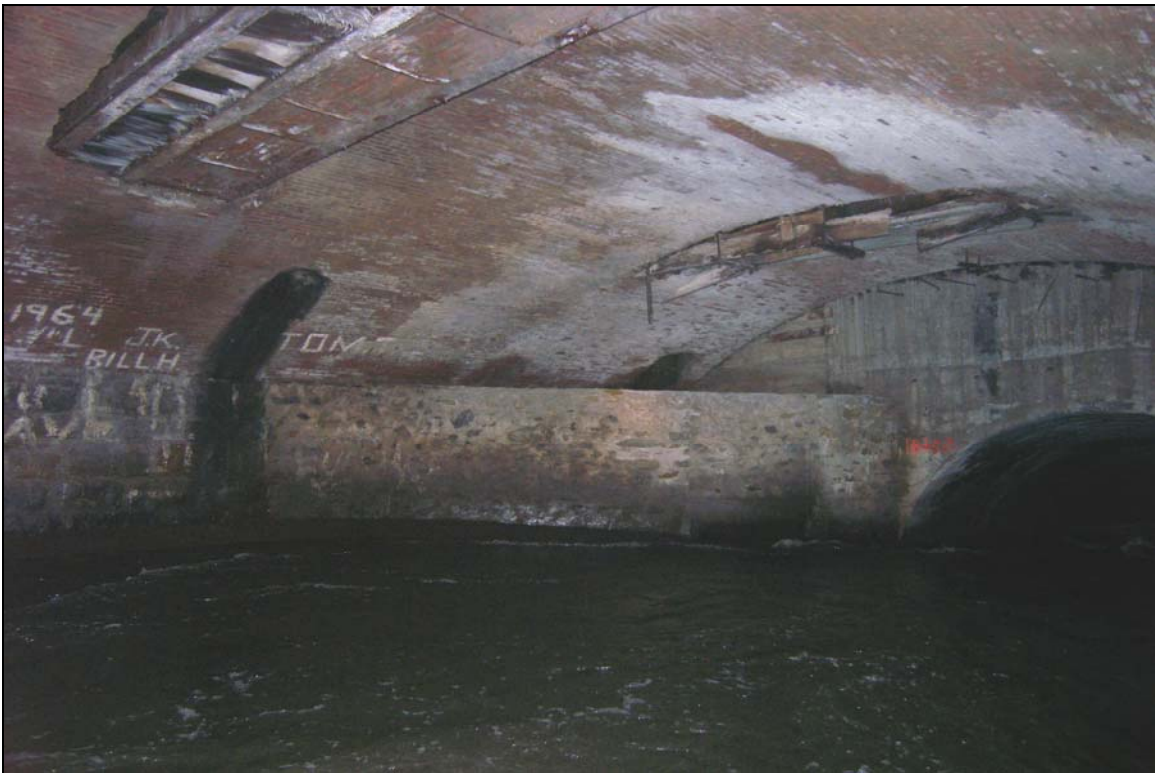
Stone masonry walls have been built along the western half of the bridge in order to divert flow into the 20' wide concrete arch culvert located downstream of the bridge (see Photo 20). The presence of these walls indicates that culvert was constructed subsequent to the brick arch bridge. Overall the arch is in fair condition with no displaced or missing bricks. Scattered areas of efflorescence were observed throughout the arch with the heaviest concentration primarily in the vicinity of the utility trunk penetrations (see Photo 20).

Photo 20 Stone masonry wall built at southwest corner of bridge in order to divert flow into concrete arch culvert. Note efflorescence on bricks in vicinity of western utility trunk penetration.

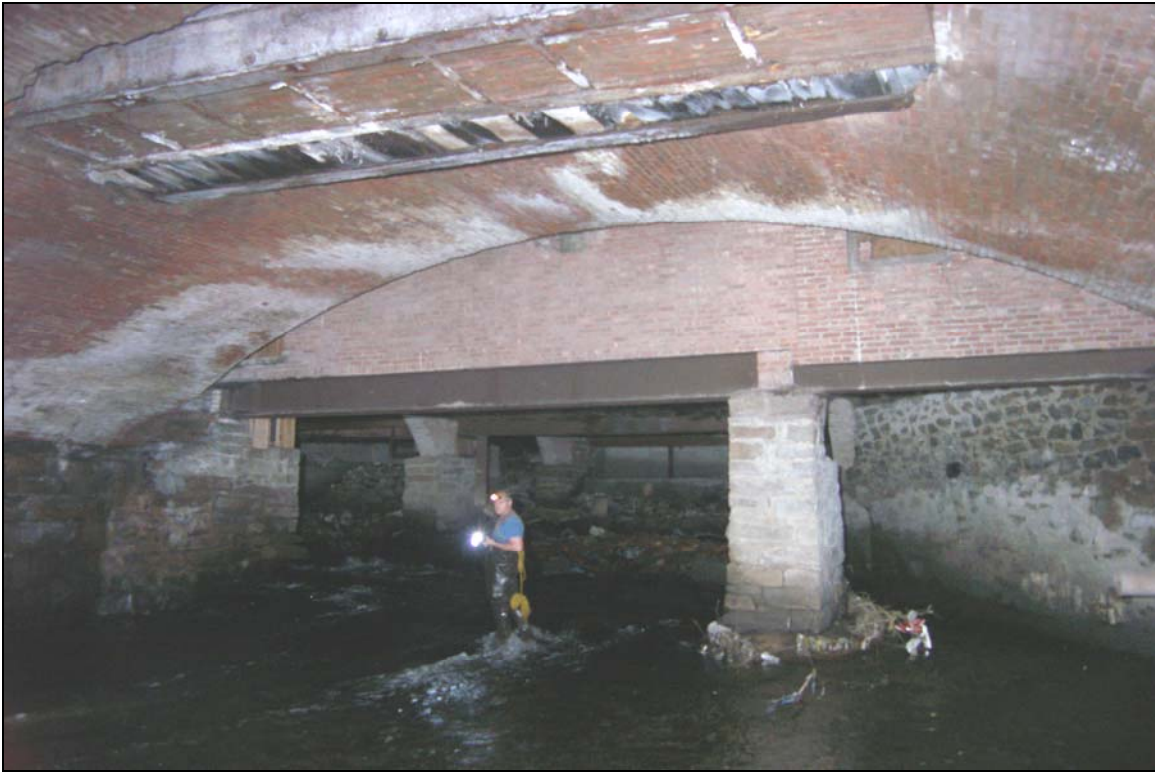
Photo 21 Eastern end of brick arch bridge located beneath Warburton Avenue.

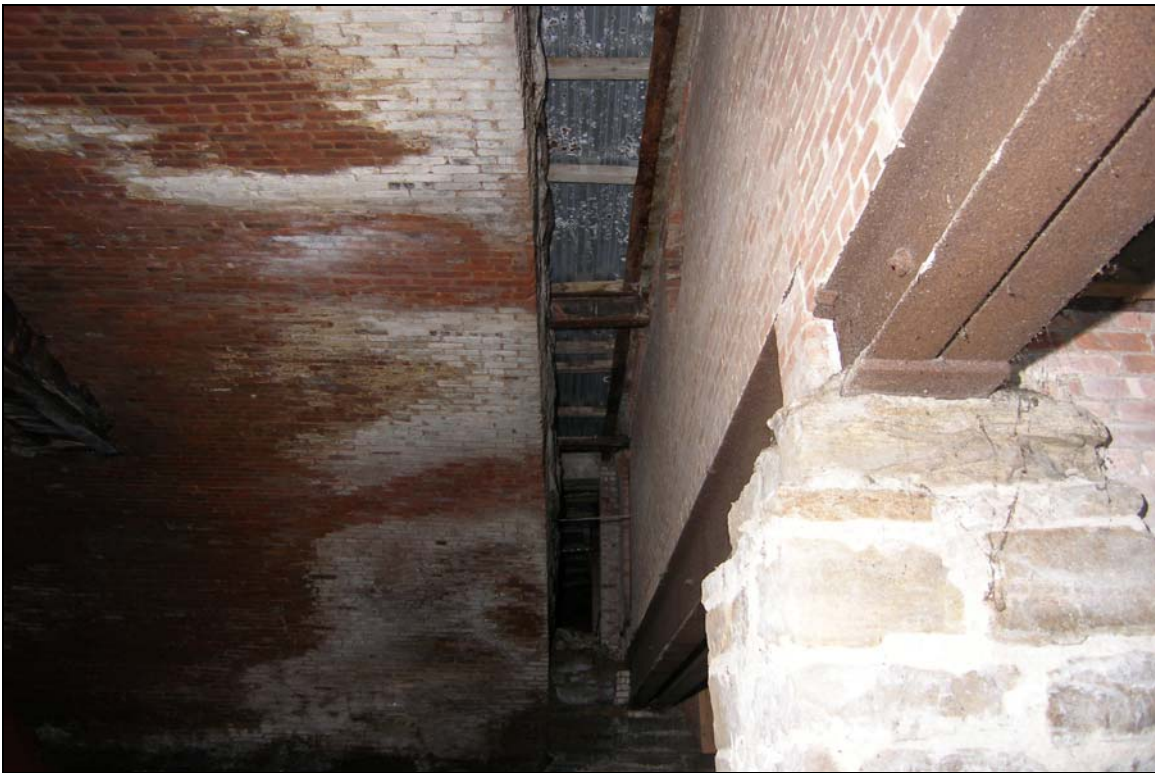
The upstream faced of the arch is approximately 3' to 4' from the adjacent building fascia. As seen in Photo 22, corrugated steel formwork supports the section of concrete sidewalk between the eastern face of the arch and the adjacent building.

Photo 22 Corrugated steel formwork supporting section of sidewalk between eastern face of brick arch bridge and adjacent buildings.

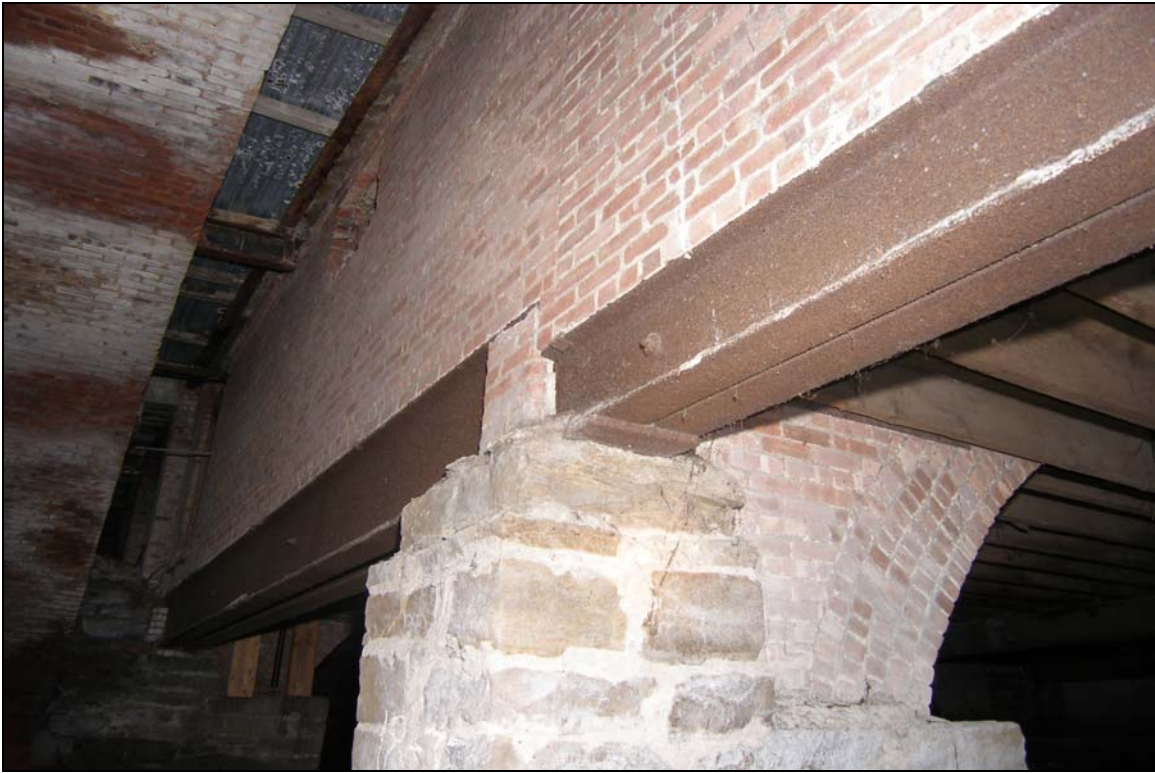
Photo 23 General view of brick building fascias and steel beams which span the Saw Mill River channel at the eastern edge of Warburton Avenue (Sta 18+75).

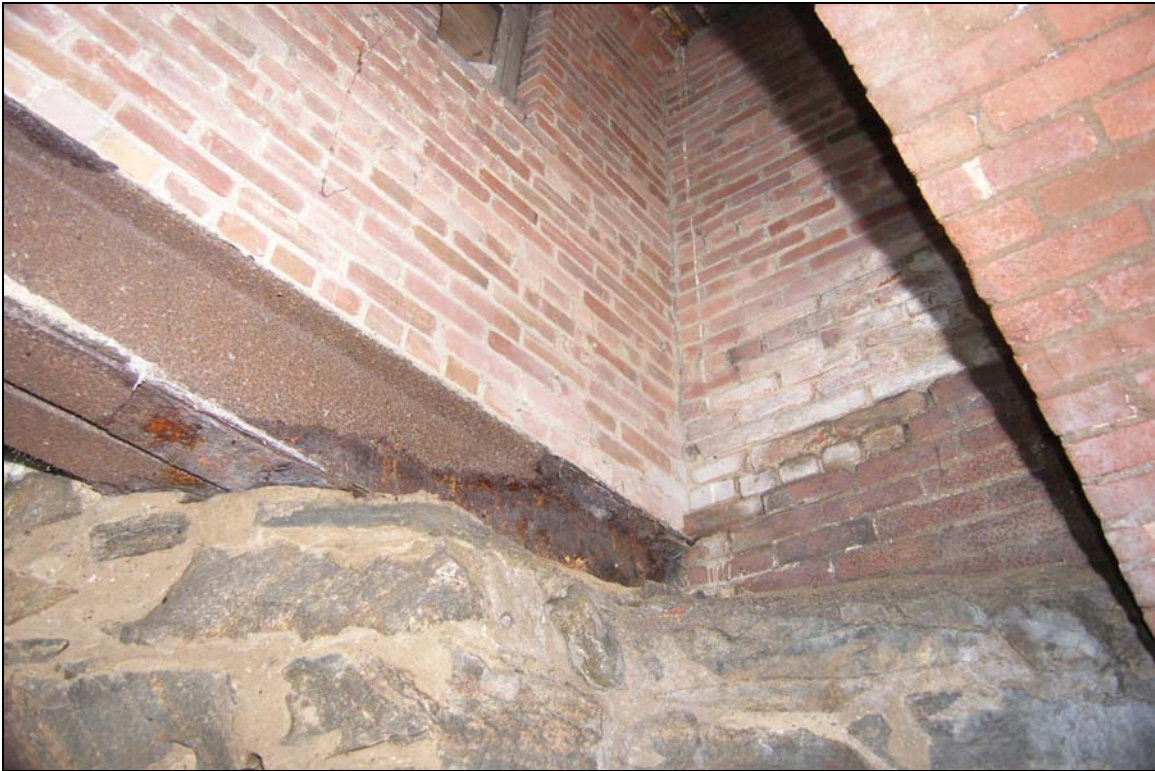
Photo 24 Moderate corrosion at the south end of above-noted steel beams.

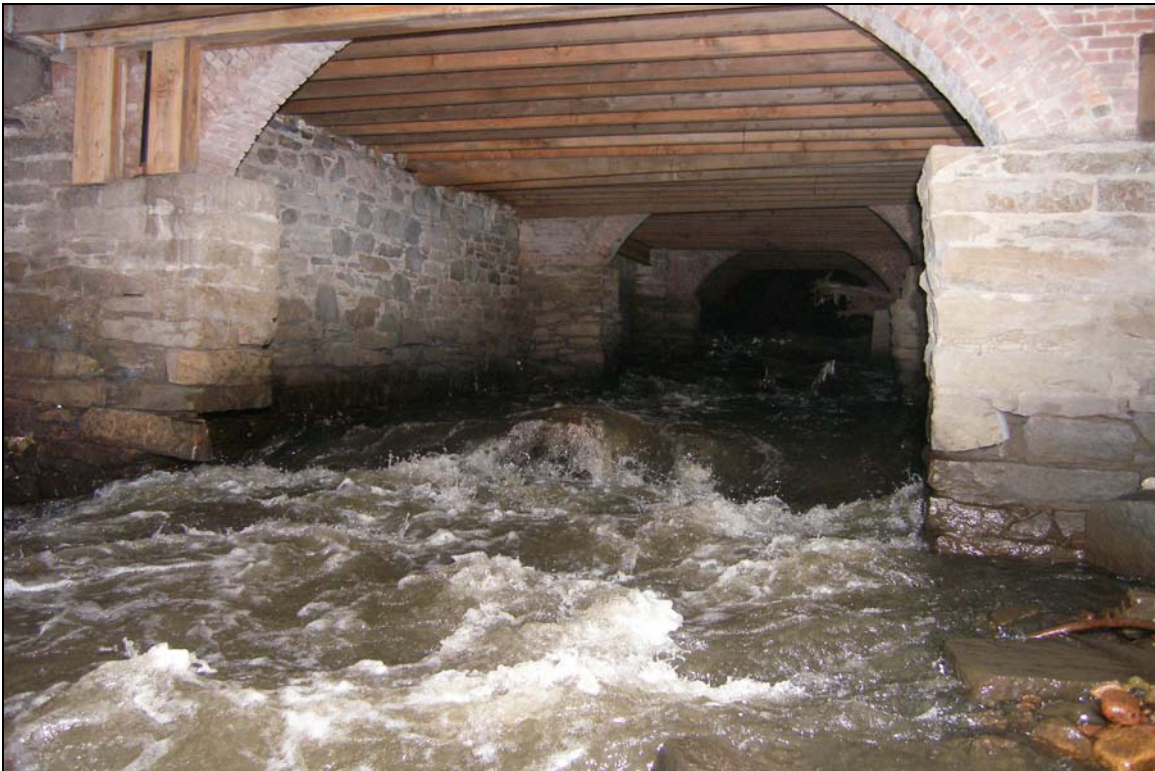
Photo 30 Looking north beneath buildings along east side of Warburton Ave.

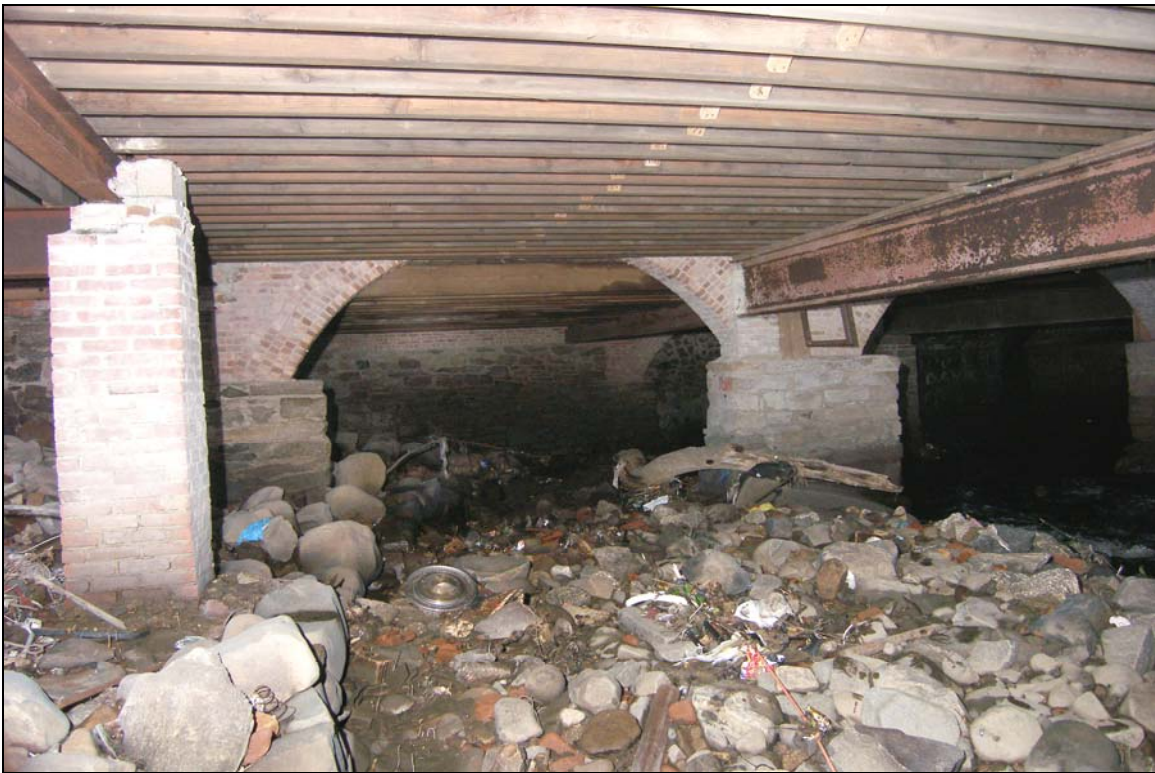
Photo 31 Accumulation of scattered debris along the eastern half of the channel looking south.

There are many locations where debris has collected within the flume. This ranges from large cobbles and stones to portions of trees and garbage. In order to restore full hydraulic capacity to the flume, it is recommended that debris should be removed from the flume. It is MEG's understanding that the City do not currently have any ownership interest in the portions of the Saw Mill River and the flume that are located within private properties, and will not have any such ownership interest during construction of the River Park City Project or after its completion. Therefore, the cleaning or debris within the private properties is the responsibility of the owners.

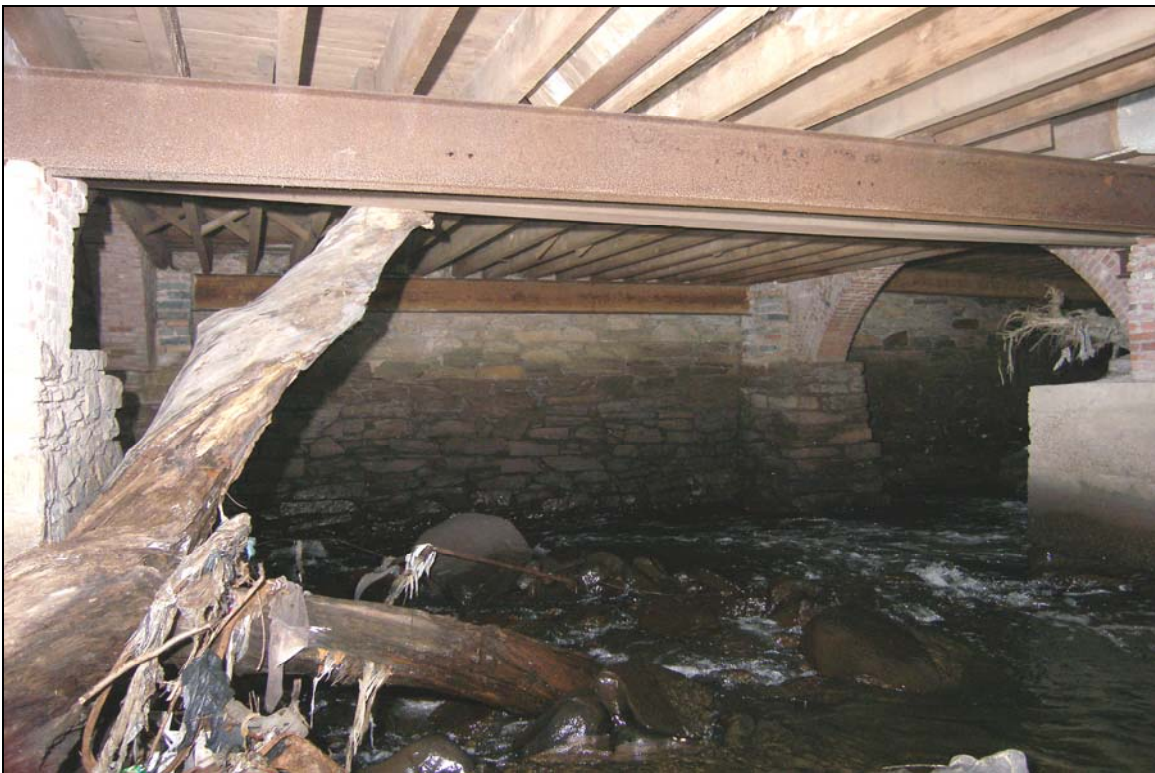
Photo 32 Large timber debris adjacent to the north face of a center stone masonry pier.

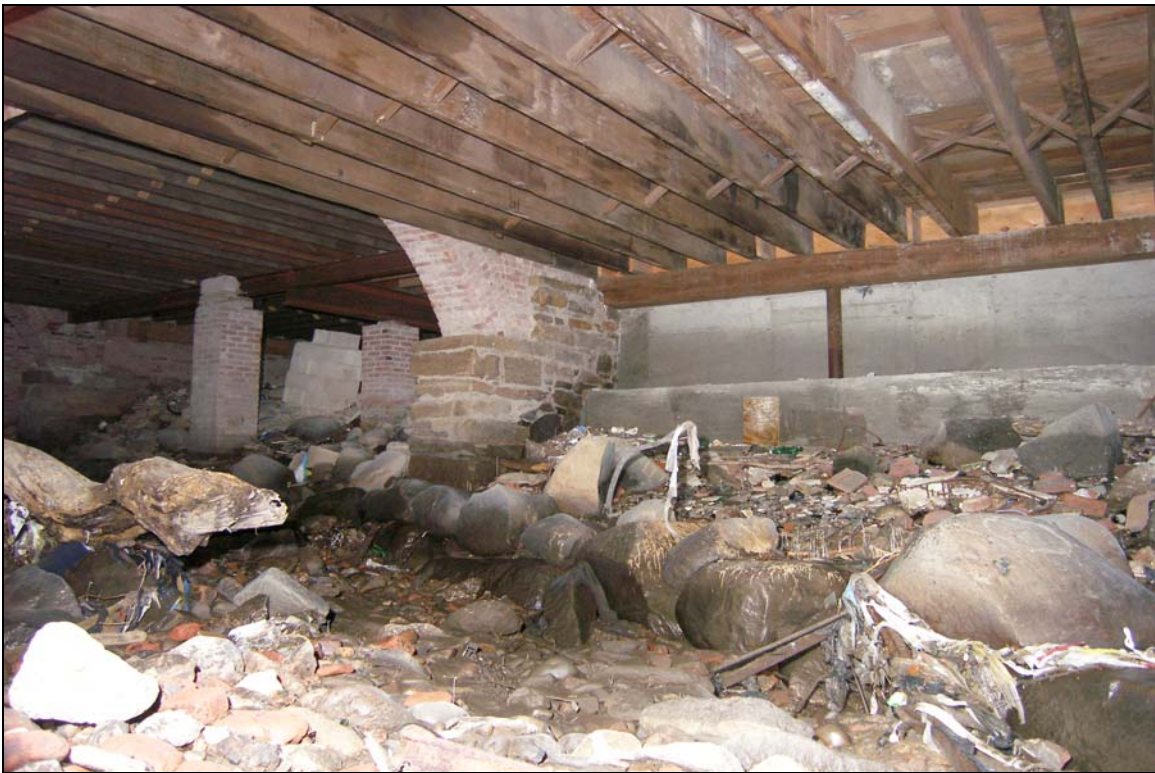
Photo 34 Northeast corner of recently constructed concrete foundation wall. Note large stones which appear to mark the eastern limits of the Saw Mill River channel.

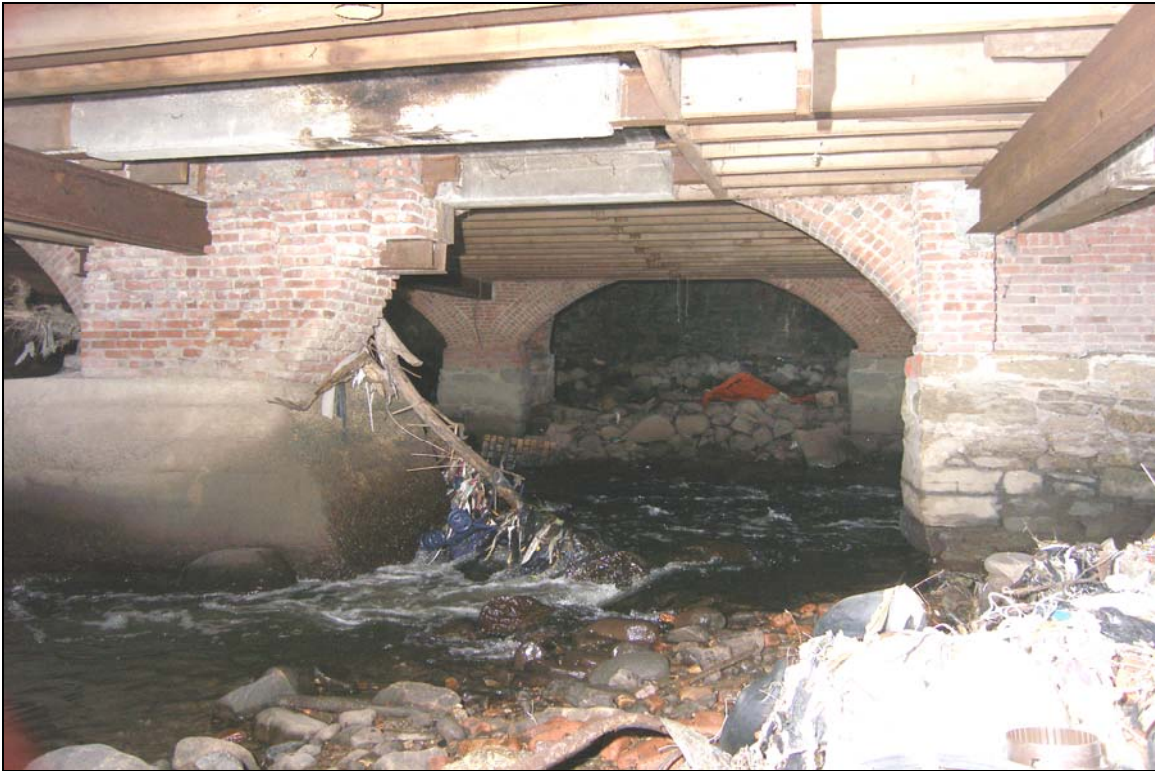
Photo 35 General view looking north beneath buildings. Note concrete encased steel beams located above repaired stone masonry pier.

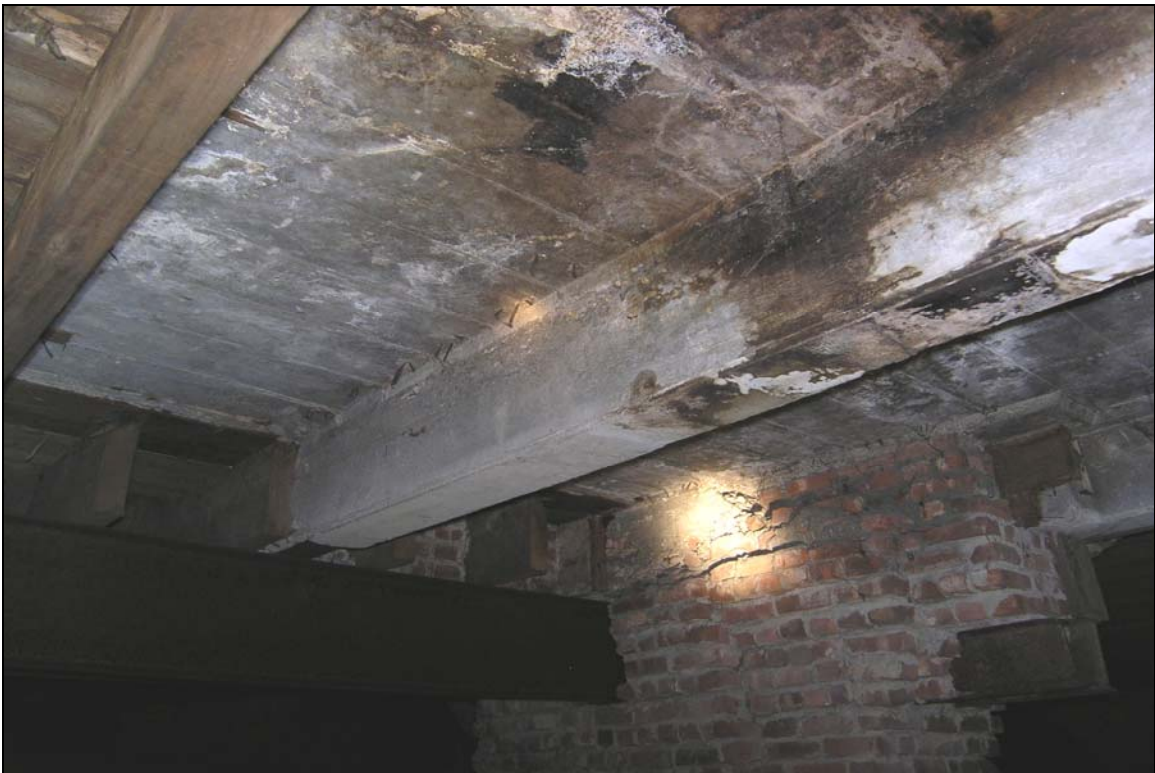
Photo 36 Original timber floor joists replaced with a concrete floor supported by a concrete encased steel beam.

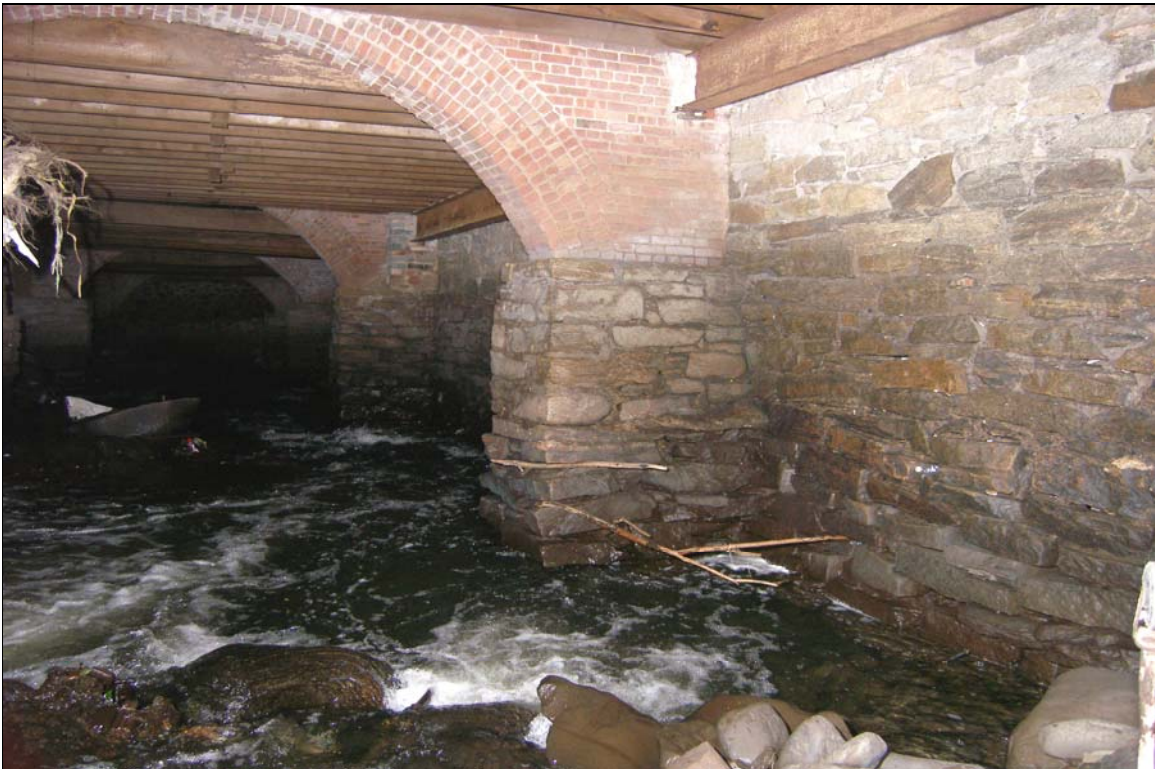
Photo 40 General view of masonry piers and wall along west face of channel.
