SAWMILL RIVER CULVERT/FLUME INSPECTION Yonkers, New York

McLaren Engineering Group
100 Snake Hill Road
West Nyack, NY 10994

August 2006
Revised December 2007

MEG Job No. 106100.01

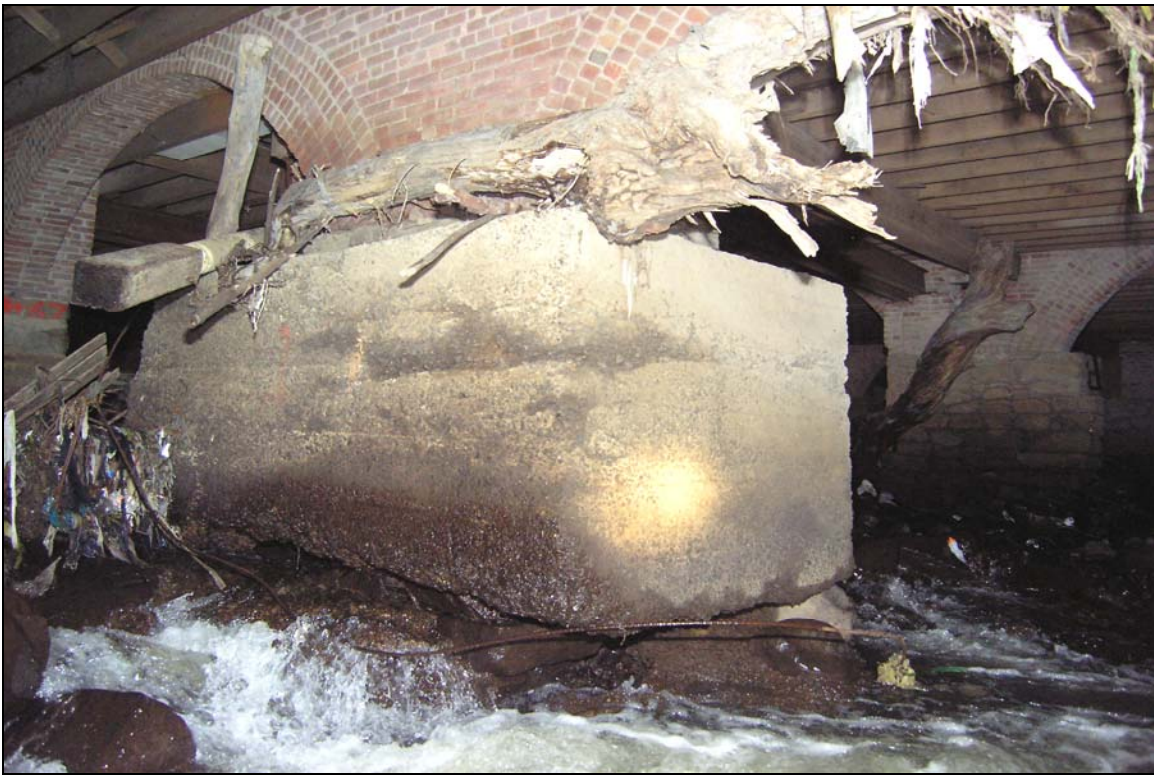
Photo 41 Severely deteriorated north and west faces of masonry pier which has been encased in concrete as a repair.

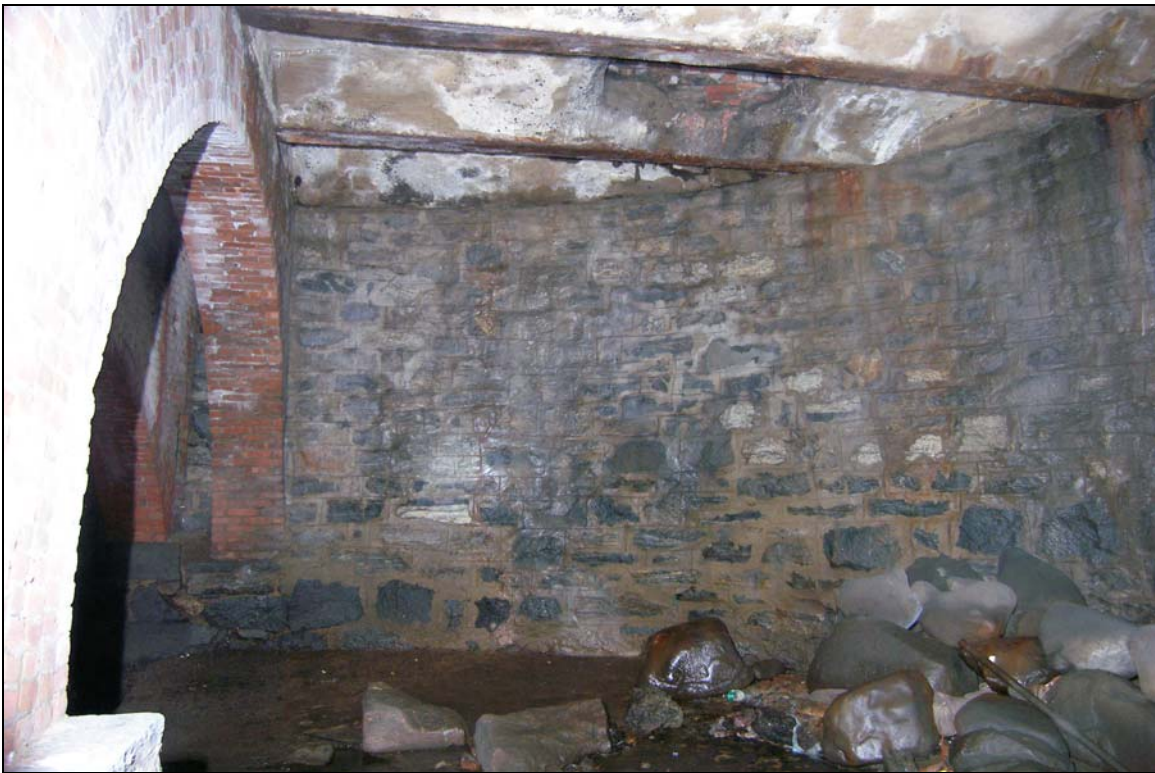
Photo 43 General view of curved stone masonry wall beneath western end of Manor House Square.

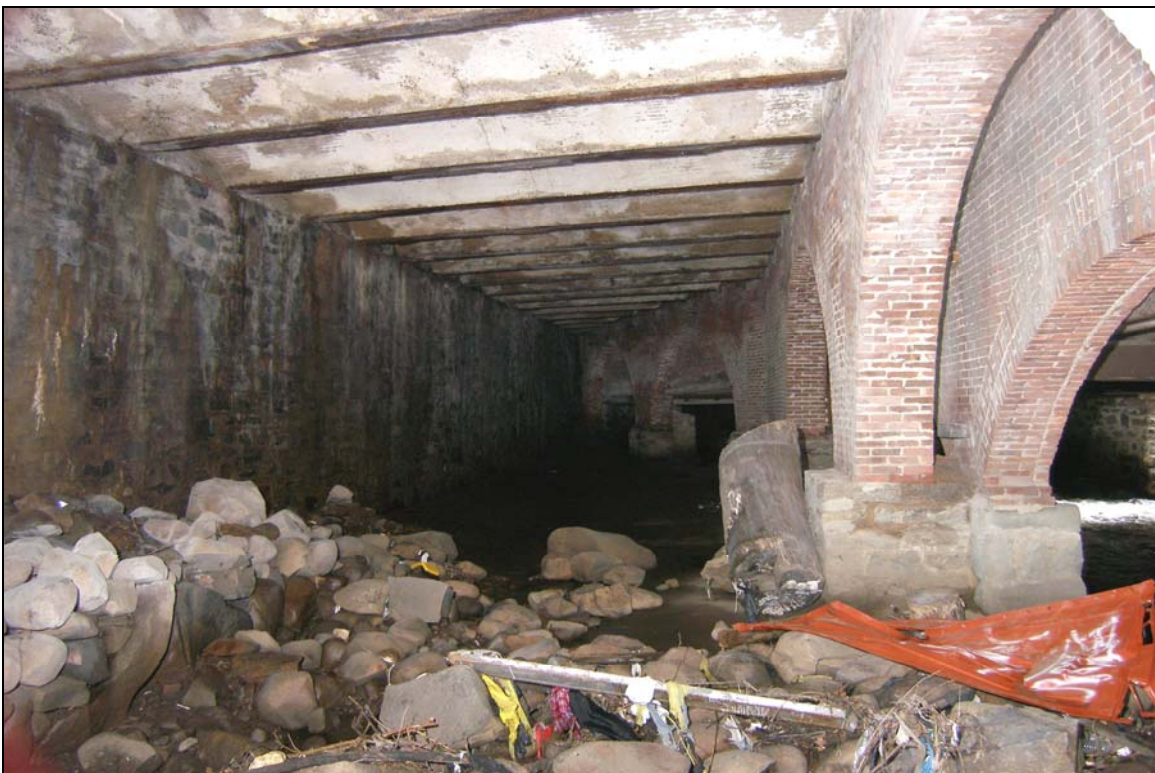
Photo 44 Brick jack-arch construction looking east beneath Manor House Square. Note general efflorescence in concrete arches and rust stains on masonry walls.

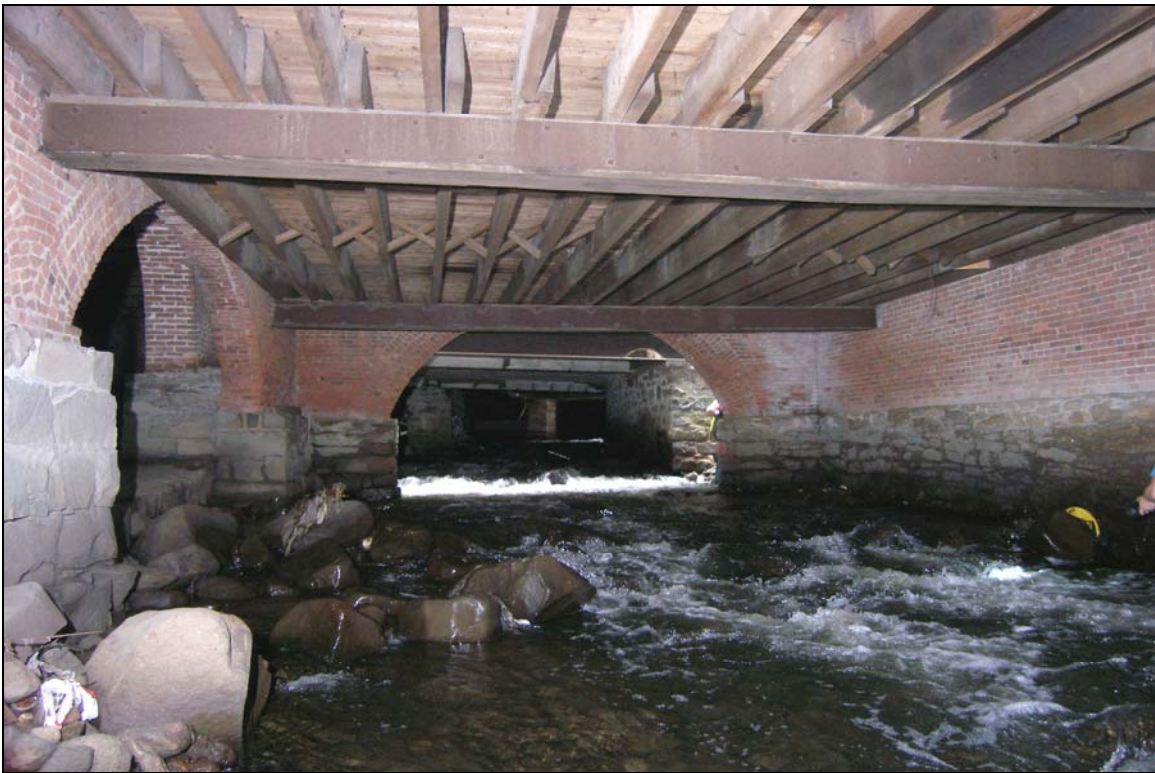
Photo 46 Looking upstream (east) from Station 19+40.

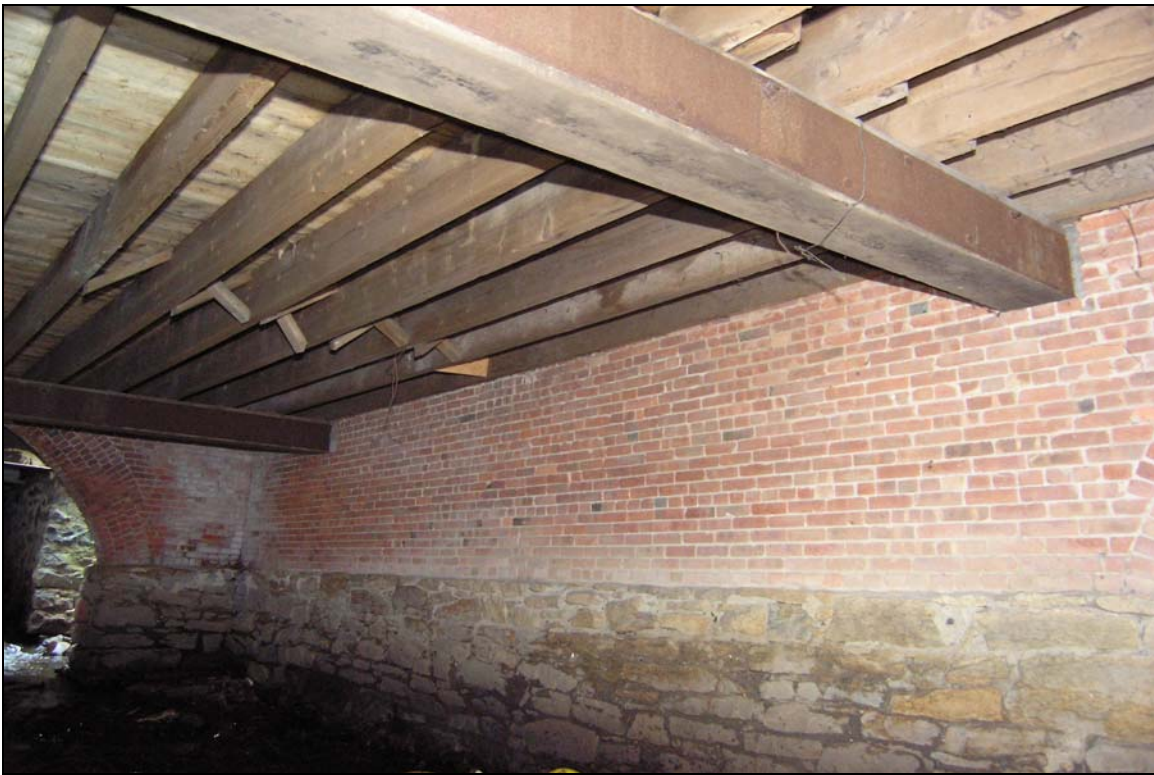
Photo 47 General view of stone masonry and brick foundation walls.

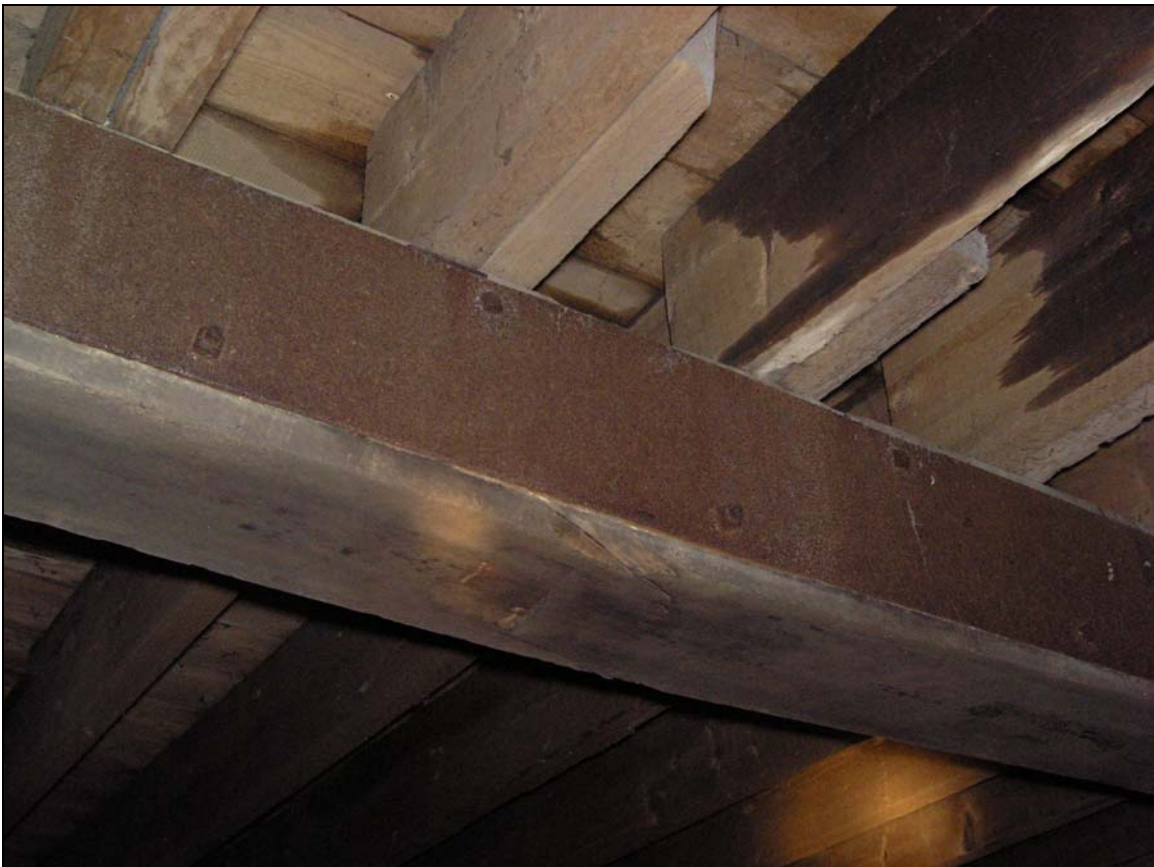
Photo 48 Crack in underside of timber 12" x 12" beam located at Station 19+50.

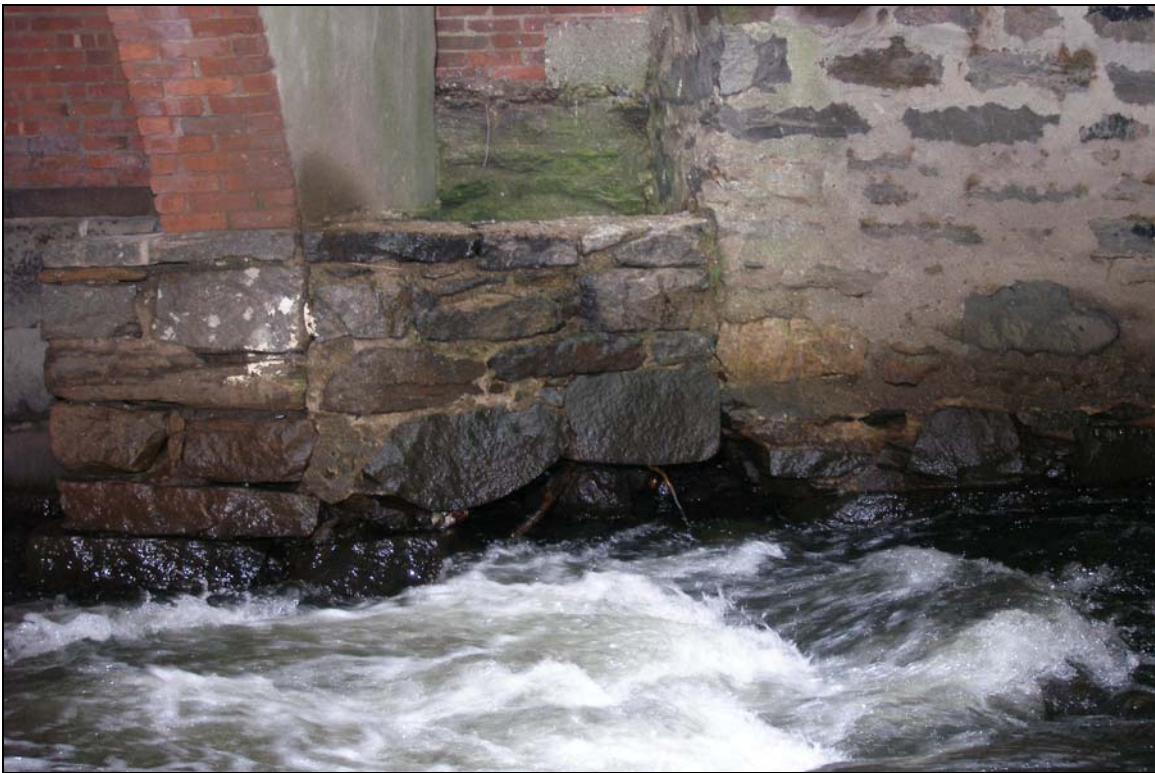
A general view of the opening to the flume located at the foot of Mill Street is shown in Photo 49. As seen in Photo 50, there is a void at the base of the stone masonry wall located directly across from the opening.

Photo 50 Void at base of stone masonry wall located directly north of the Mill Street opening.

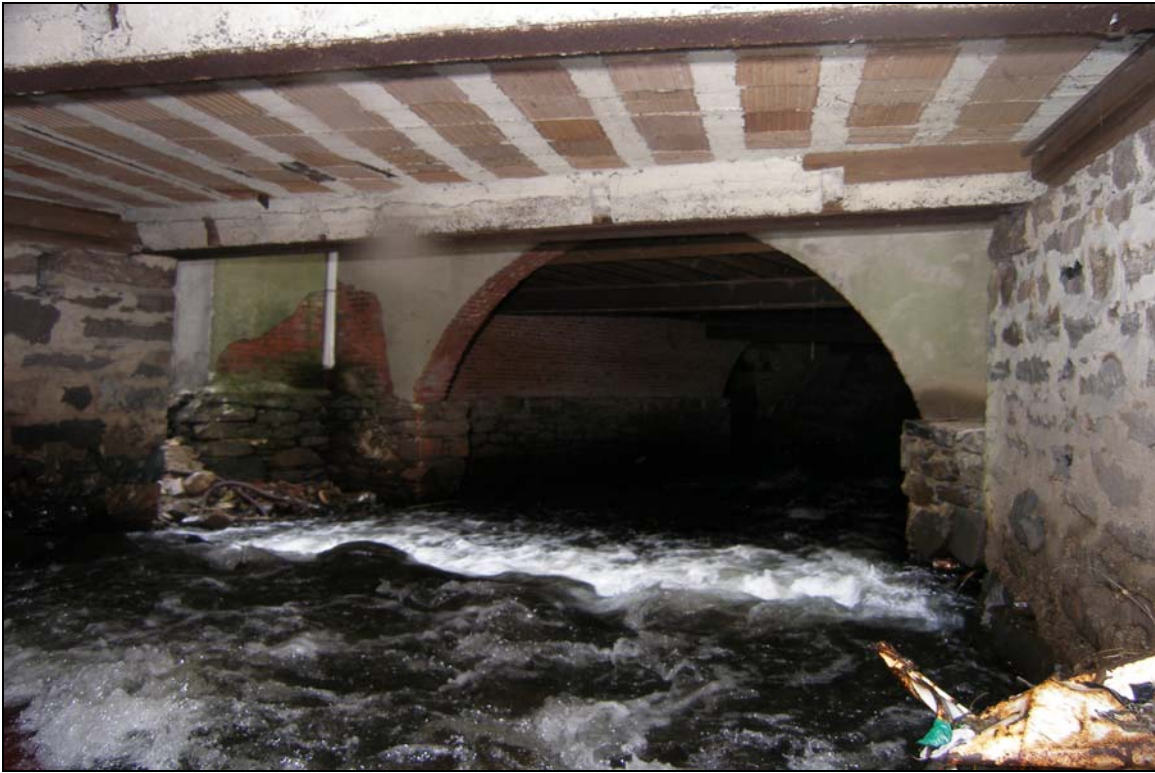
Photo 51 General view beneath the building located directly upstream of the Mill Street opening.

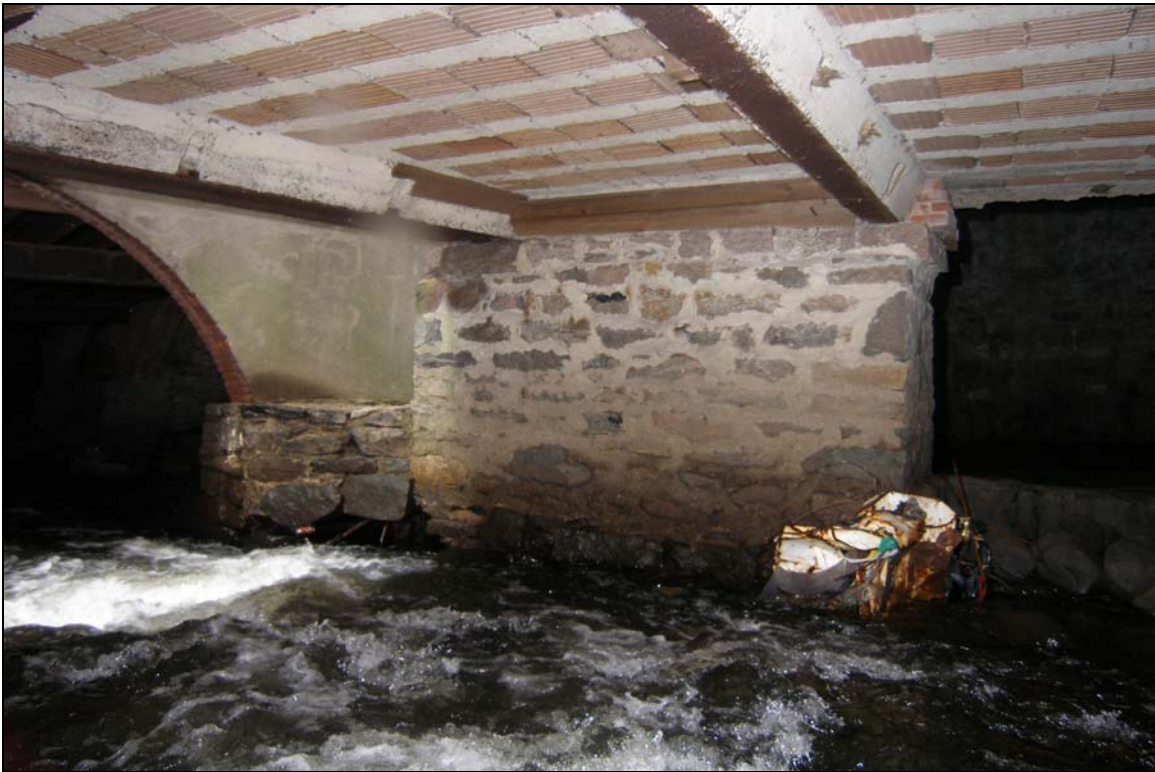
Photo 52 Stone masonry pier along north face of river channel.

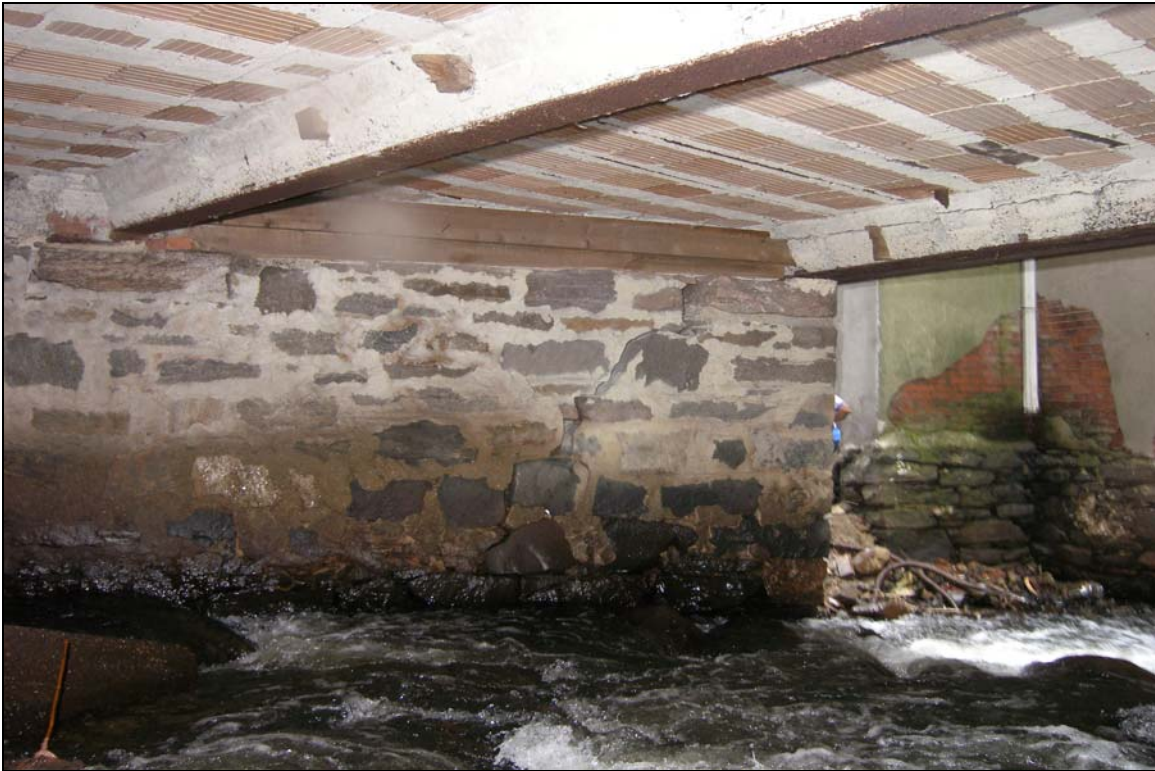
Photo 53 Stone masonry foundation along south face of river channel. Note diagonal crack in corner of building foundation.

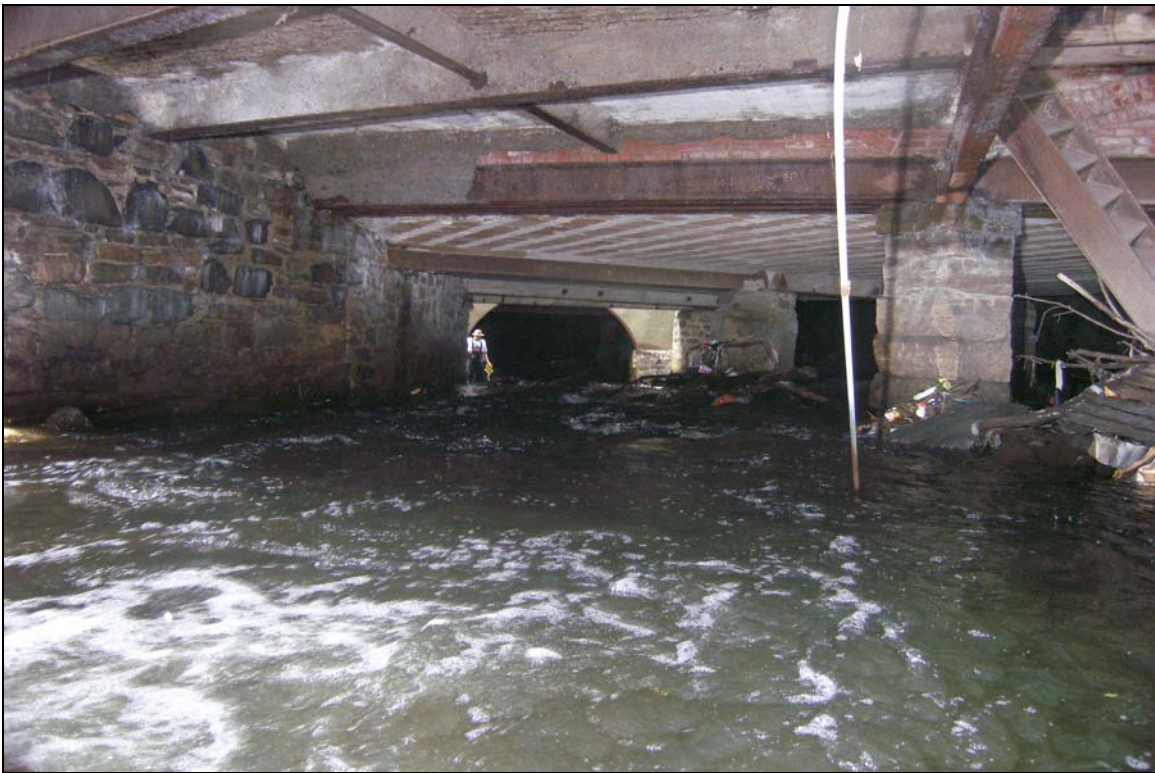
Photo 56 General view looking downstream from Station 20+60.

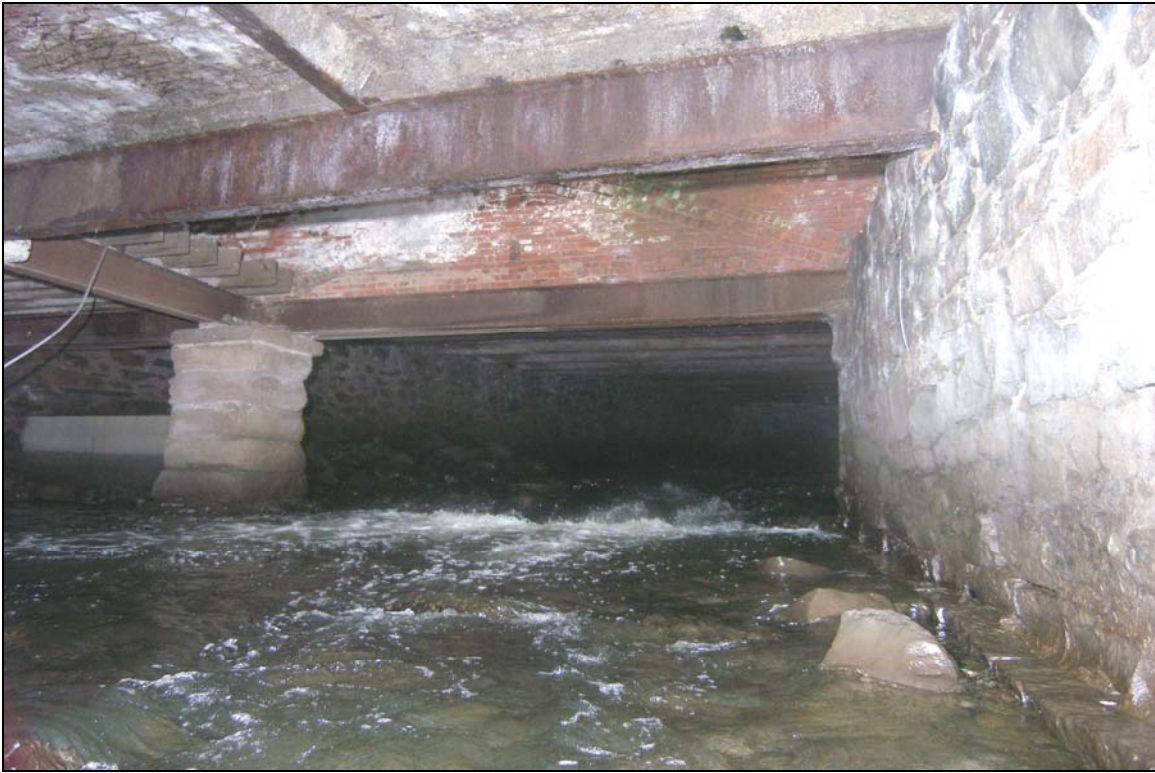
Photo 57 General view looking upstream from Station 20+50

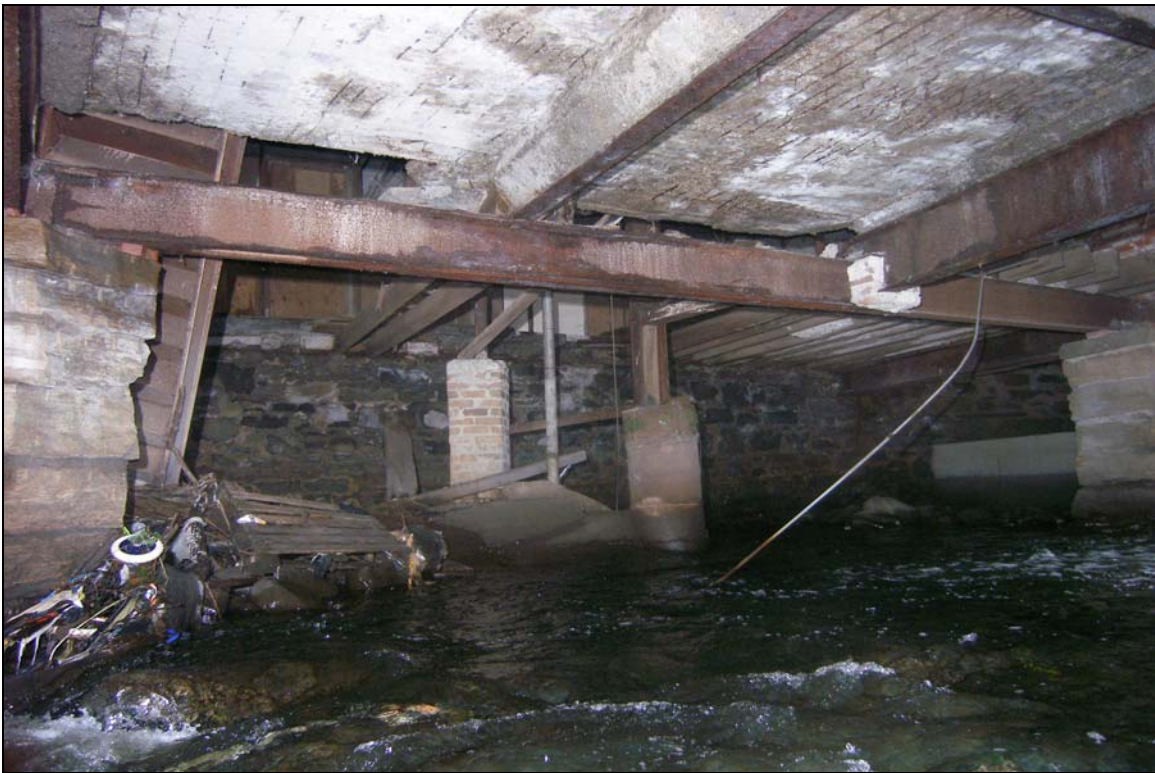
Photo 58 General view inside abandoned building located between Stations 20+35 and 20+75.

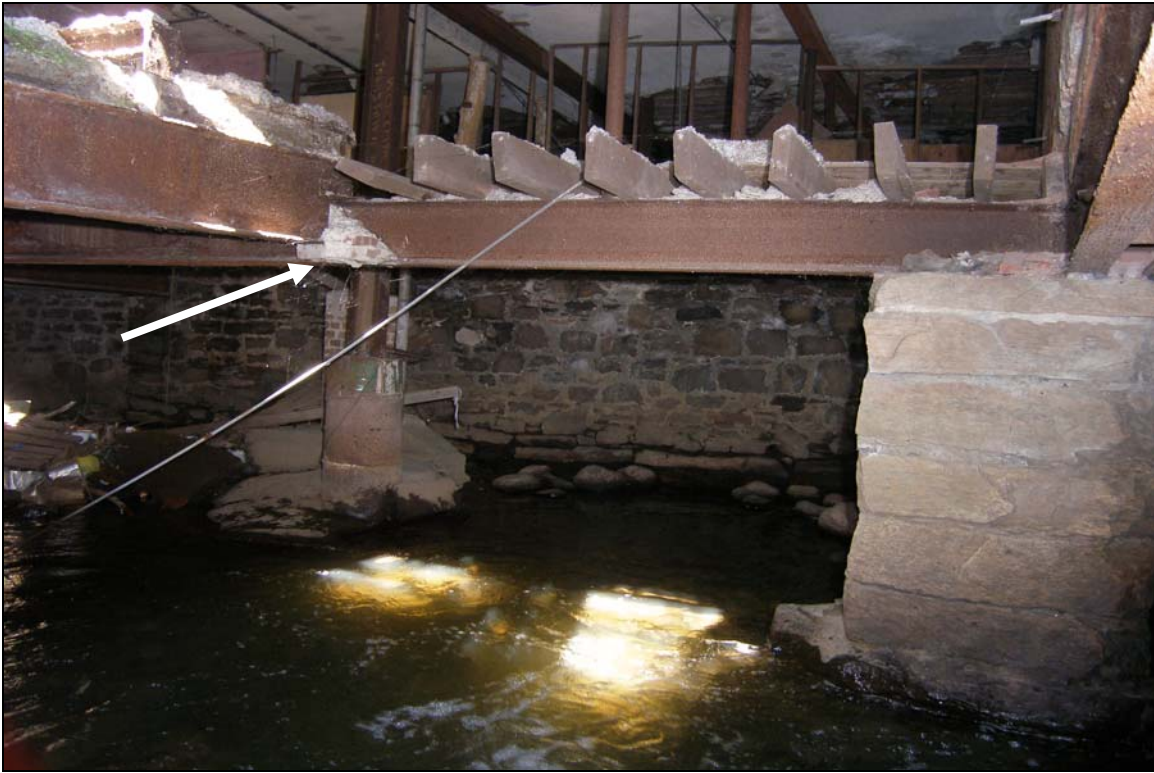
Photo 59 Brick and concrete remnants from missing support column.

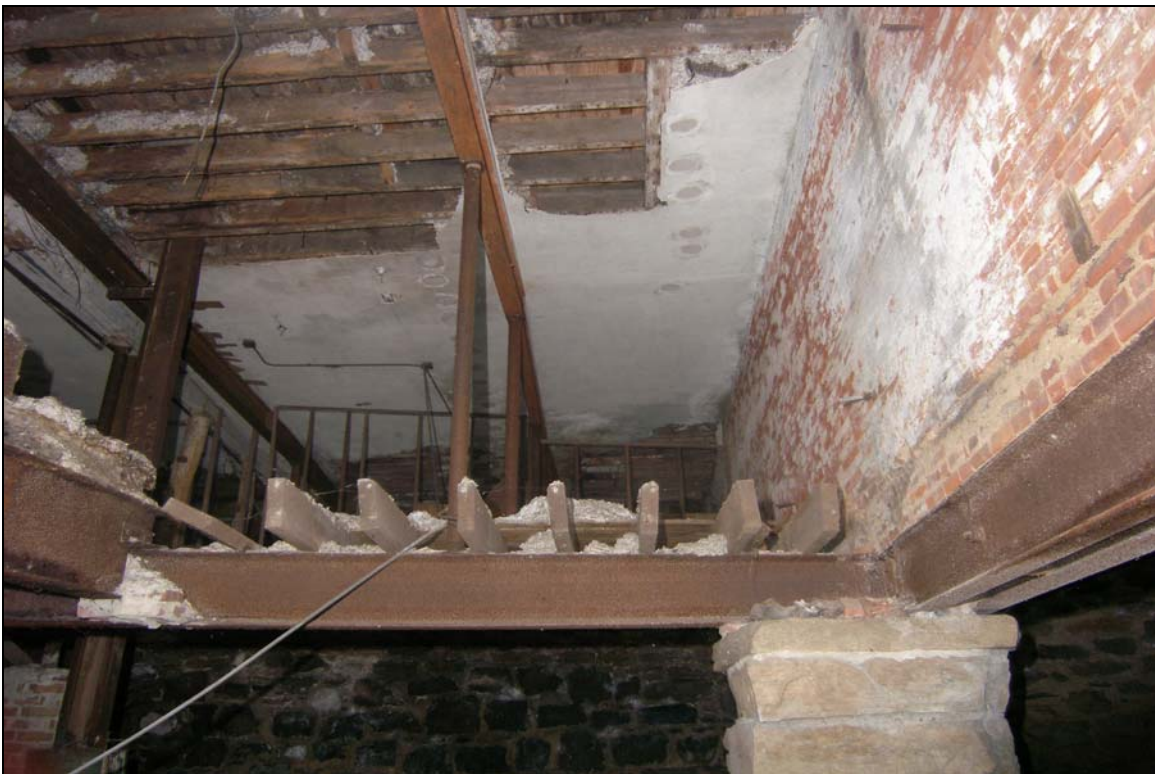
Photo 62 General view of abandoned building interior. The steel beams and brick wall at right adjoin the upstream property.

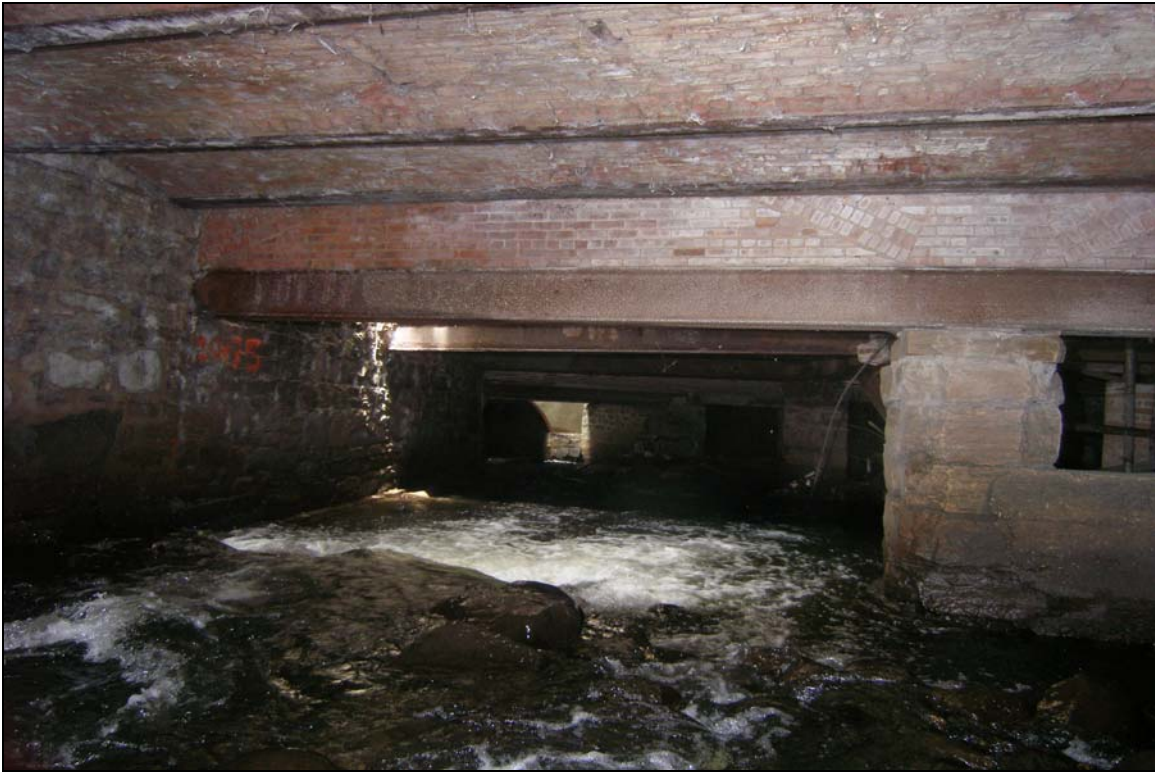
Photo 63 General view of Saw Mill River looking downstream from Station 21+00.

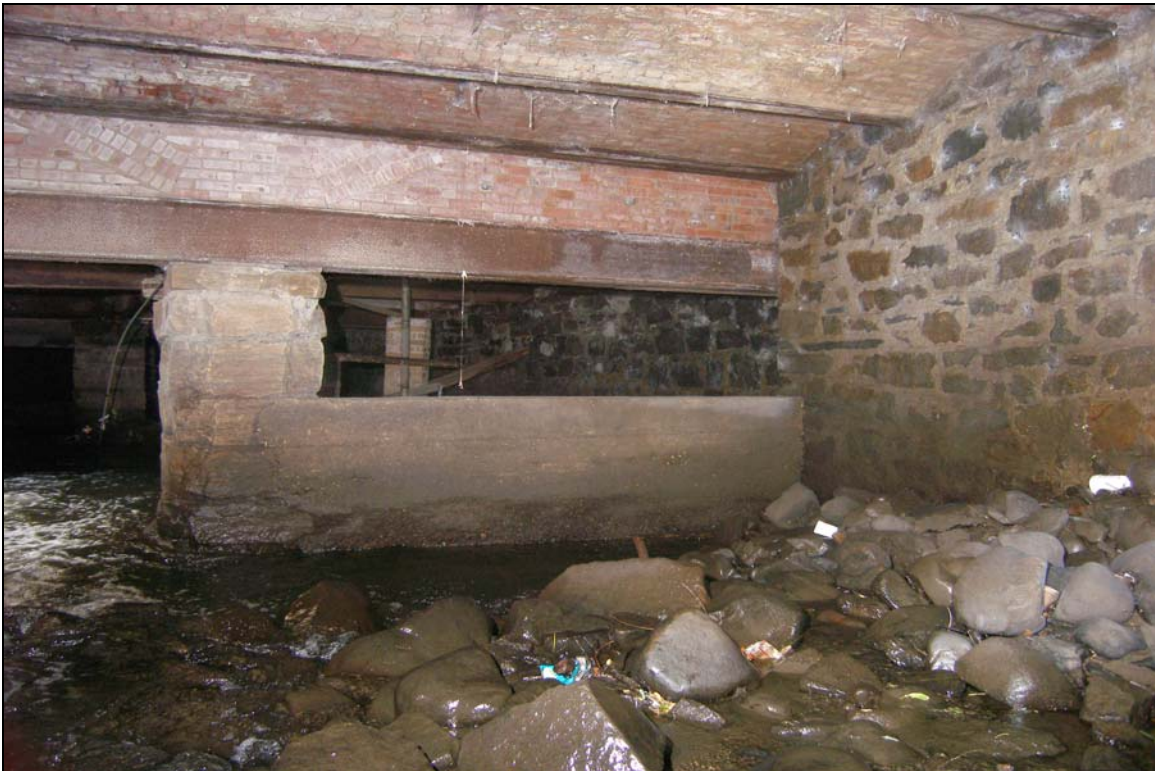
Photo 64 Four foot high concrete wall which has been constructed along the north half of the channel at Station 20+75.

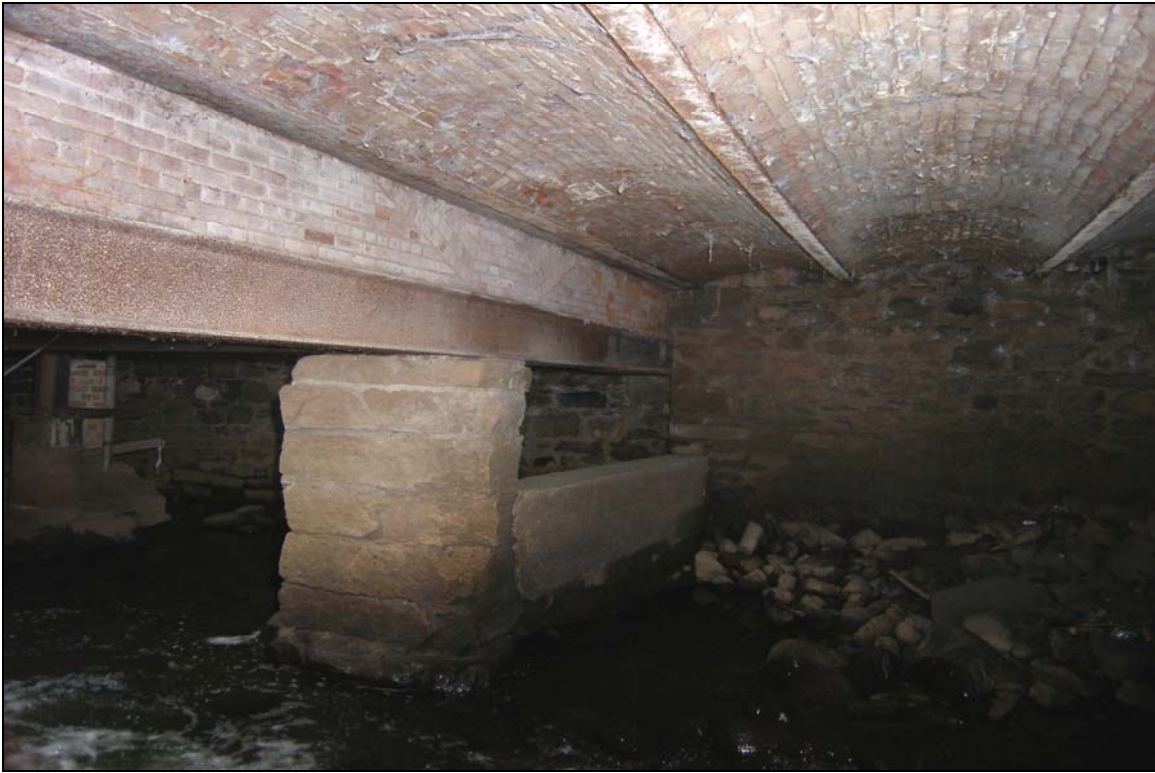
Photo 65 General view of the jack-arch construction located upstream of Station 20+75.

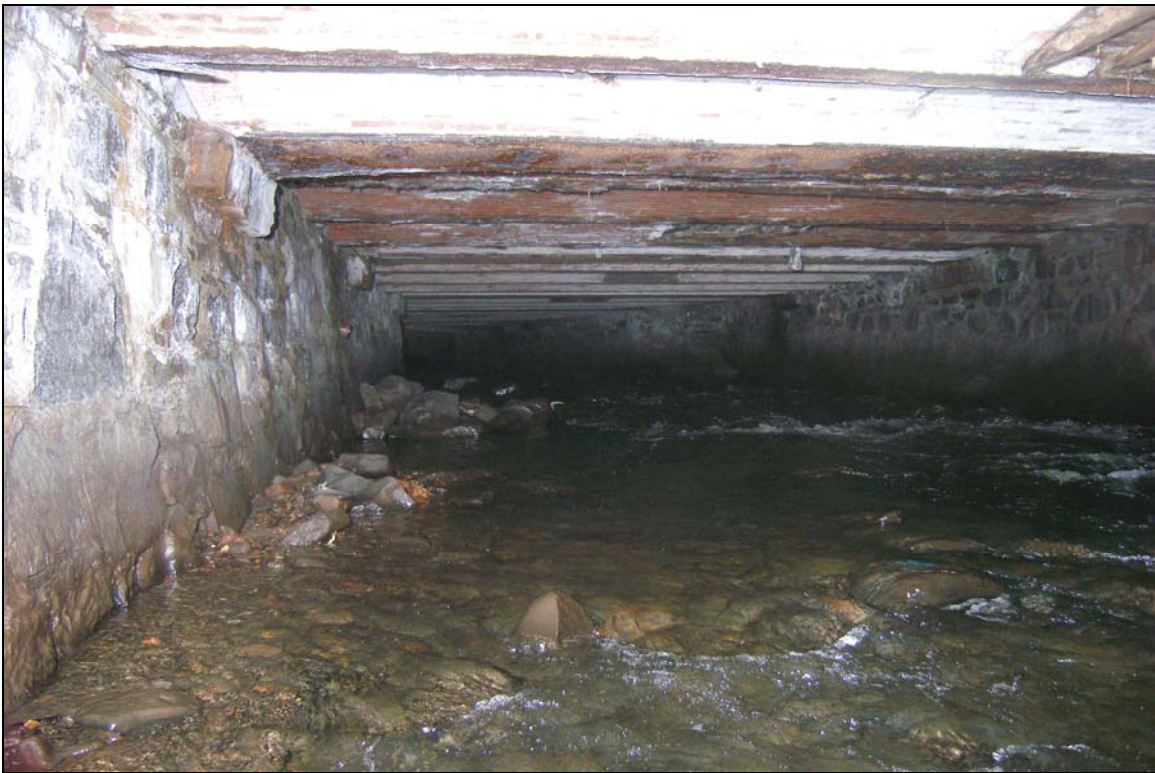
Photo 66 General view of the left side of the channel looking upstream from Station 22+00.

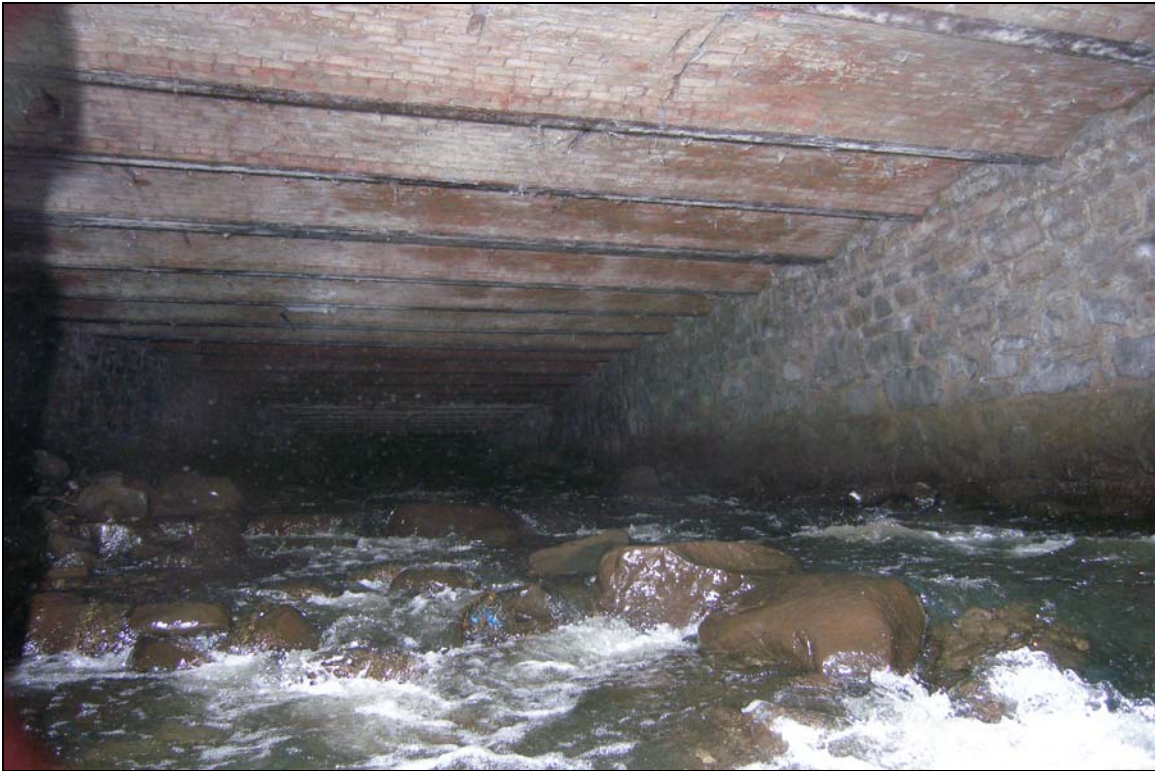
Photo 67 General view of the right side of the channel looking upstream from Station 21 + 50.

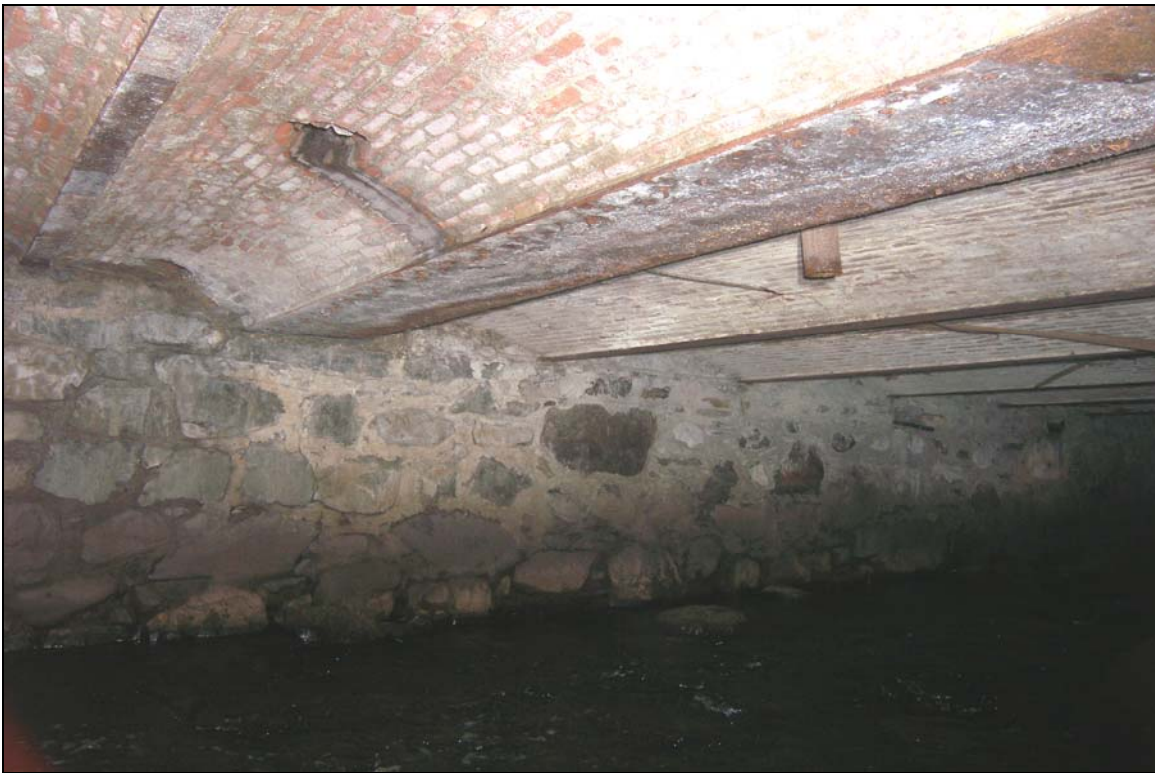
Photo 68 Transition in jack-arch construction (Station 22 + 12).

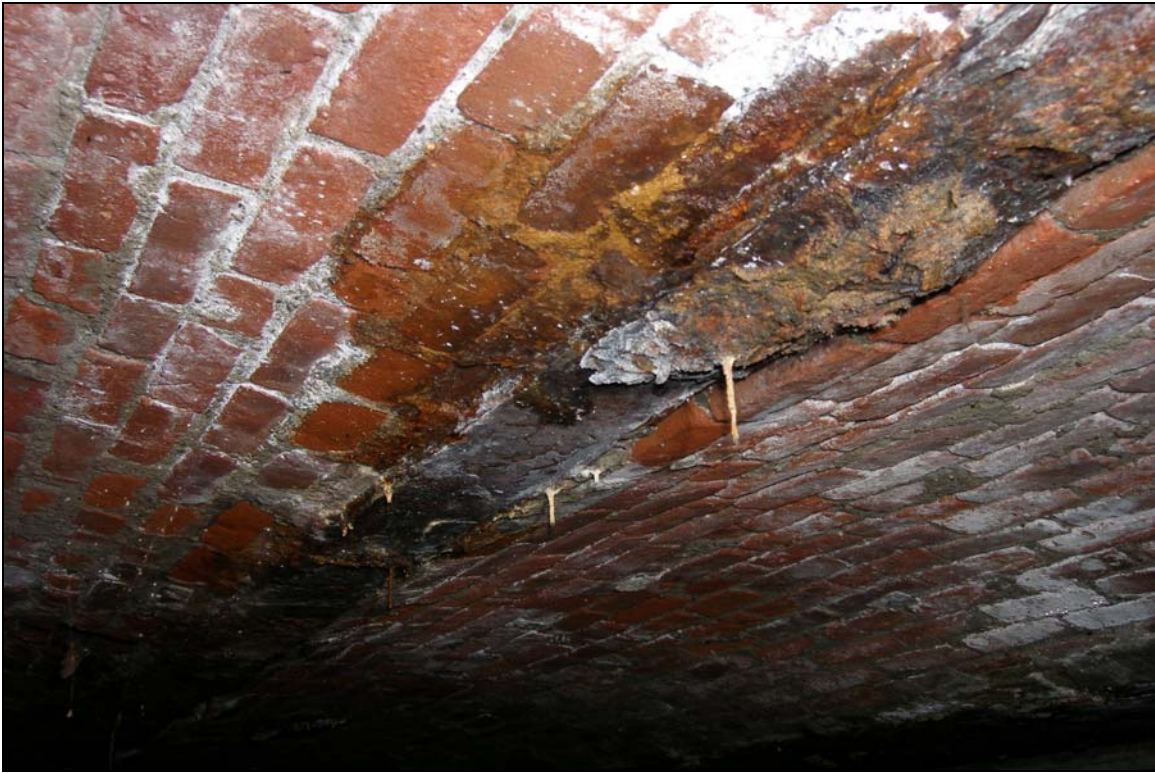
Photo 69 Heavy corrosion of bottom flange of steel beam.

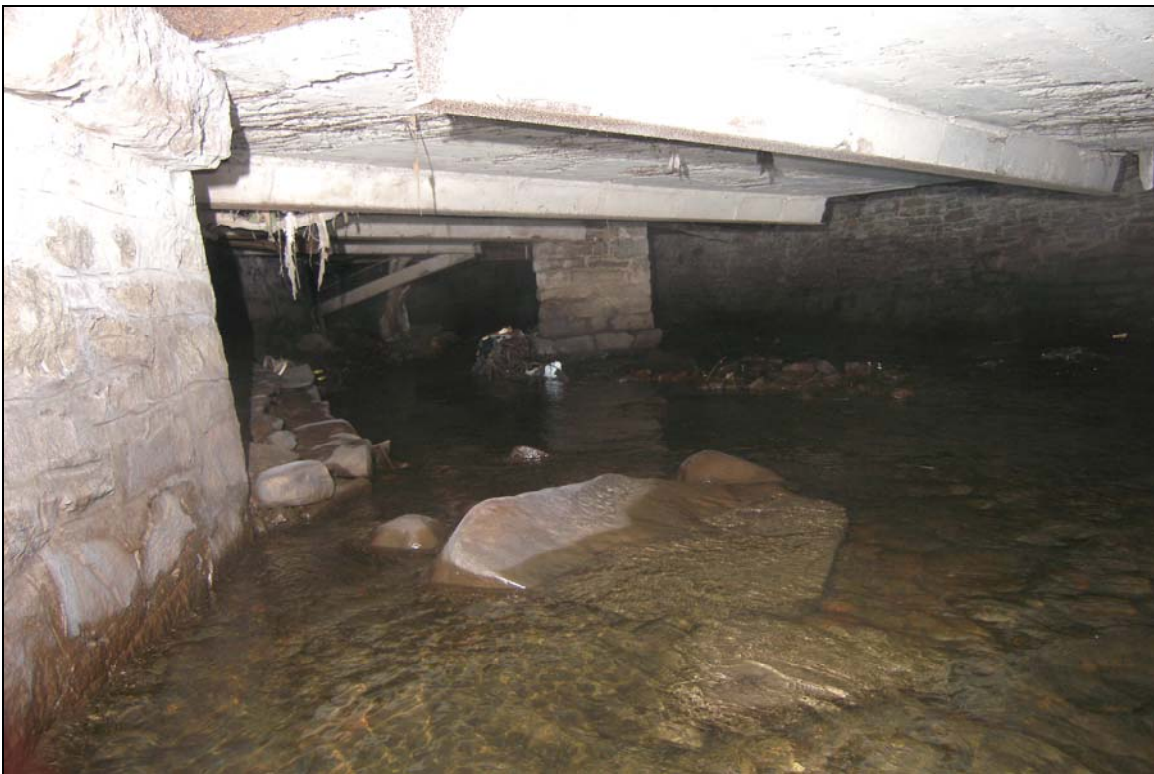
Photo 72 General view of steel beam of concrete deck construction located along left half of channel north of Station 23 + 35.

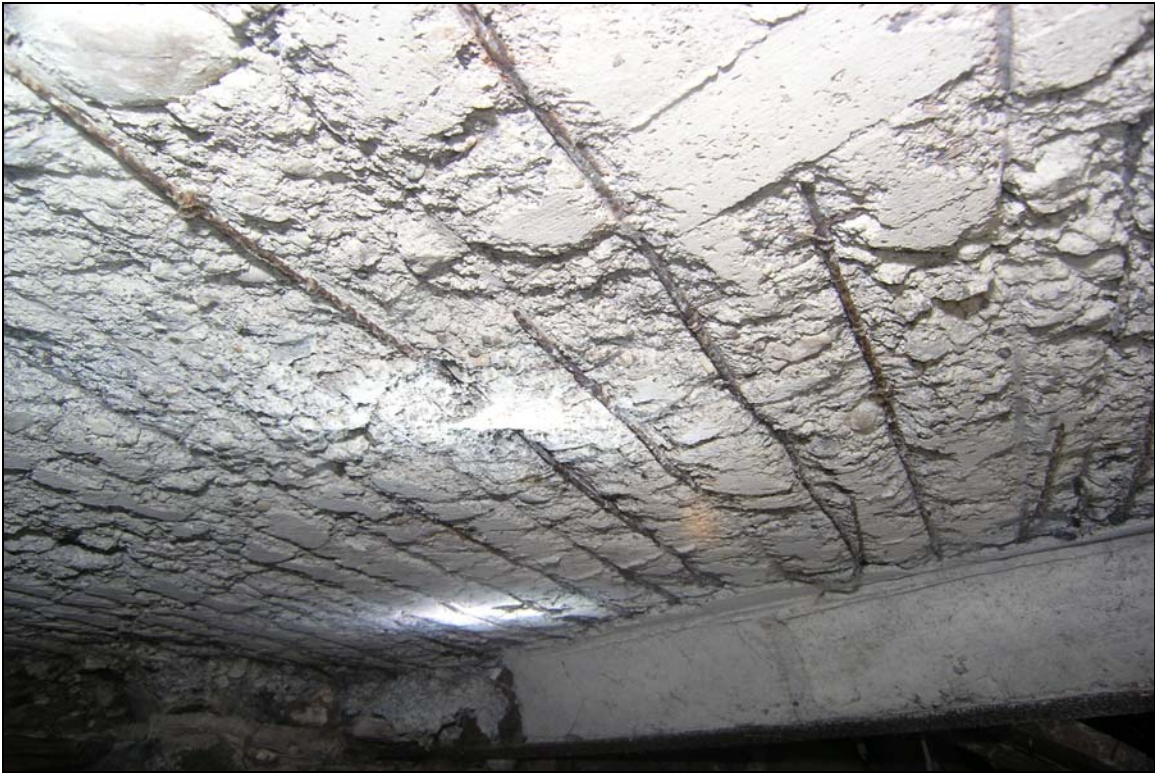
Photo 73 Concrete scale with exposed reinforcement in underside of deck at Station 23 + 50.

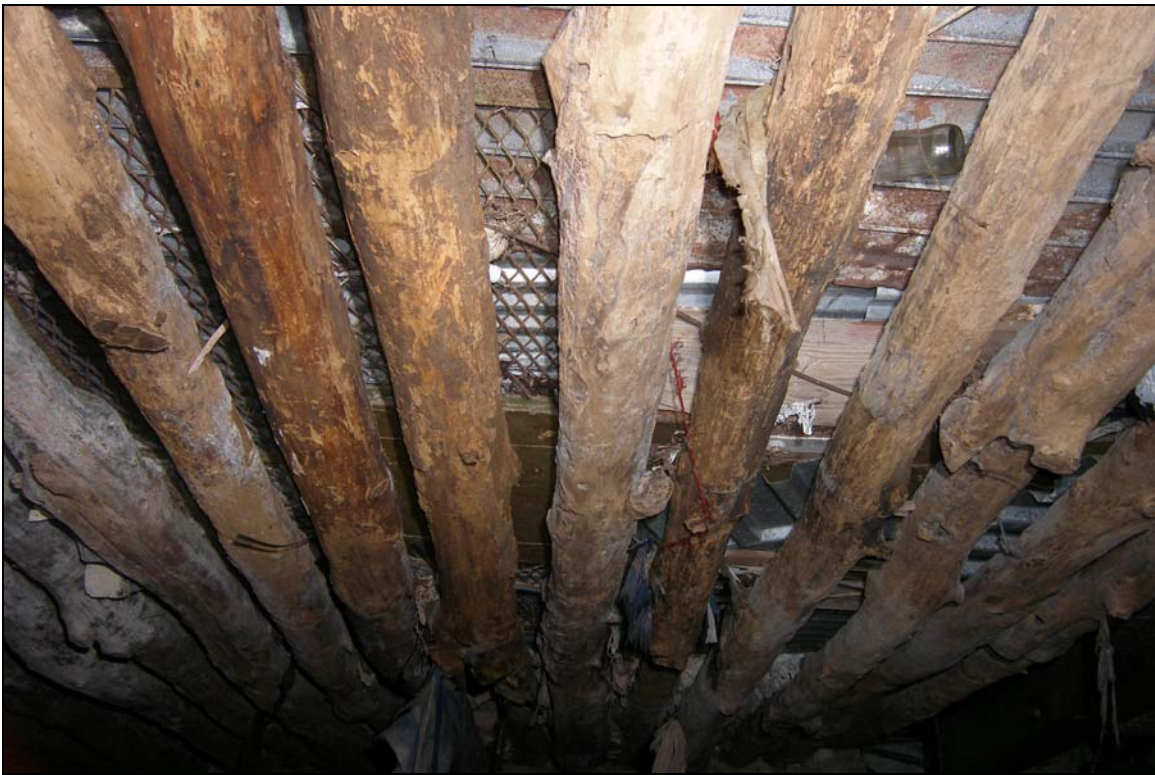
Photo 74 Timber logs supporting corrugated steel formwork at Station 23 + 75.
