SAWMILL RIVER CULVERT/FLUME INSPECTION Yonkers, New York

McLaren Engineering Group
100 Snake Hill Road
West Nyack, NY 10994

August 2006
Revised December 2007

MEG Job No. 106100.01

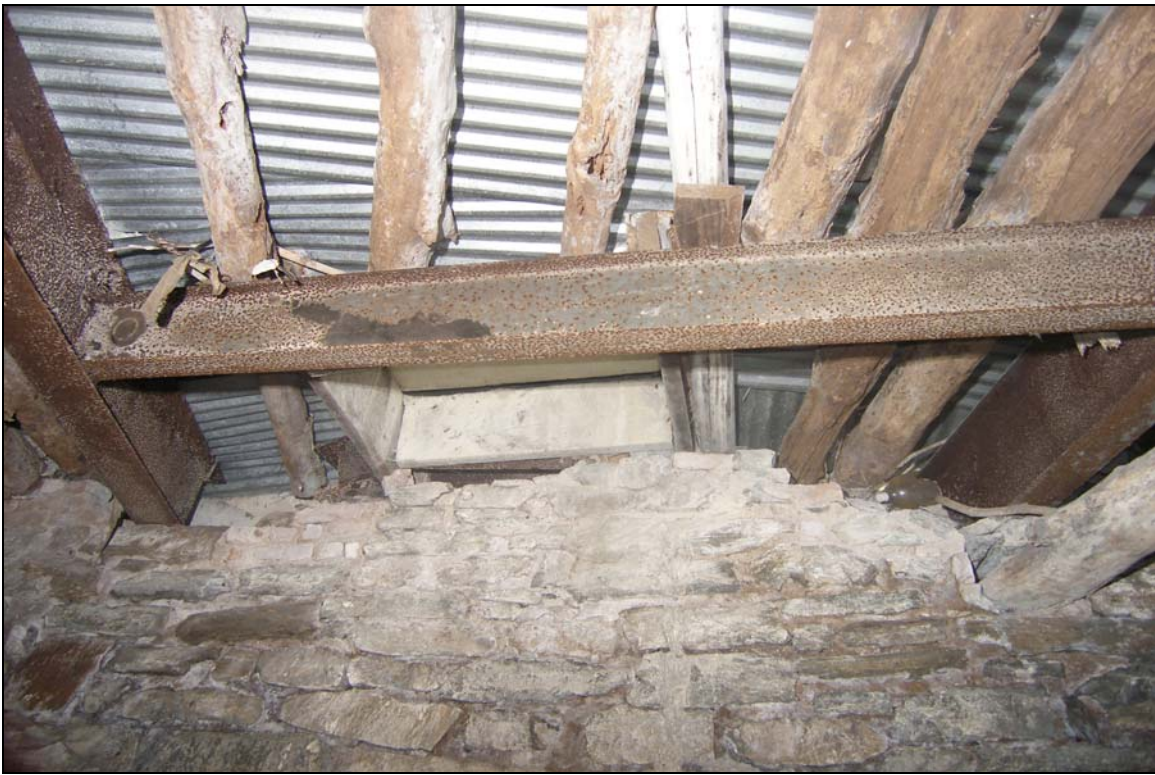
Photo 75 Steel beams installed to replace deteriorated/missing timber logs. Note corrugated steel formwork above.

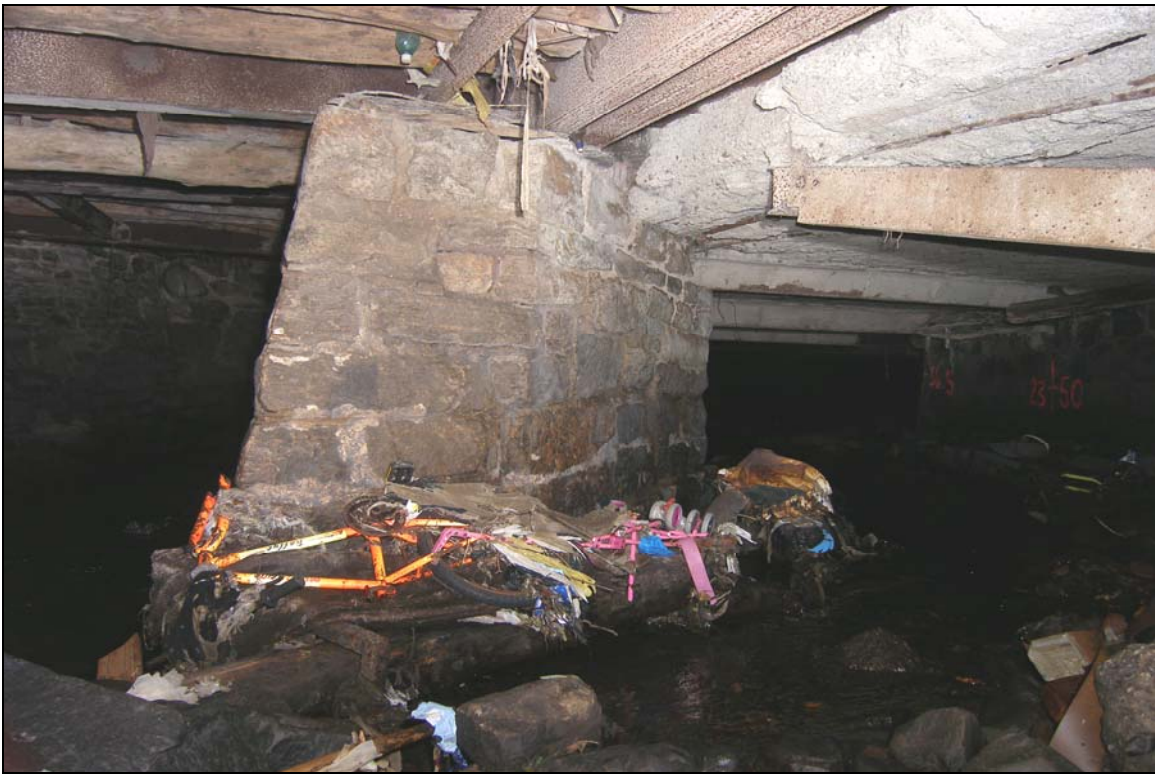
At Station 23+70, a stone masonry pier divides the two types of construction. As seen in the Photo 76, there is a significant build-up of debris along the face of the pier. Due to a change in direction in the flume at this location, the majority of the flow is directed to the channel along the south side of the pier. As a result, there are voids due to missing stones and undermining of the masonry wall along this section of the flume. Photos 77 and 78 show the general views of the observed undermining in this area.

Photo 76 Build-up of debris at stone masonry pier (Station 23+70).

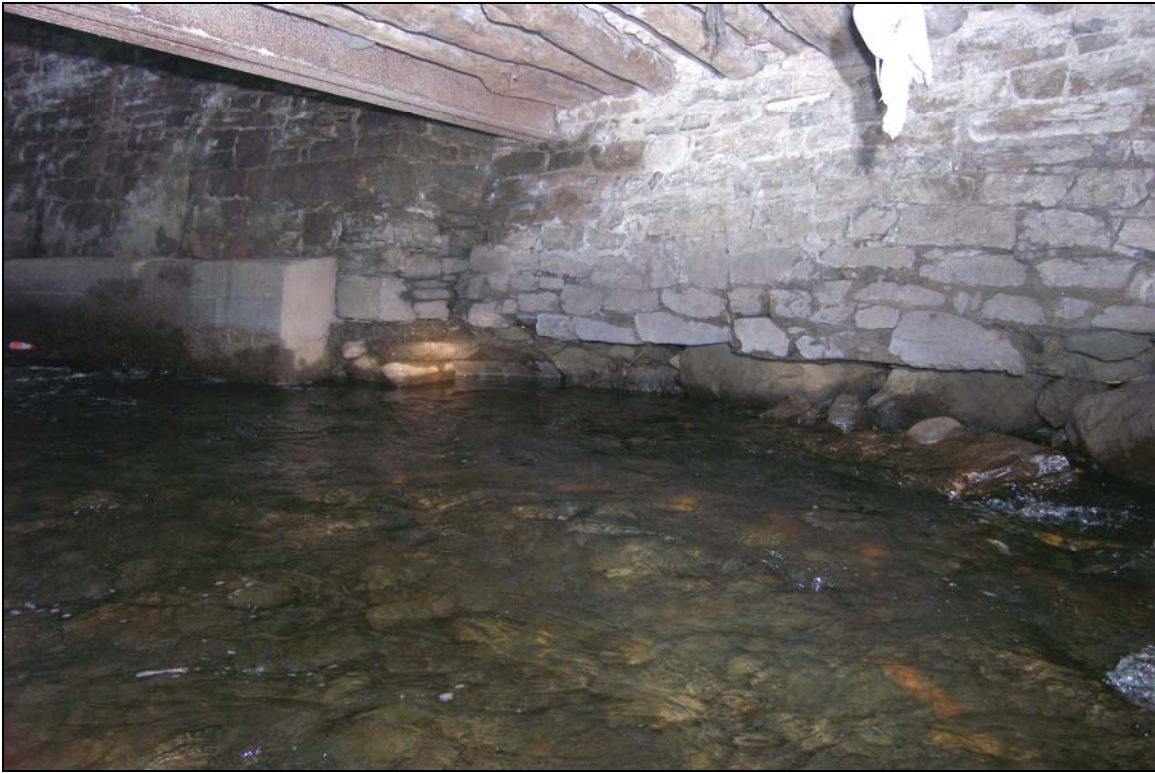
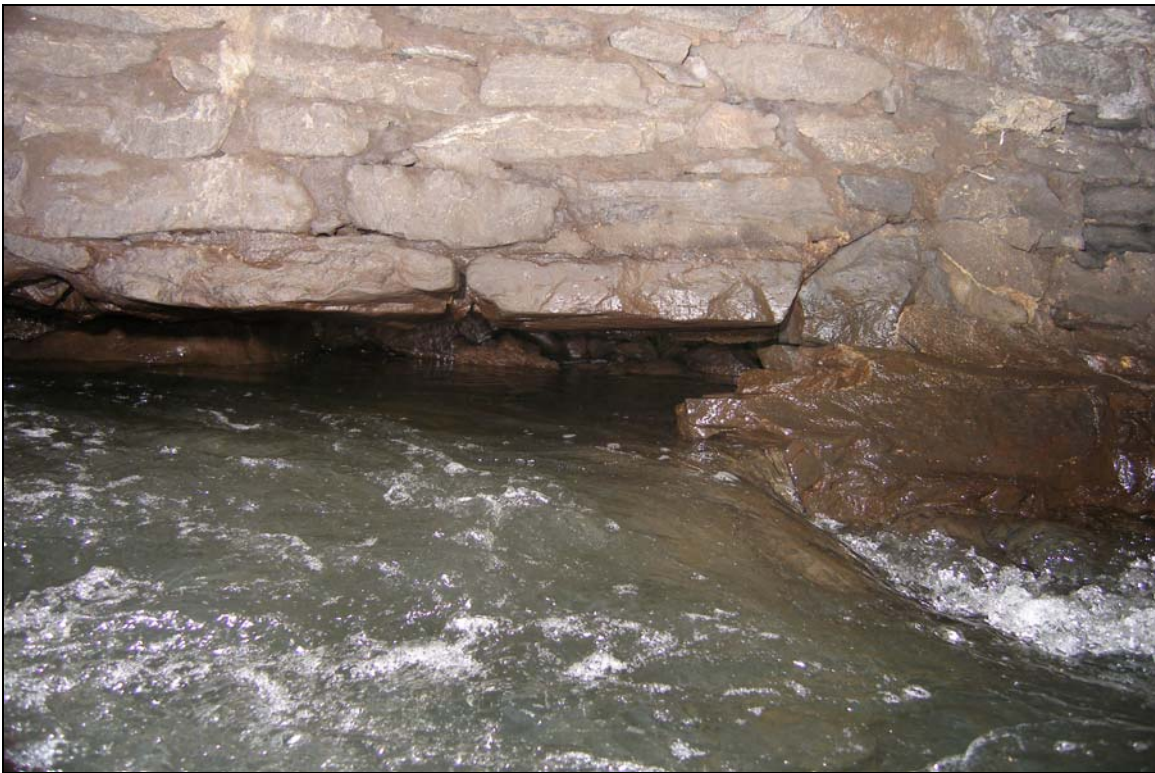
Photo 77 Void/undermining of stone masonry wall located from Station 23+88 to 23+63.

Photo 78 Void/undermining of stone masonry wall located at Station 23+50.

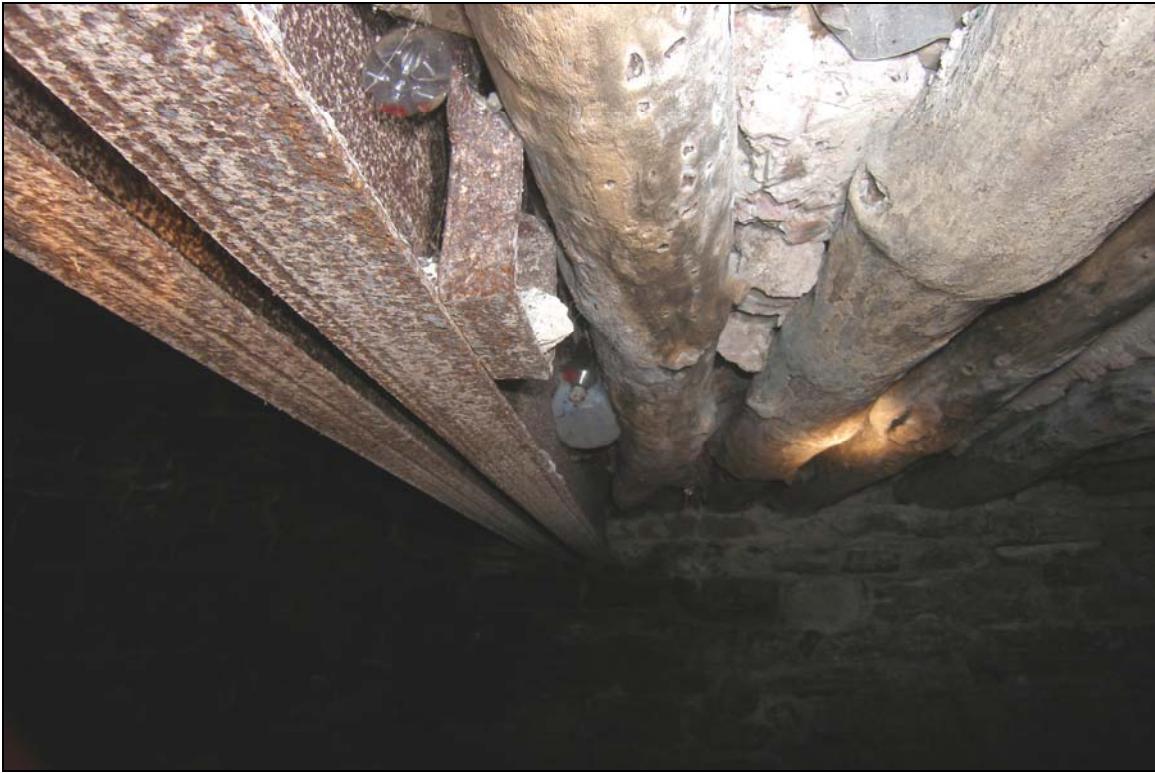
Photo 79 Underside of deck just downstream of Station 23+88 building transition.

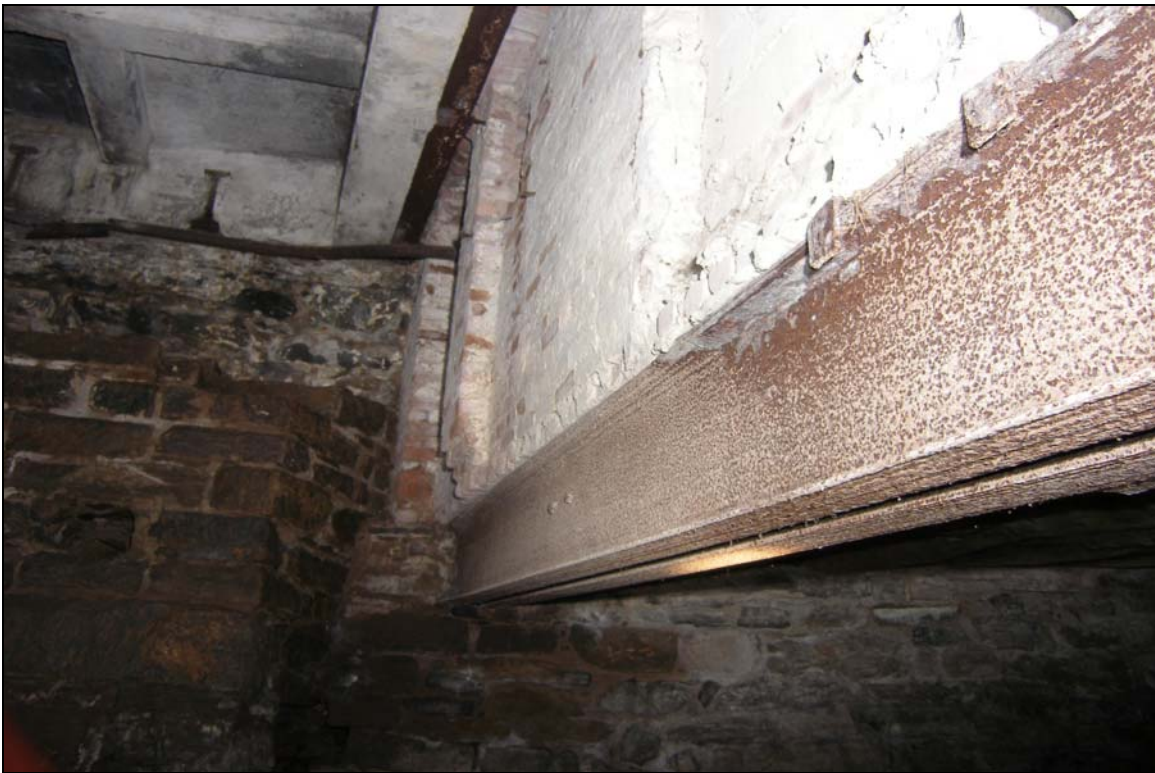
Photo 80 Building fascia located at Station 23+88. North Broadway bridge is located upstream of this station.

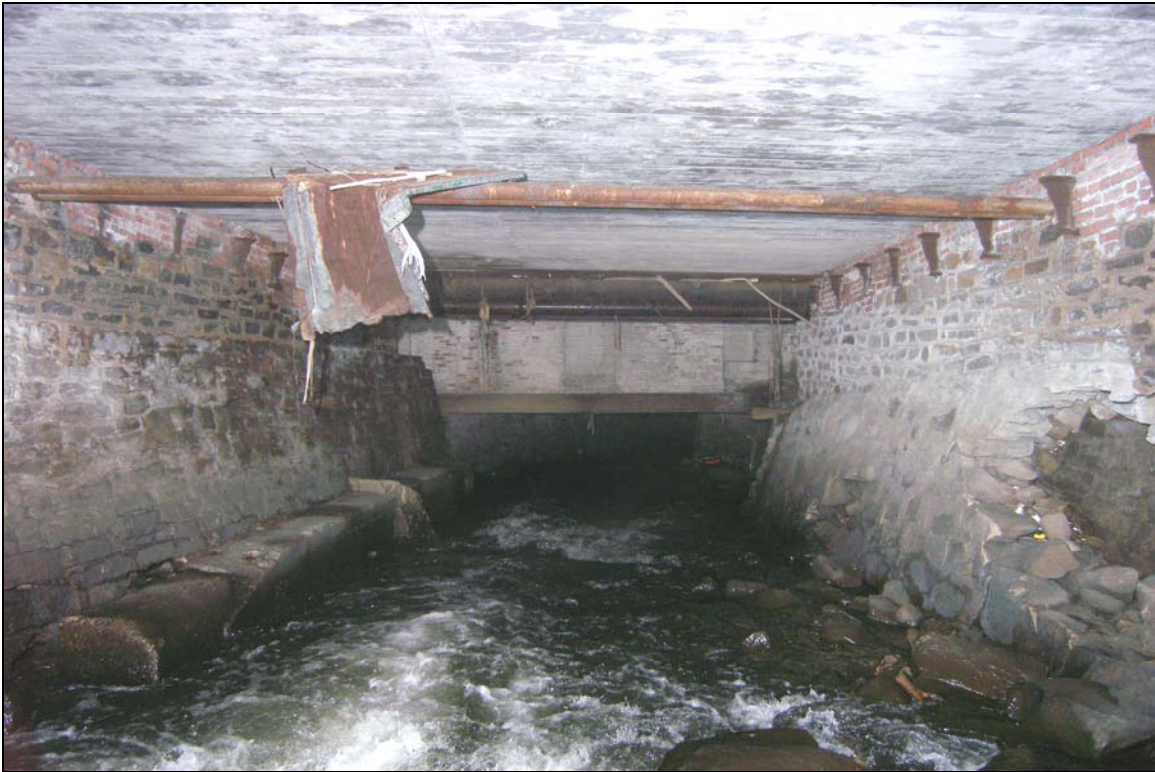
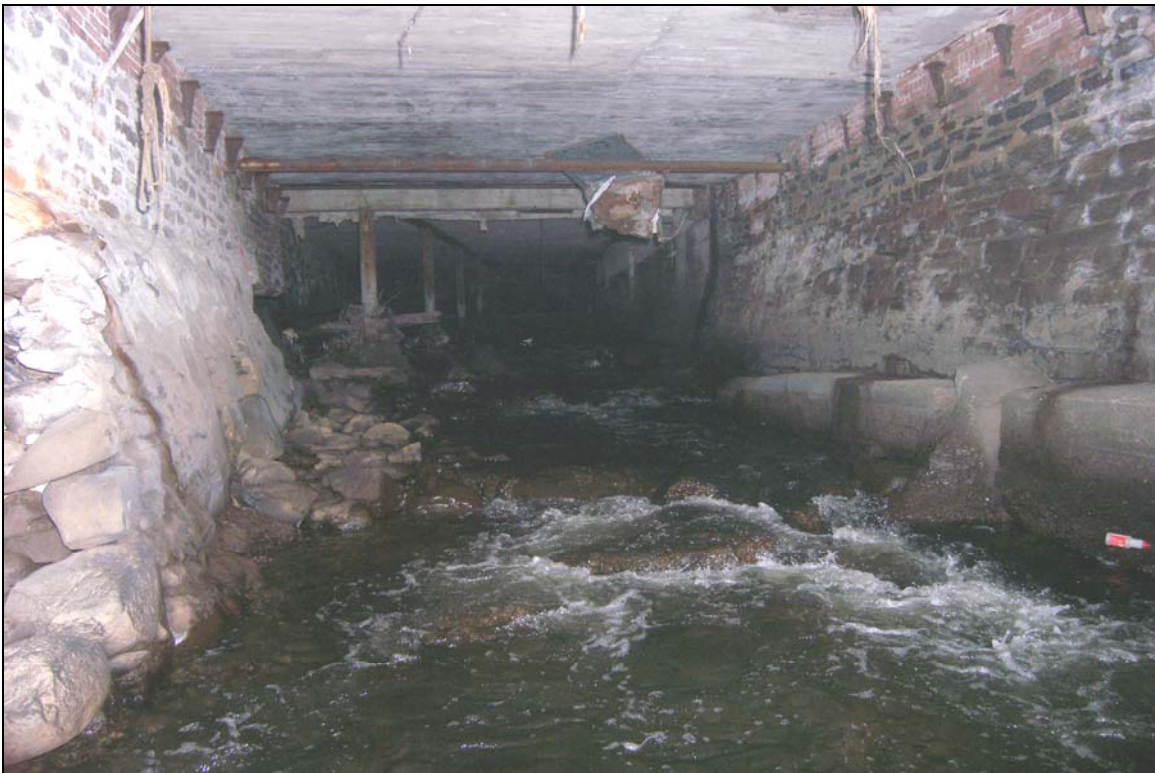
The North Broadway Bridge is located between Stations 23+88 and 24+45. It is approximately 19' wide and there is 13' between the bottom of the concrete deck and the river bottom. Downstream and upstream views of the bridge are shown in Photos 81 and 82, respectively. As seen in the photos, the original steel beam supported deck has been reconstructed with a cast-in-place concrete slab deck. Remnants of the cut-off steel stringers can be seen at the top of the stone masonry abutments.

Photo 81 North Broadway bridge viewing downstream. Note replacement of original steel beams with a concrete deck.

Photo 82 North Broadway bridge viewing upstream.

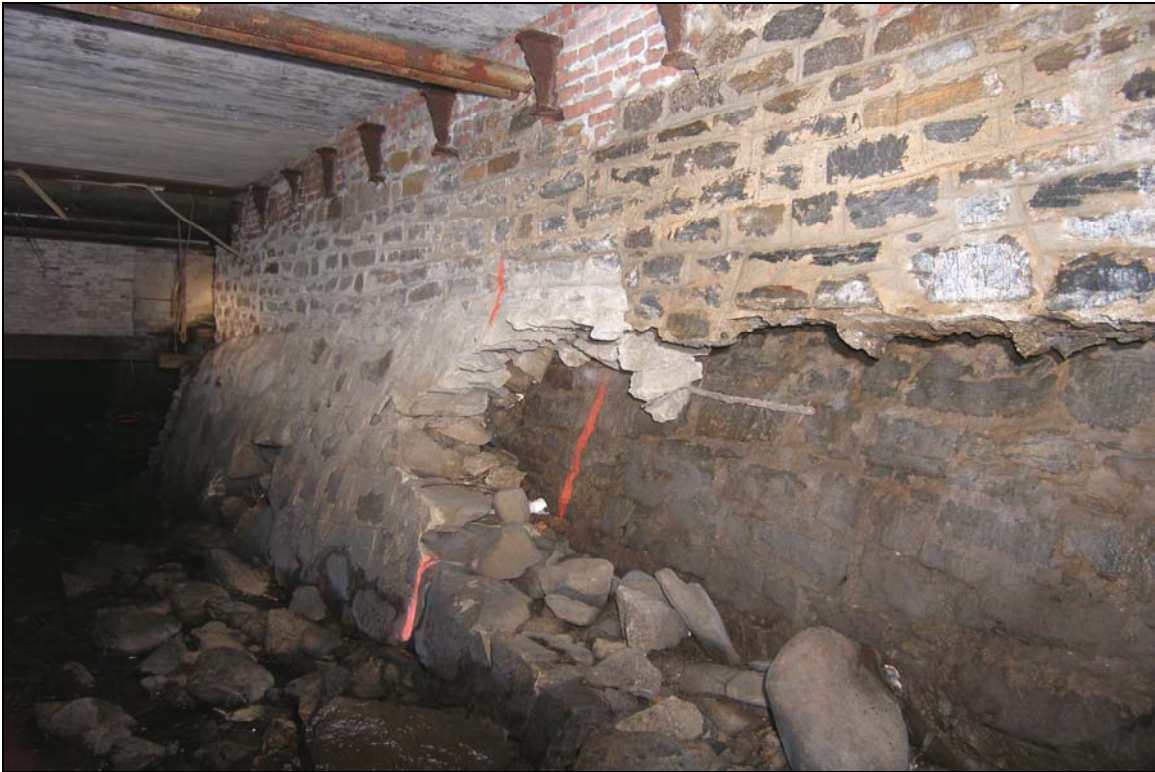
A 16' long by 5' high by 3' deep void is located along the left wall (looking upstream) between Stations 24+22 and 24+38. As seen in Photo 83, the original abutment is located behind the new stone masonry. Due to the slope of the wall and rubble masonry construction, it appears that the outer wall may be a previous repair or scour protection measure to prevent the abutment from undermining. A 2' high by 2' wide concrete repair has been constructed along the base of the right abutment from Station 23+88 to 24+25 (see Photo 84).

Photo 83 Void in left abutment of North Broadway bridge. Note original stone abutment located behind.

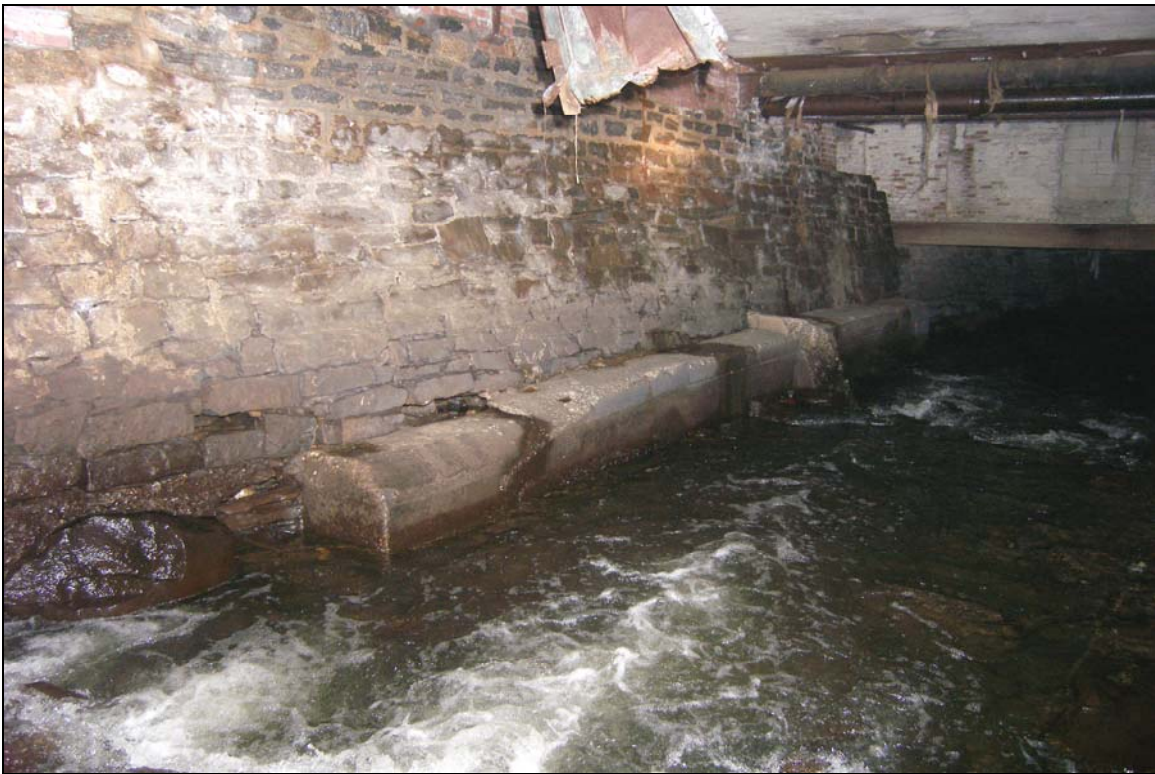
Photo 84 North Broadway bridge abutment, right side.

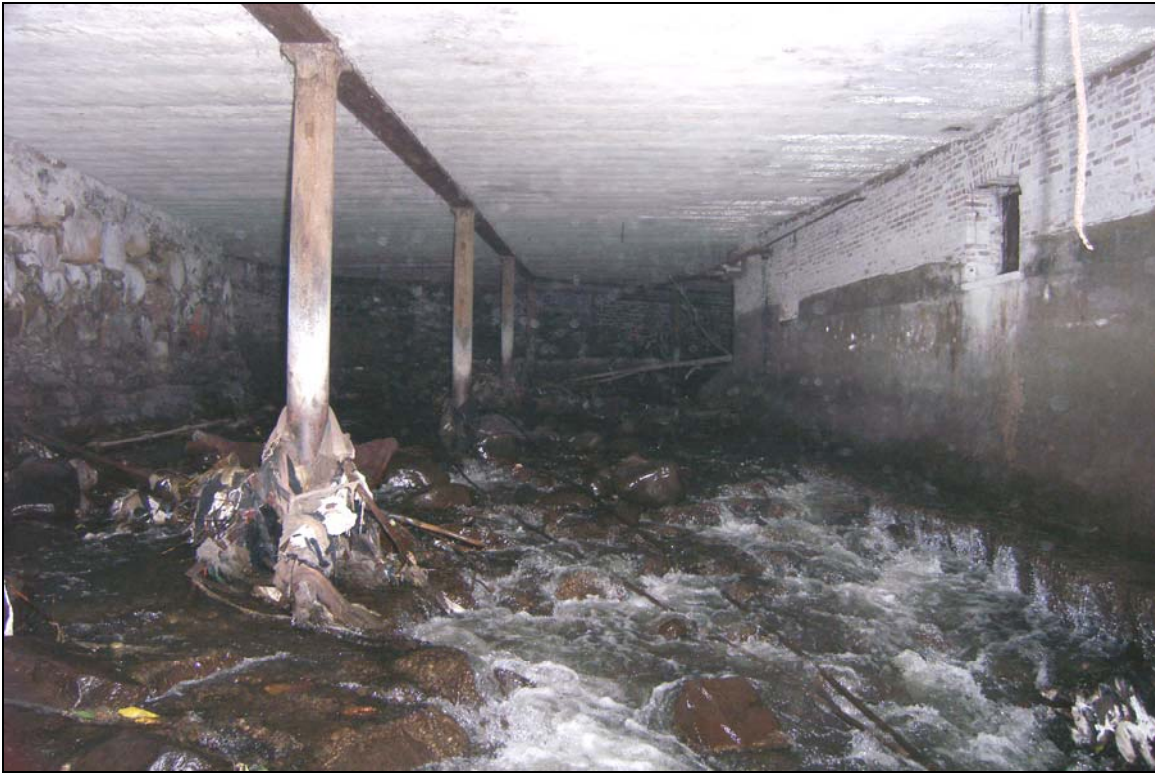
general view of the flume looking upstream from Station 24+50 is shown in Photo 85. As depicted in the photo, steel girders run longitudinally between the steel columns and support timber floor joists. Stucco has been applied along the bottom face of the floor joists. Along the right wall, there is an area of missing stucco located in the vicinity of Station 24+60. The exposed timber beams at this location exhibit moderate to severe rot (see Photo 86). The 14' distance between the bottom of the joists and the streambed at this location precluded a hands-on inspection of this area.

Photo 85 General view looking upstream of Station 24 + 50.

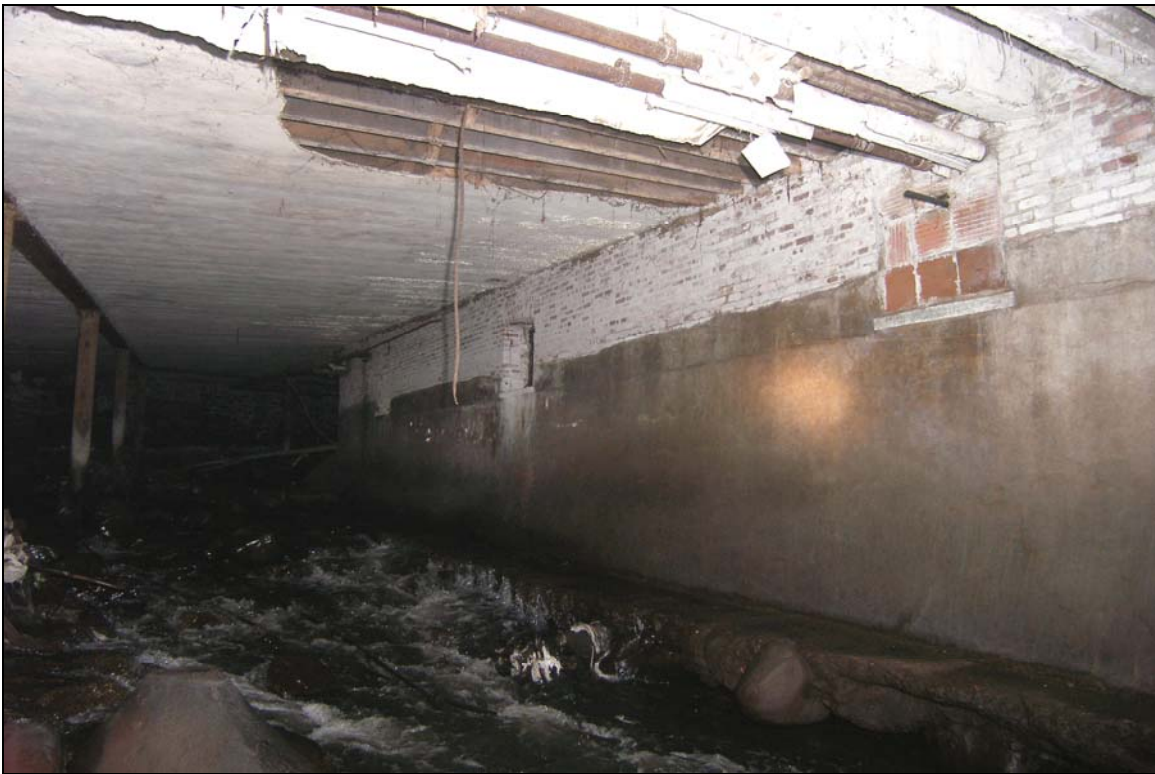
Photo 86 Building fascia located along right side of channel upstream of Station 24 + 50.

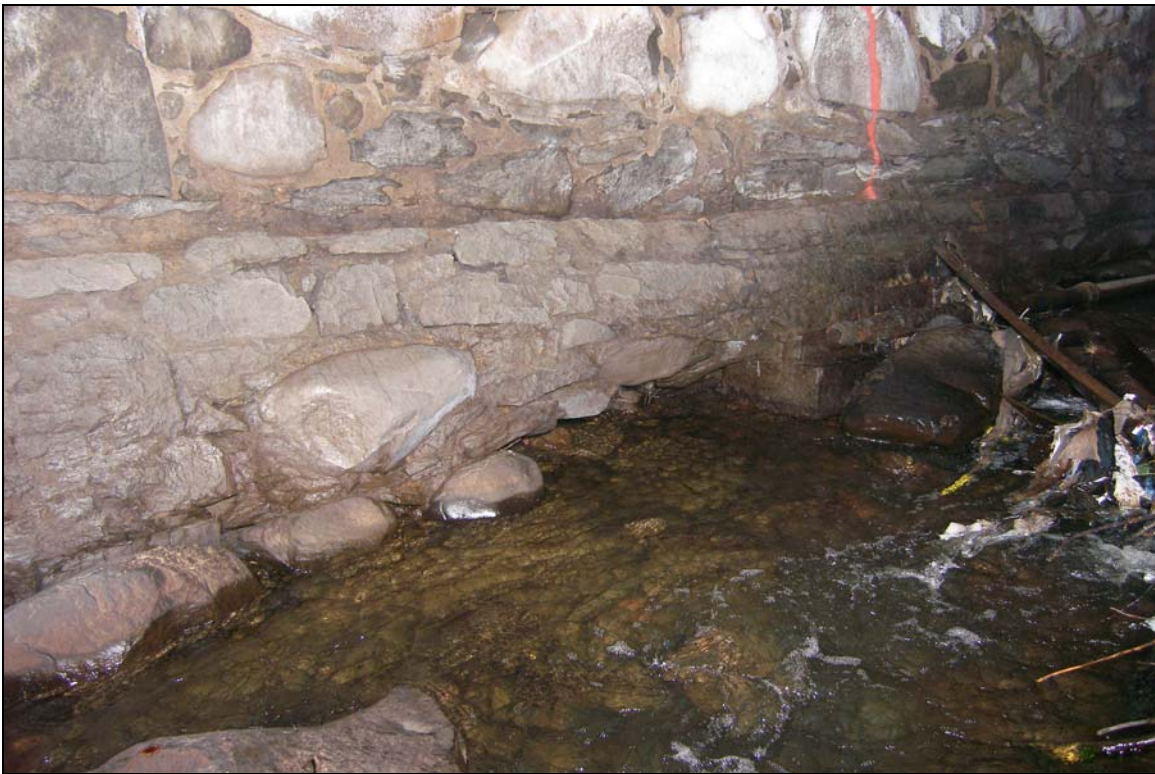
Heading upstream, the flume turns approximately 30 degrees to the right (southeast) at Station 25+25. A general view looking upstream from Station 24+75 is shown in Photo 89. As a result of the change in stream channel alignment, an 8' long by 3' high by 4' deep void is located in the left wall at Station 25+10 (see Photo 90). Upstream and downstream views of the flume from Stations 25+50 and 25+60 are shown in Photos 91 and 92, respectively. As seen in Photo 92, a significant amount of debris has accumulated at the base of the steel column located at Station 25+25. This is typical of all the steel columns in this section.

Photo 90 Void/undermining of left wall at Station 25+10.

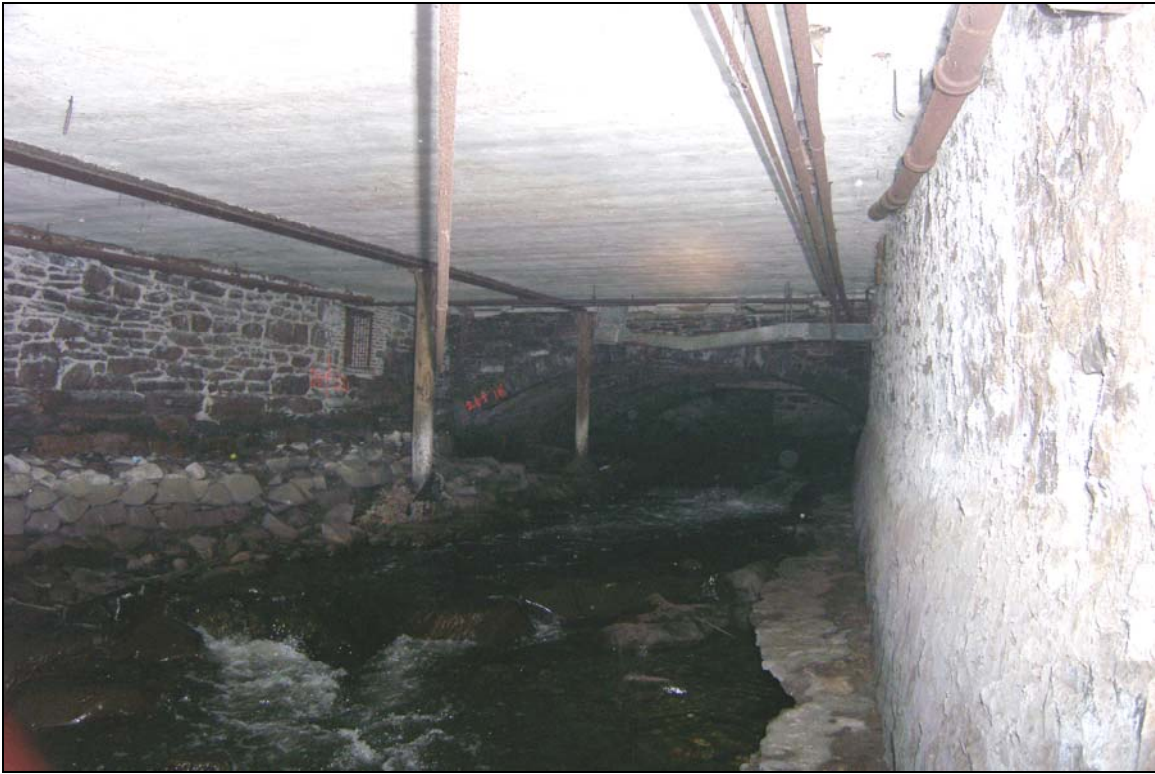
Photo 91 General view looking upstream from Station 25+50. Note downstream fascia of Palisade Ave. bridge in background.

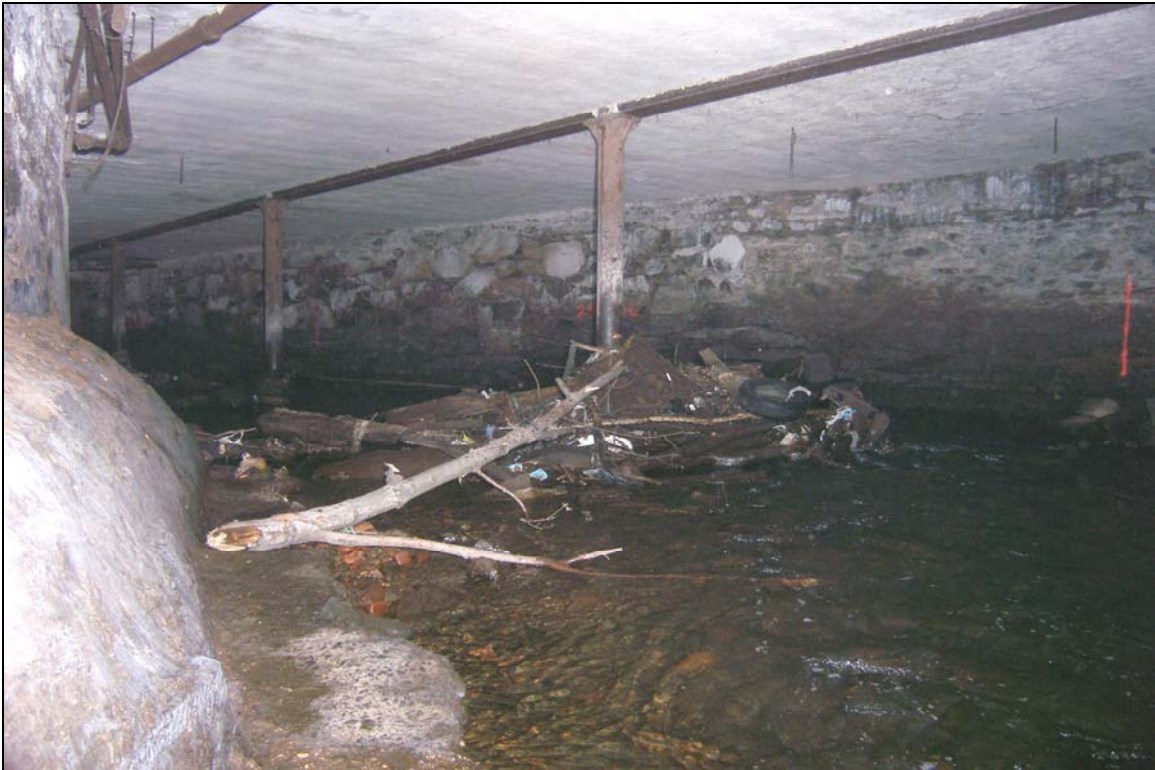
Photo 92 General view looking downstream from Station 25+60. Note build-up of debris in center of channel.

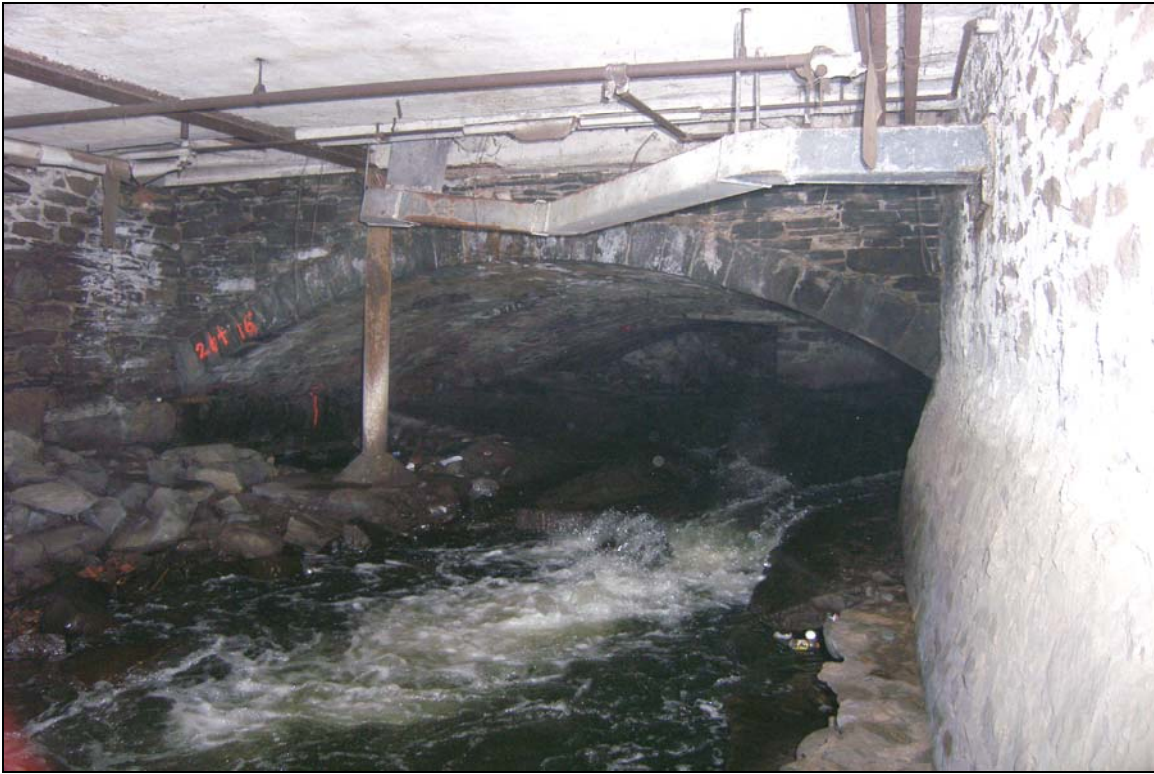
The Palisade Avenue Bridge is located between Stations 26+16 and 26+64. A general view of the downstream bridge fascia is shown in Photo 93. The bridge is approximately 32' wide and ranges in height between 7' and 9.5' at the upstream and downstream fascias, respectively.

Photo 93 Downstream fascia of Palisade Ave bridge located at Sta 26+16.

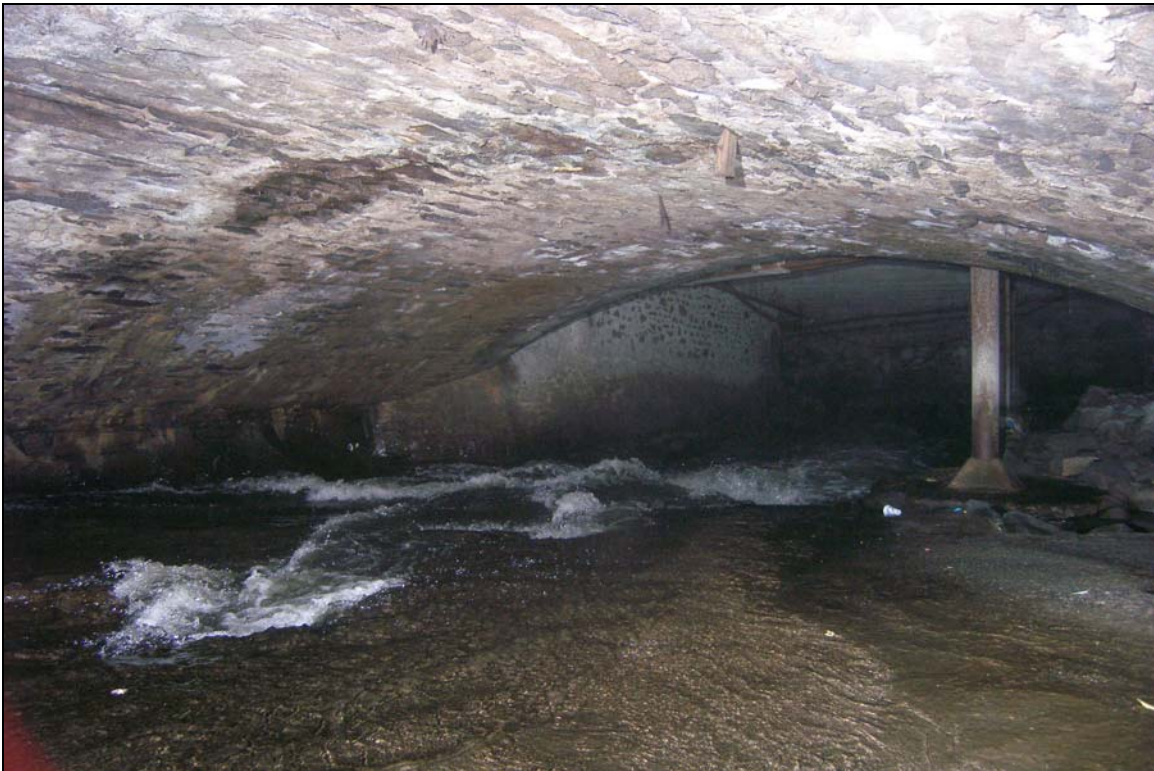
Overall the stone masonry arch is in fair condition with no missing or displaced stones. Photo 94 provides a general view of the underside side of the arch. Approximately 15 percent of the joints exhibit 1" to 3" deep areas of missing grout. In addition, efflorescence was observed at more than half the joints. The concrete floor of the bridge is generally in fair condition and exhibits localized areas of severe concrete scale. At the downstream fascia of the bridge, there is a concrete floor bench approximately 1' higher than the downstream channel bottom.

Photo 94 General view beneath the Palisade Ave masonry arch bridge. Note efflorescence located in joints between stones.

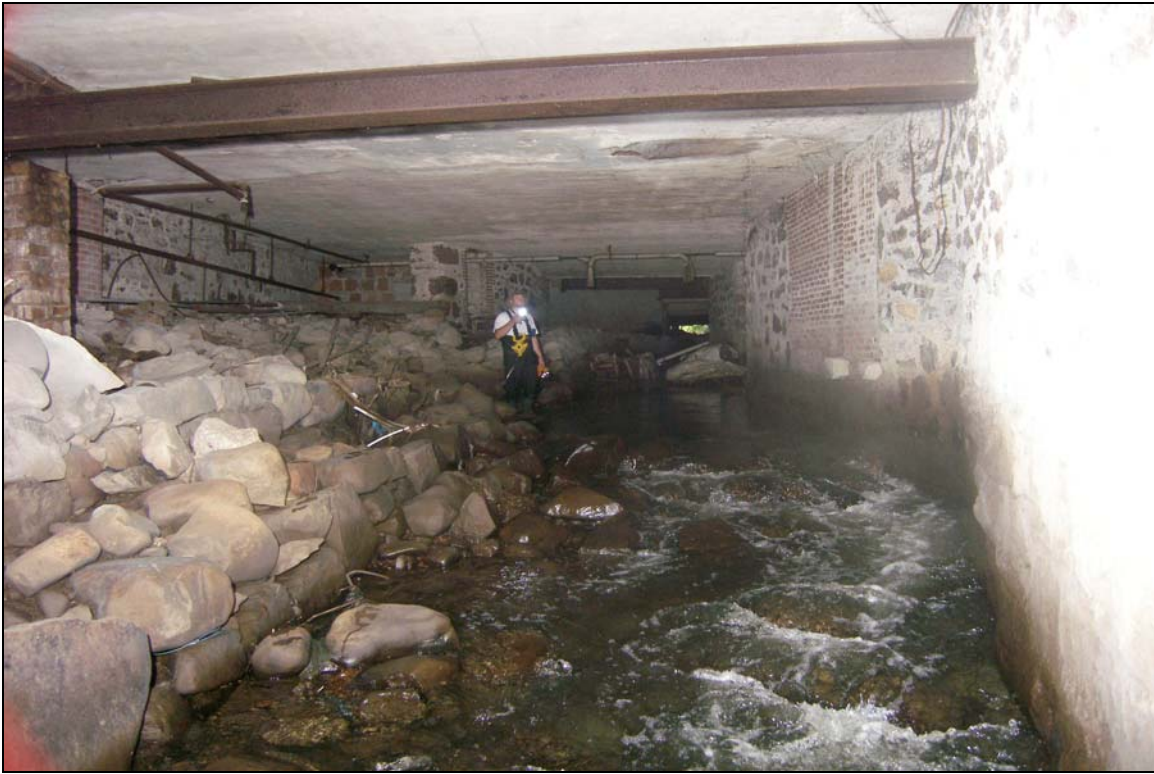
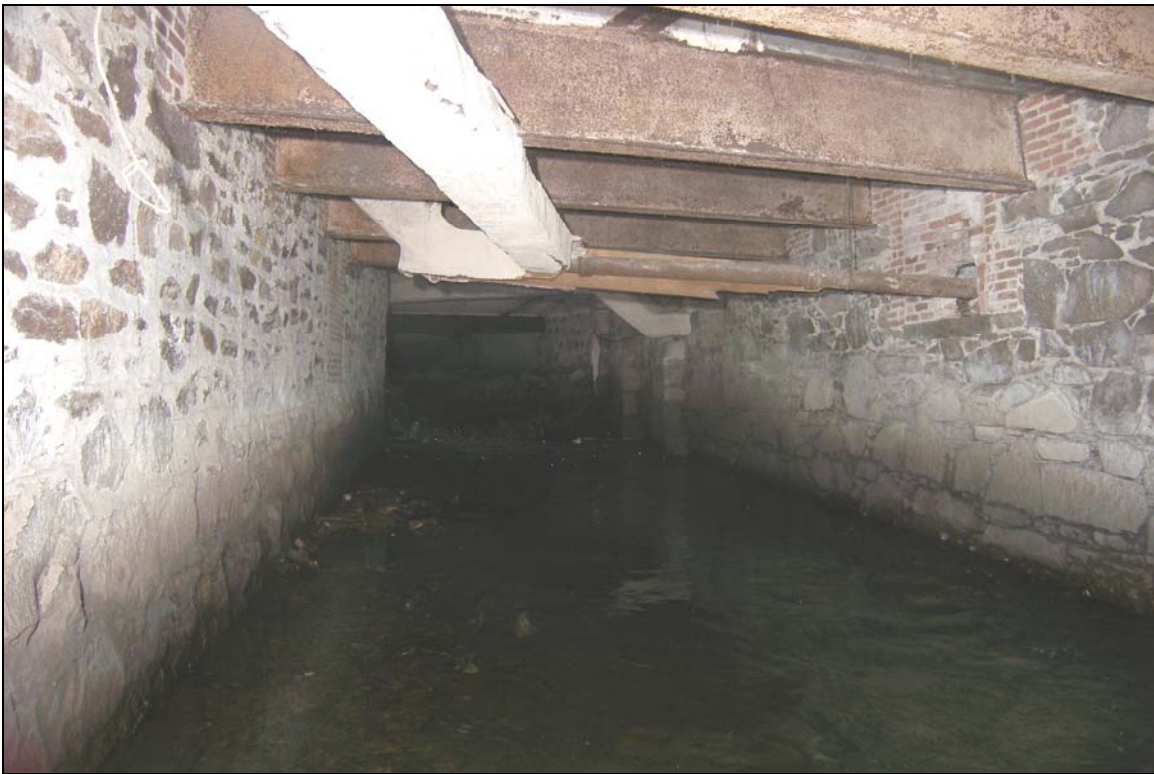
Upstream of the Palisade Avenue Bridge, a series of stone masonry piers divide the waterway into two channels. General views of the left and right channels looking upstream from Station 26+64 are shown in Photos 95 and 96, respectively. As depicted in the Photo 95, a 10' wide stone wall located along the left side of the channel limits the width of the waterway to approximately 9'. As a result, the majority of the flow in this section of the flume is directed towards the 27' wide channel located to the right side of the pier. At the nose of the 46' long pier (Station 27+00), a 3' high accumulation of debris has created a small dam which stretches across the right channel.

Photo 95 Viewing upstream from Station 26 + 64, left channel.

Photo 96 Viewing upstream from Sta 26 + 64, right channel.

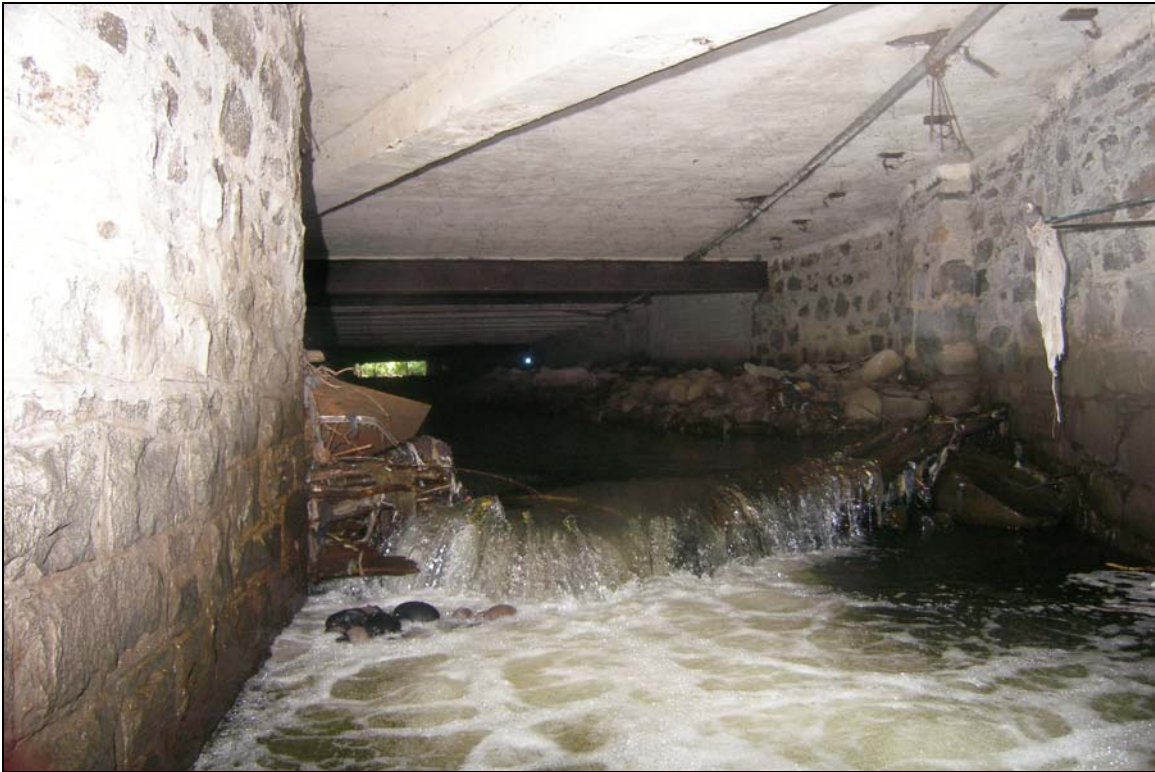
Photo 97 Viewing upstream from Sta 27+00 along right side of the pier. Build-up of debris has created a 3' high dam.

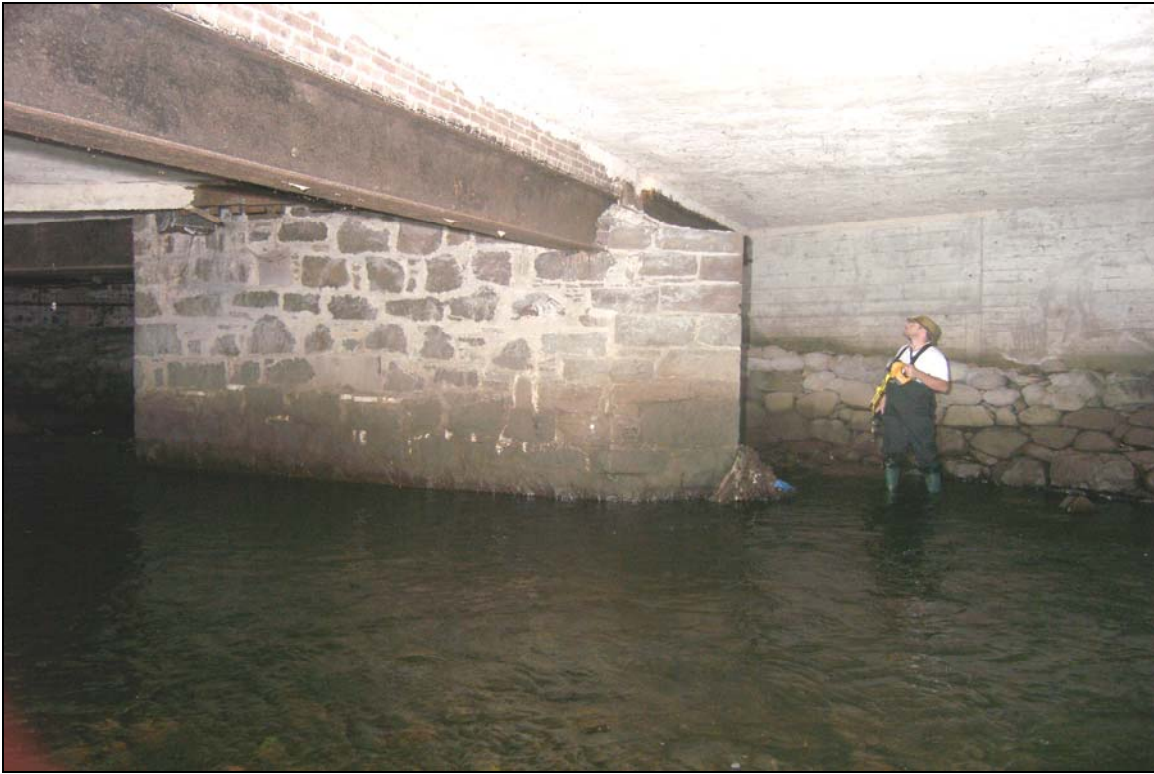
Photo 99 Construction transition at Sta 27 + 42.

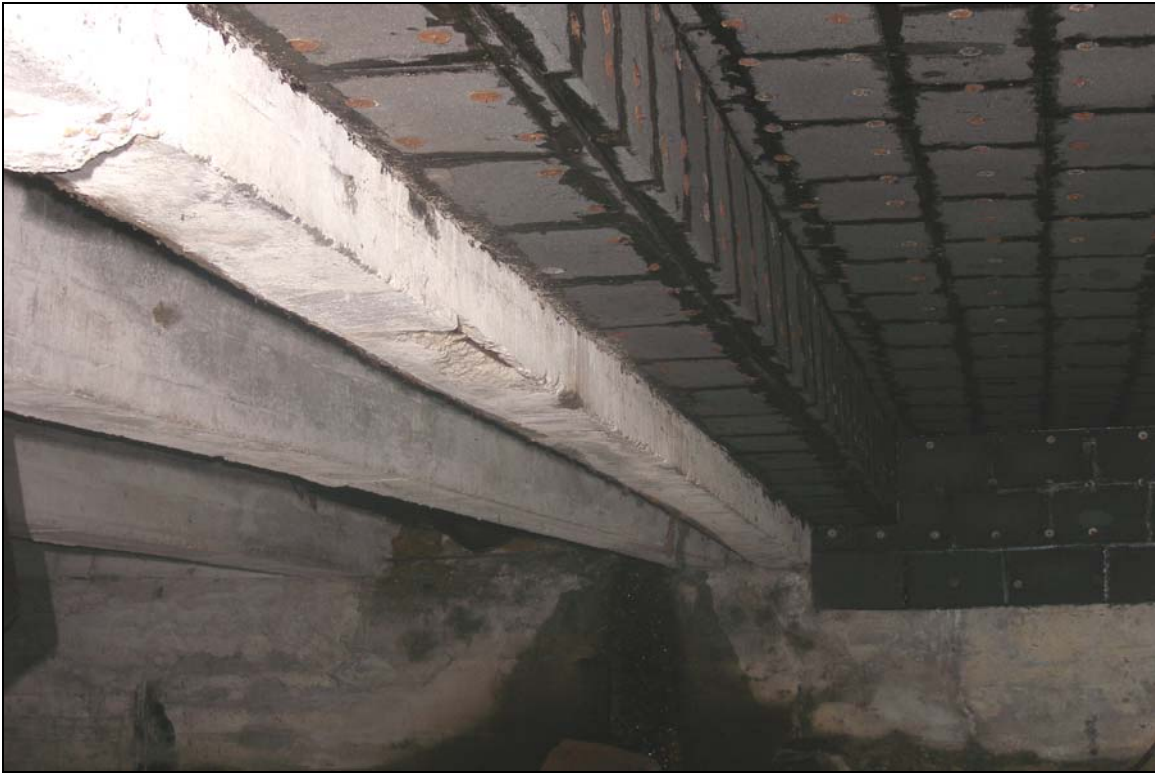
Photo 101 Construction transition at Sta 28+30. Note foam insulation applied to underside of deck and beams in right side of photo.

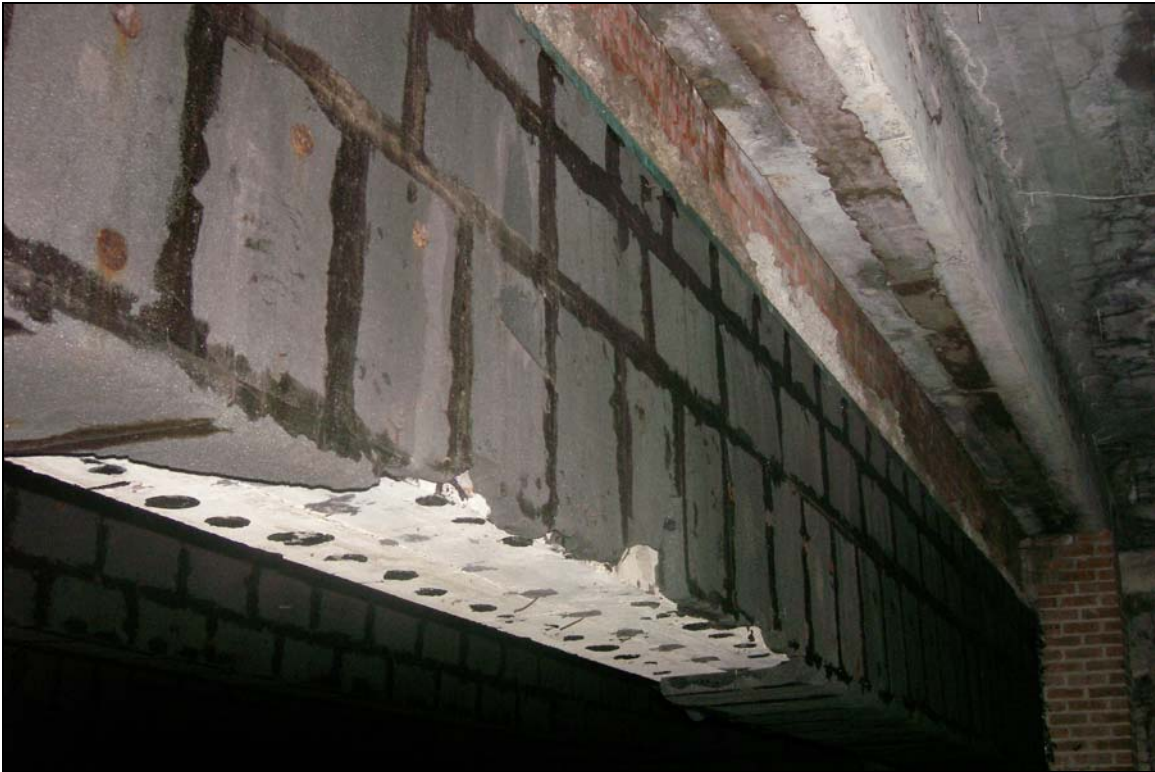
Photo 103 Construction transition at Sta 28+94. Note sections of missing insulation exposing concrete beam.
