SAWMILL RIVER CULVERT/FLUME INSPECTION Yonkers, New York

McLaren Engineering Group
100 Snake Hill Road
West Nyack, NY 10994

August 2006
Revised December 2007

MEG Job No. 106100.01

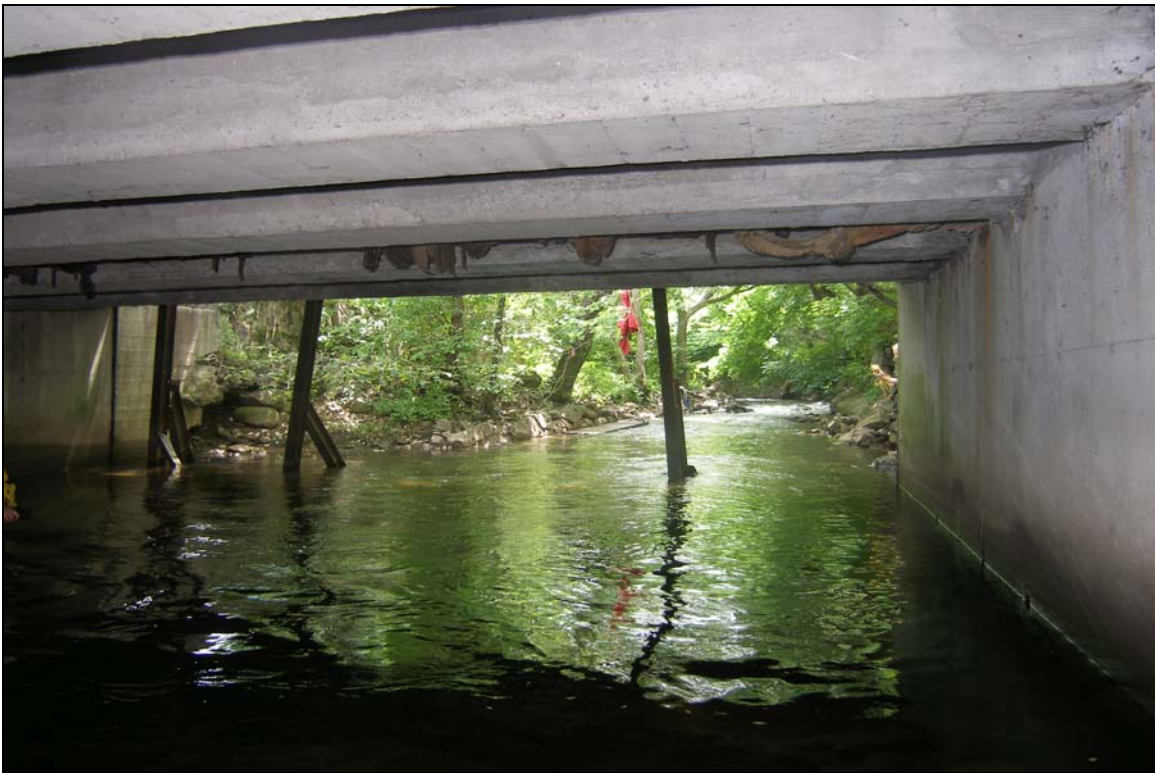
Photo 105 Underside of concrete beams and abutment at Ann Street Bridge. Note steel support beam remnants from original trash racks at entrance to flume (Sta 31+00).

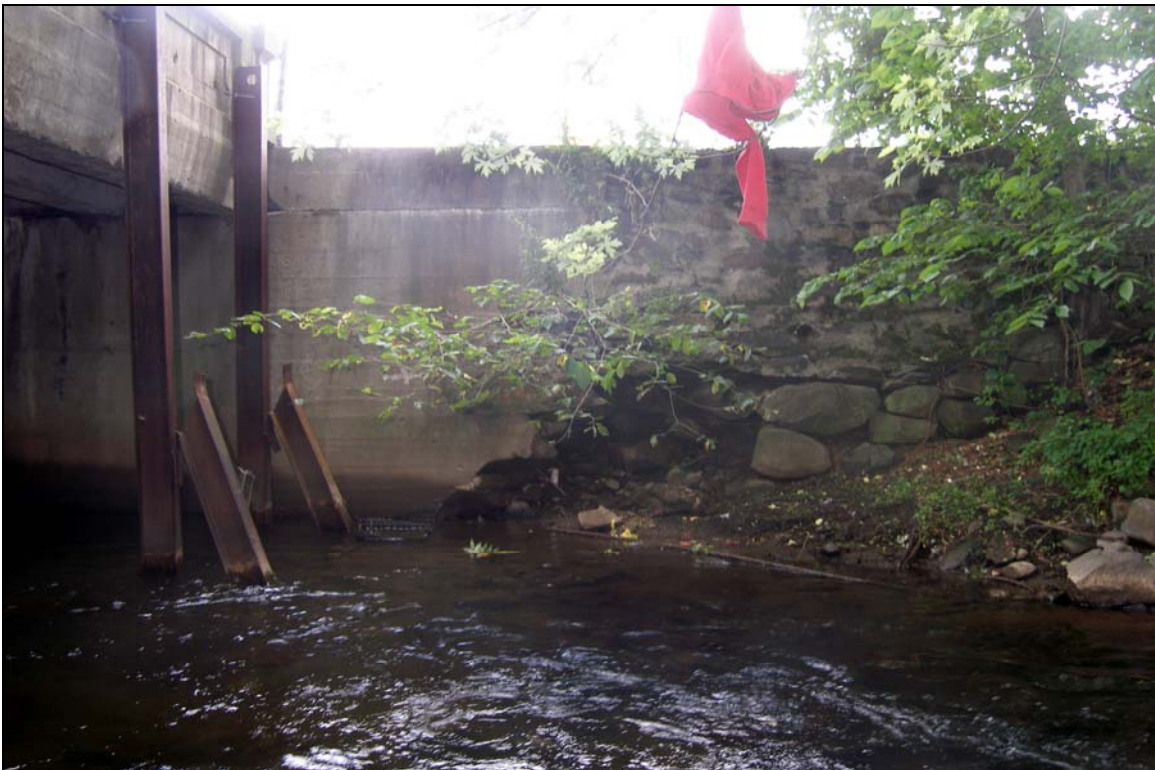
Photo 106 Station 31+03 to 31+13, 5' high by 3' deep void at base of stone masonry wall at interface with southeast wingwall for Ann St. Bridge.

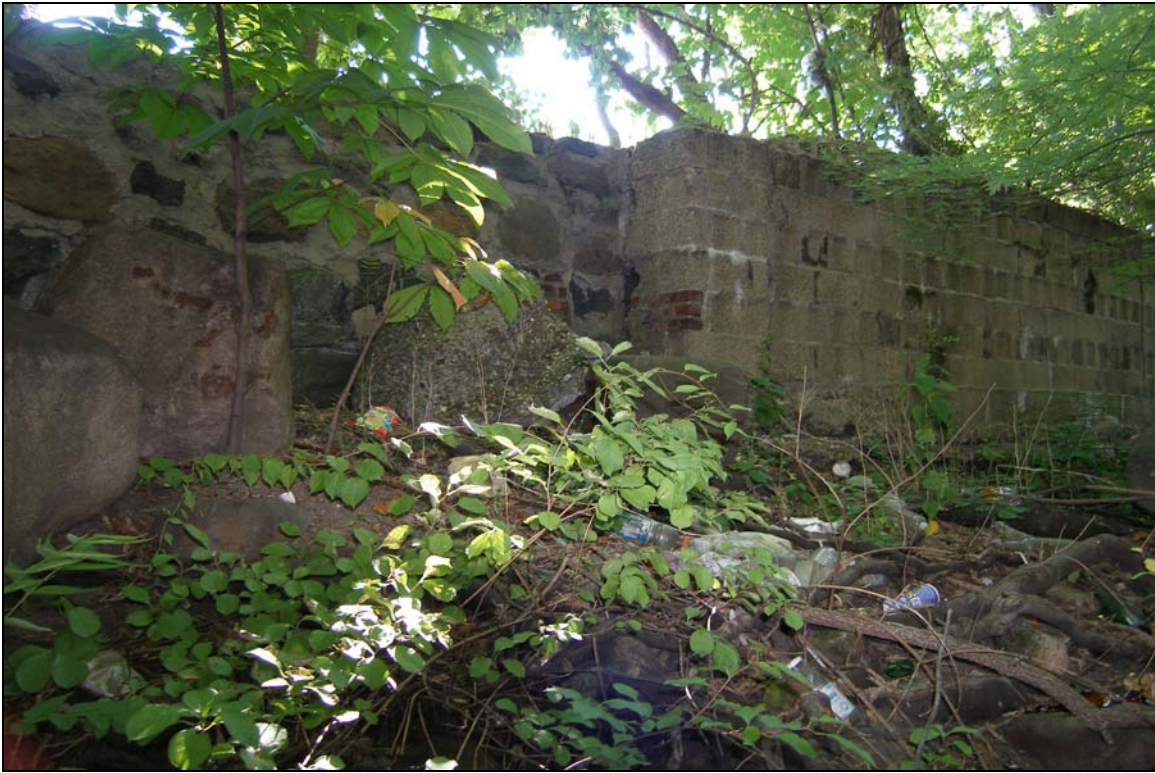
Photo 107 Station 31+40, change in construction from stone masonry wall to concrete block wall.

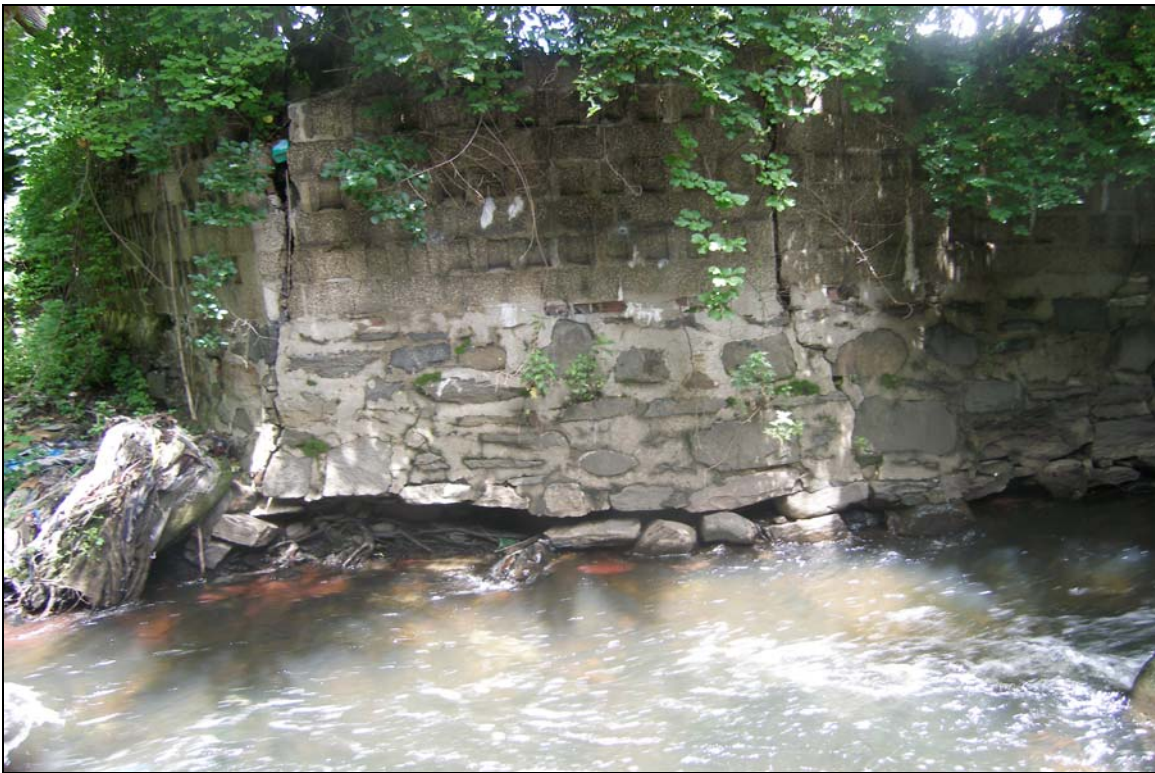
Photo 110 Left embankment, Station 32+00 to 32+15. 2.5' high by 2.0' deep undermining and 1" wide vertical cracks in stone masonry wall.

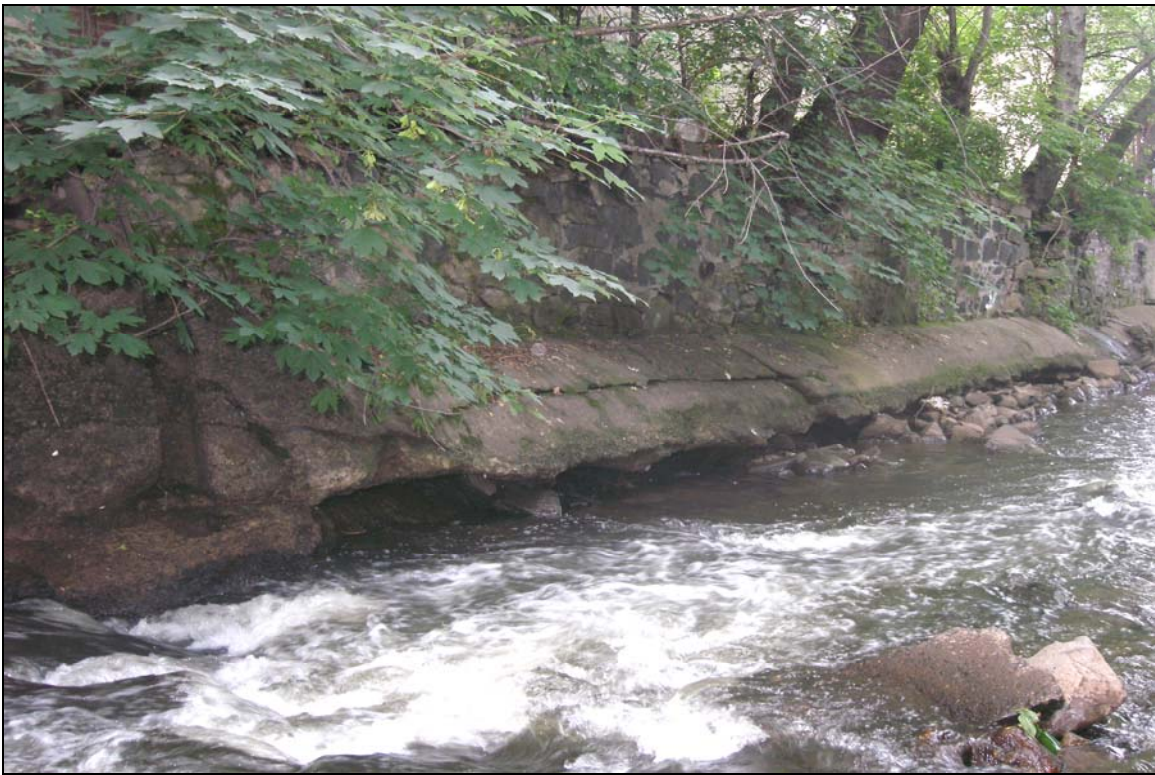
Photo 112 Right embankment, upstream of Ann Street bridge. Concrete repair is undermined up to 1' high by 2' deep from Station 31+03 to 32+10.

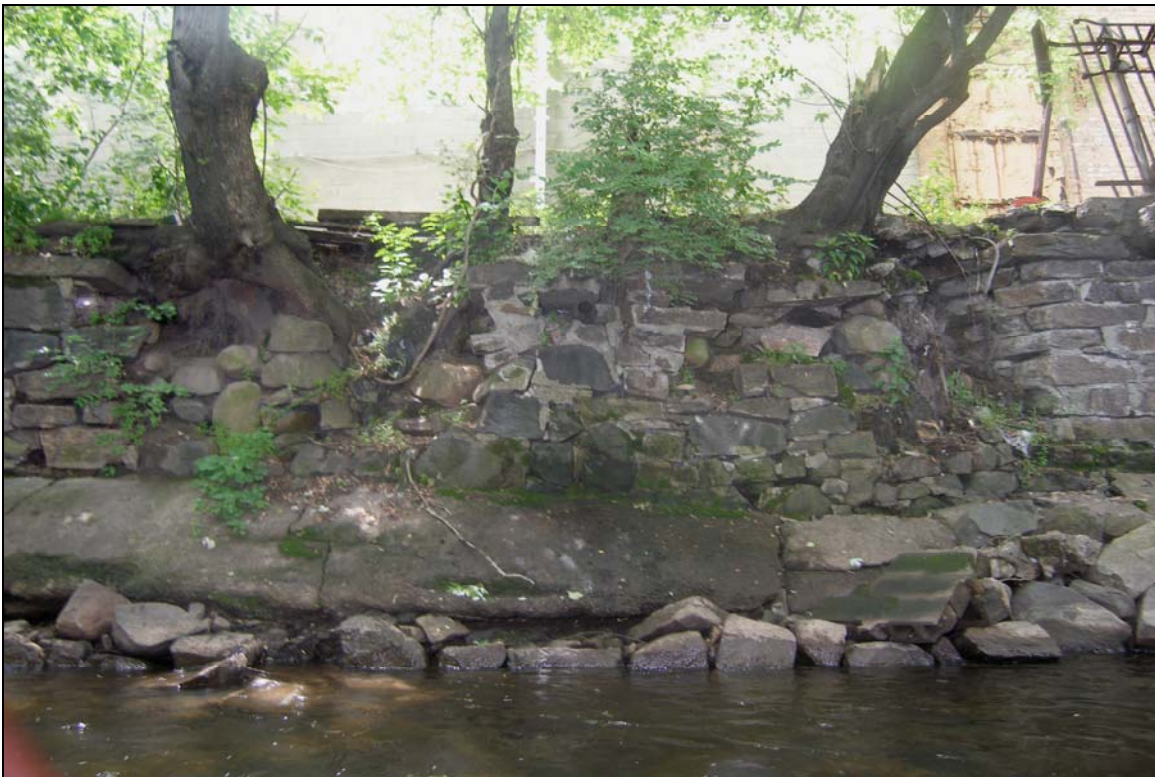
Photo 114 Right retaining wall, upstream of the Ann St. Bridge. Typical condition whereby vegetation and missing chink stones are compromising the integrity of the retaining wall.

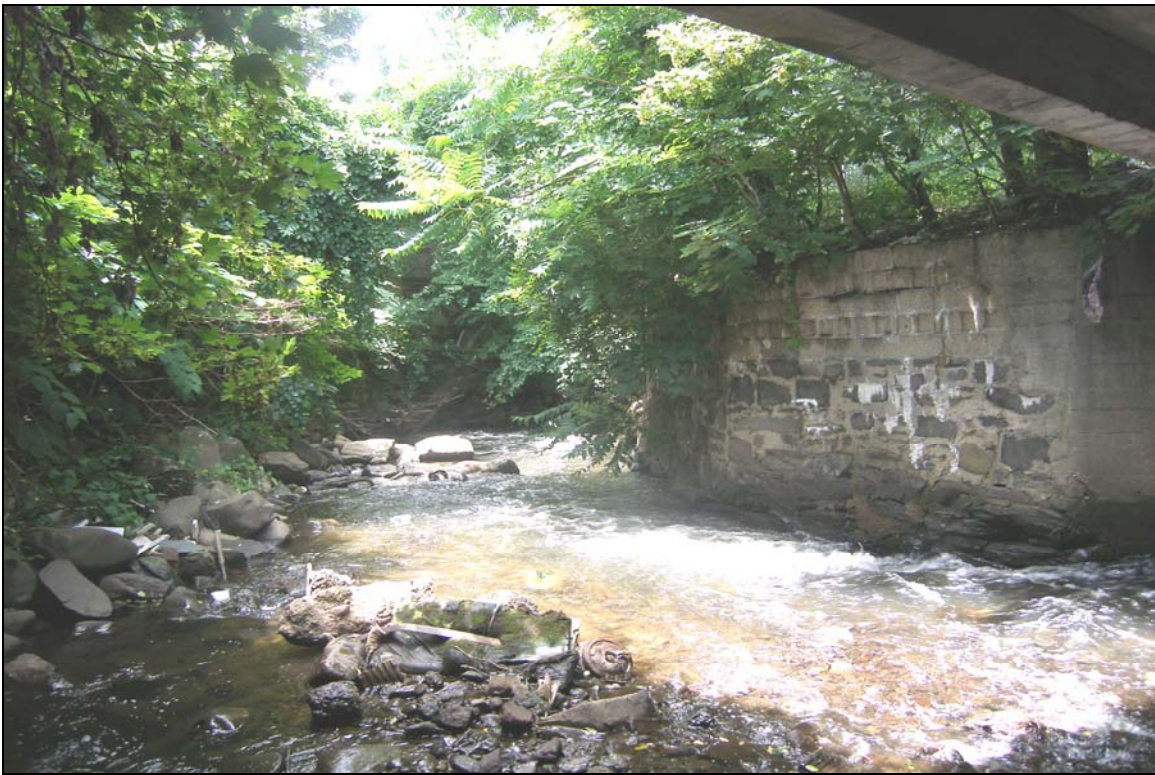
Photo 116 General view looking downstream from Henry Herz Street Bridge.

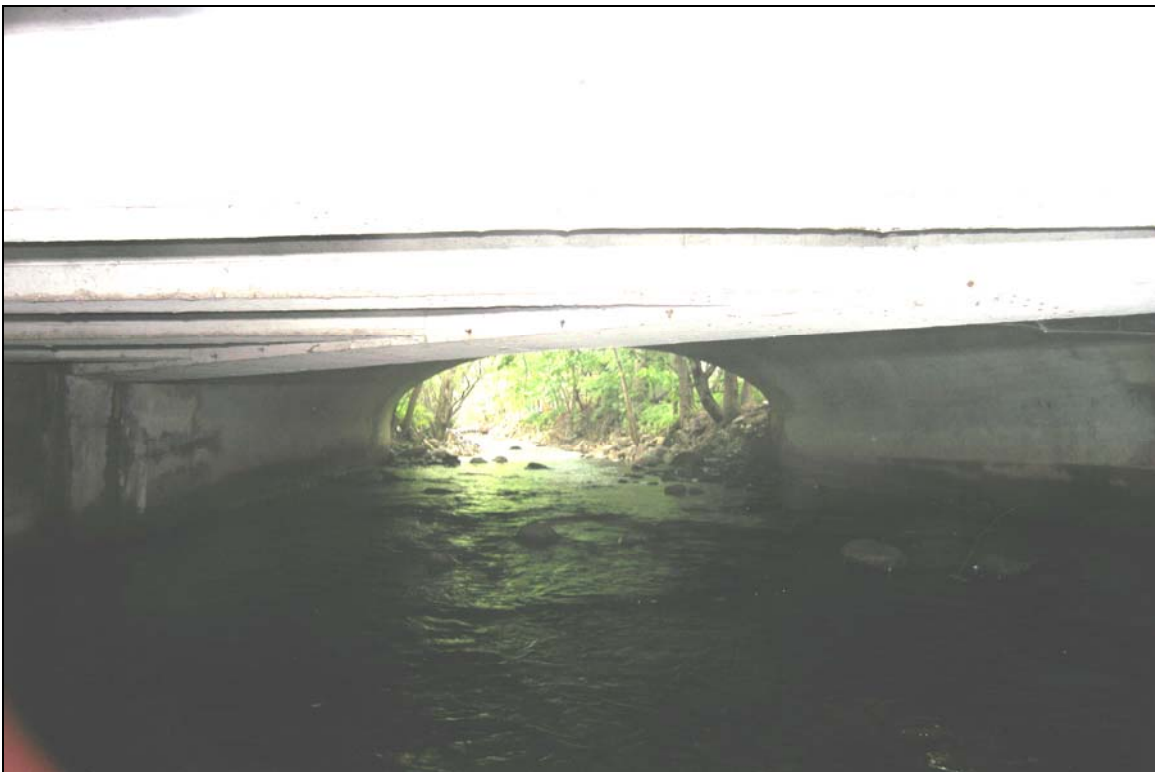
Photo 120 General view looking upstream from the transition between the parking lot structure and the School Street Bridge.

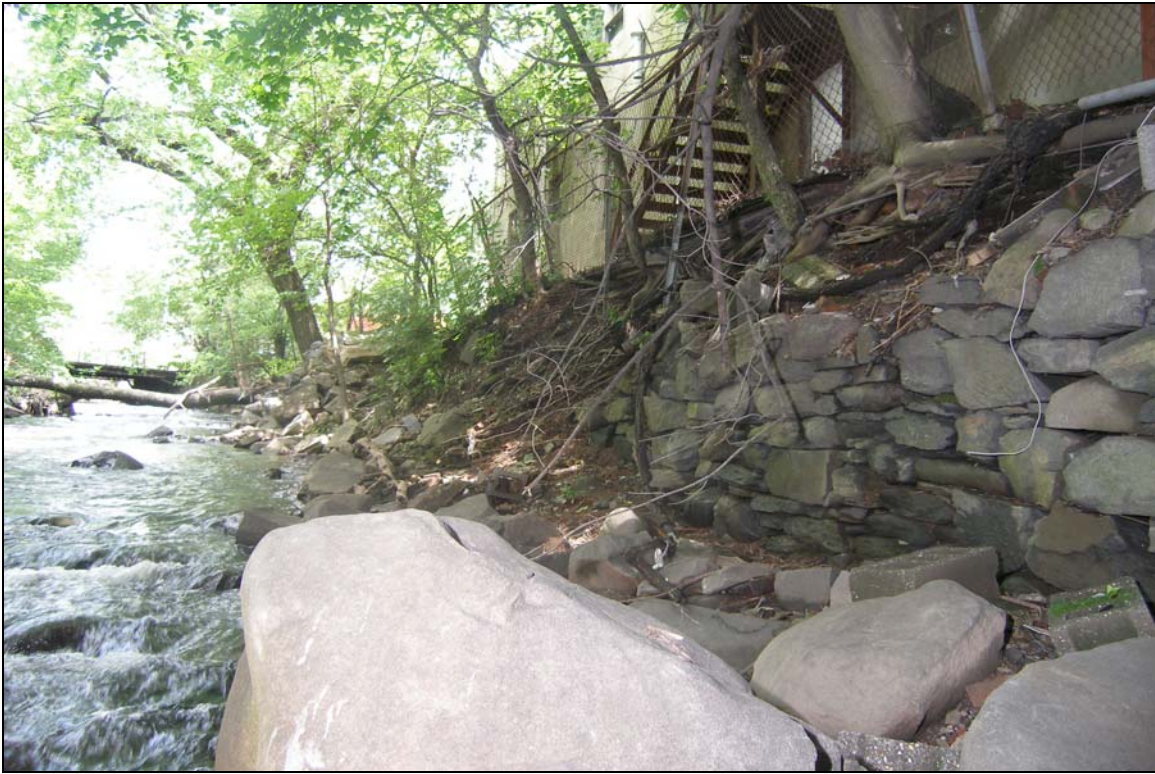
The right (east) embankment from Station 36+46 to 37+40 is mostly comprised of destabilized riprap, loose earth and vegetation (see Photo 122). A stone masonry wall is located between Stations 37+40 to 37+90. Overall the wall is in poor condition and exhibits areas of missing and displaced stones. A general view of the upstream end of the wall is shown in Photo 123. As seen in this photo, between Stations 37+60 and 38+50, a building is located approximately 10' from the top of the embankment.

Photo 123 Right embankment. Upstream end of stone masonry wall at Station 37+90. Note building in right side of picture is located approx. 10' from top of embankment.

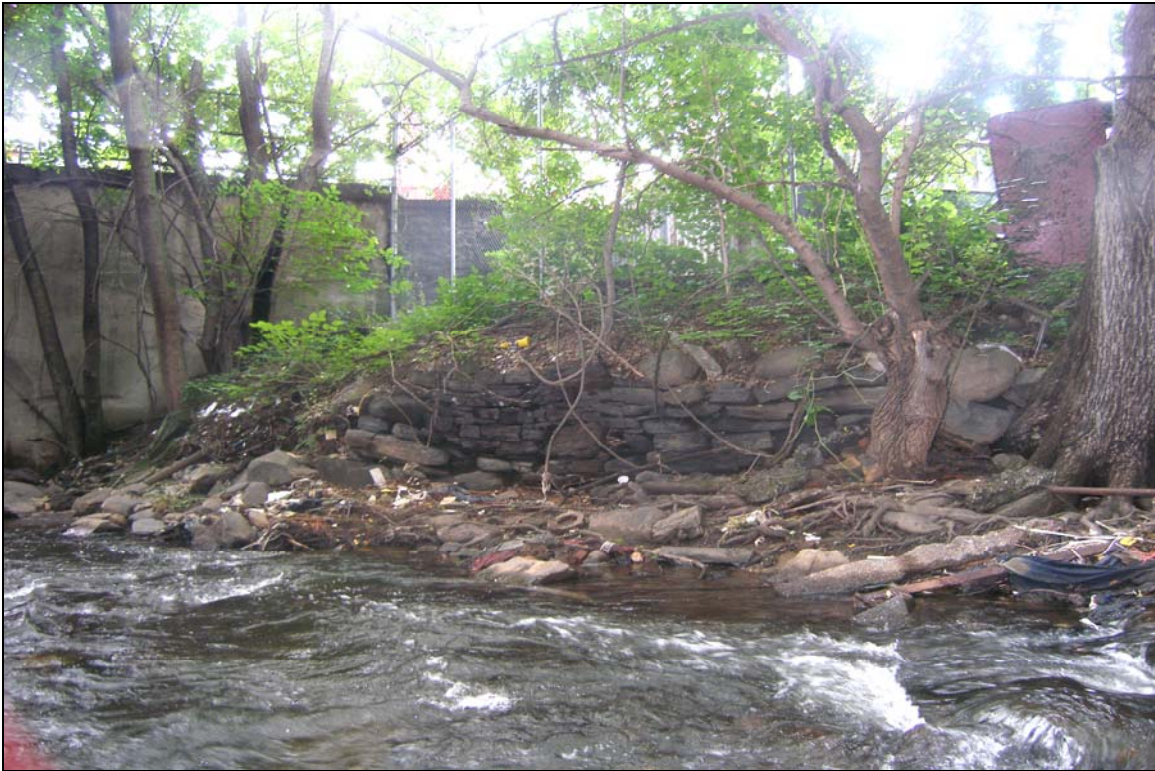
Along the left (west) embankment, from Station 36+76 to Station 39+33 the sloped embankment is primarily comprised of loose earth, destabilized riprap, and vegetation. In addition, there is a deteriorated stone wall located between Stations 37+00 and 37+50 (see Photo 124). Photo 125 provides a general view looking upstream from Station 38+65. As seen in the photo, a fallen tree extends across the channel approximately 2' above the water surface at Station 38+65.

Photo 124 Left embankment. Deteriorated stone masonry wall located between Stations 37+00 and 37+50. Note accumulation of debris along edge of river.

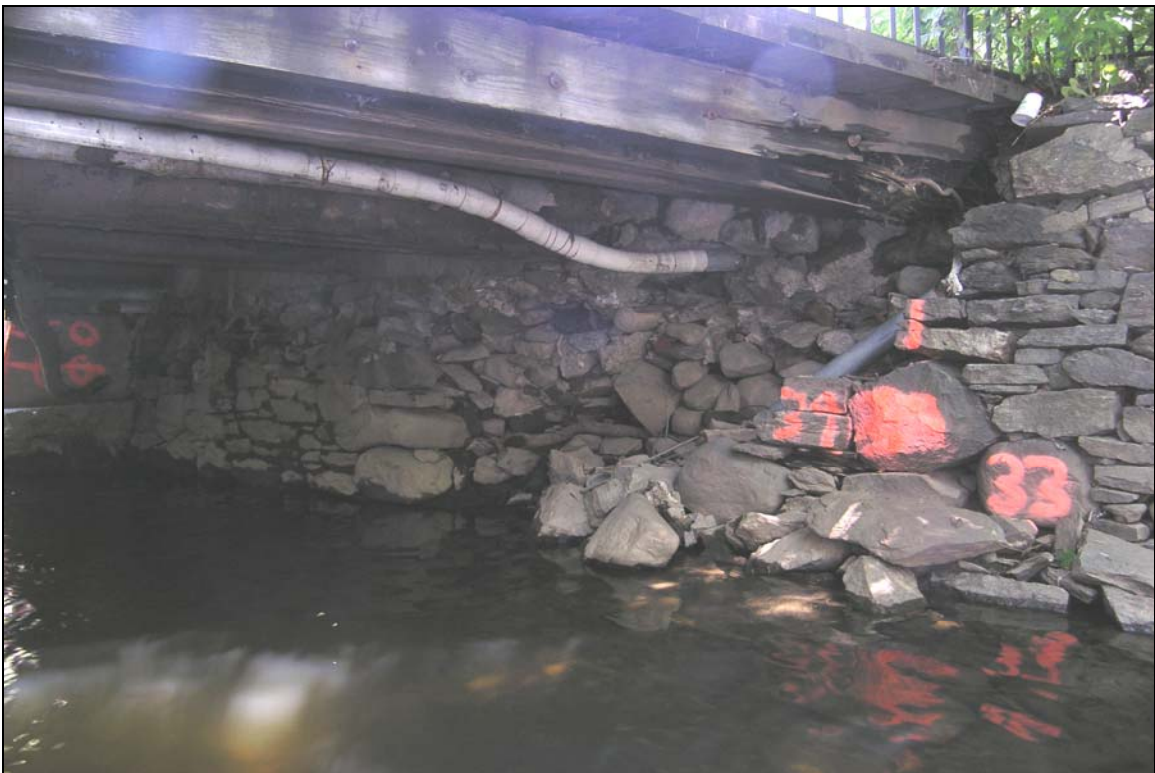
The John Street Alley Bridge is located between Stations 39+33 and 39+50. Overall the bridge is in poor condition. At the east stone masonry abutment, there is a 10' long by 5' high by 3' deep void located at Station 39+36 (see Photo 126). In addition, the entire length of the west abutment is undermined approximately 1' high by 1' deep. As shown in Photo 127, a section of the northwest wingwall has been displaced to the north and has rotated out of plumb.

Photo 126 John Street Alley Bridge, East Abutment. 10' long by 5' high by 3' deep void in stone masonry abutment at Station 39+36. Note severely deteriorated timber fascia beam.

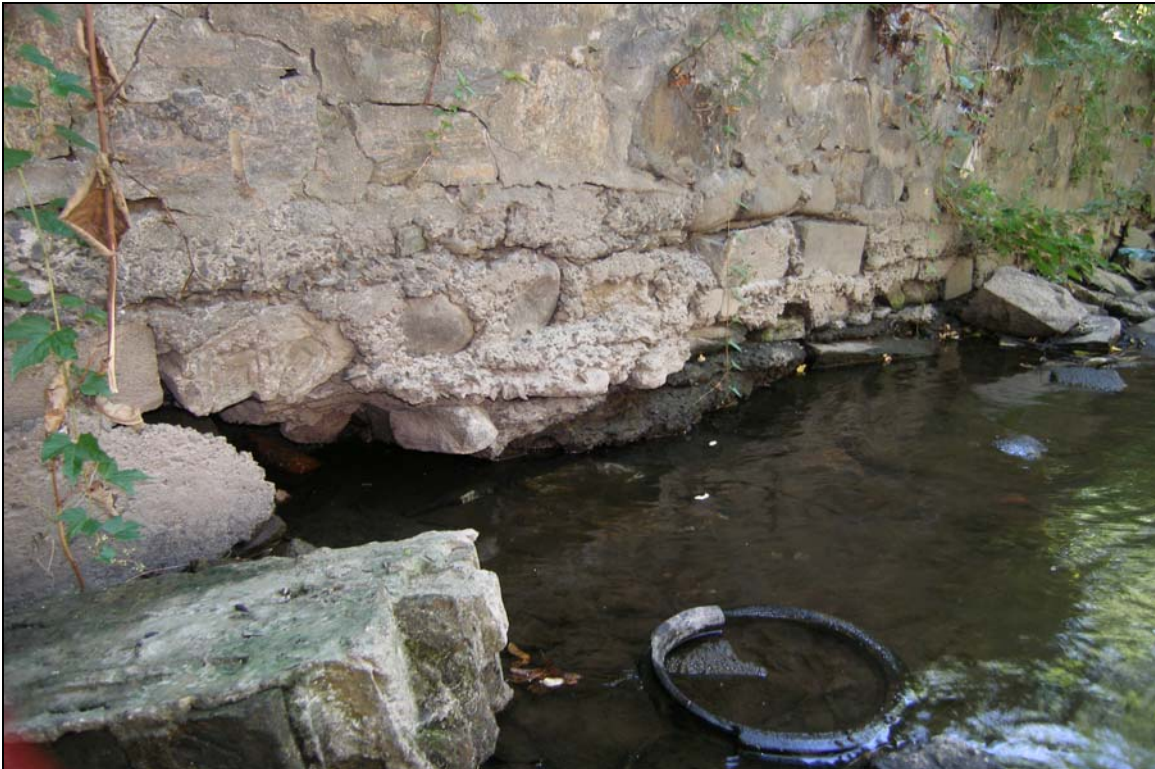
Along the right (east) embankment of the channel, a stone masonry wall extends from Station 39+50 to 40+05. Overall, the wall is in fair to poor condition with up to 20 percent deterioration. A general view of the wall is shown in Photo 129. The wall exhibits intermittent undermining up to 1' high by 1' deep with 1/2" wide cracks throughout (see Photo 130). Upstream of the stone masonry wall is a natural earthen bank with vegetation that extends to the Elm Street Bridge (see Photo 134). A general view of the river looking upstream from Station 39+90 is shown in Photo 131.

Photo 130 Typical undermining and cracks in stone masonry wall. Wall exhibits intermittent undermining up to 1' high by 1' deep.

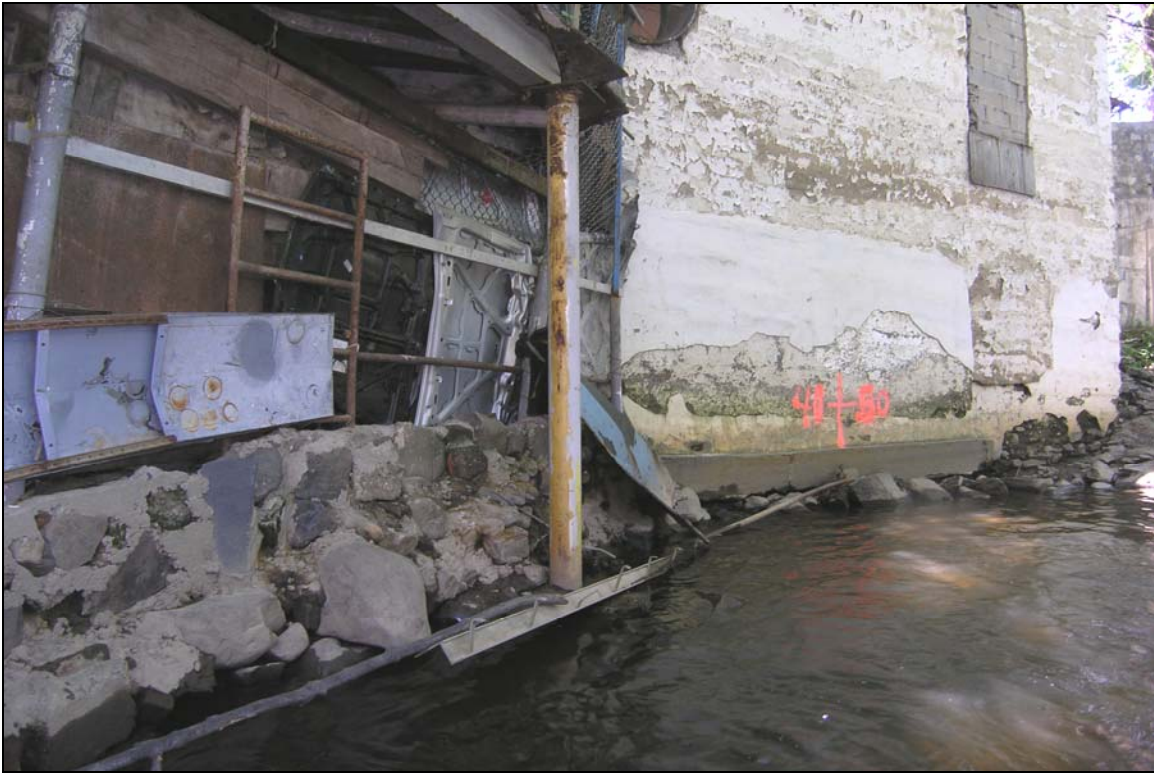
A combination of scrap metal, stone, concrete, and timber has been used to construct a retaining wall along the left (west) embankment between Stations 39+50 and 40+40 (see Photos 132 and 133). As seen in Photo 133, a masonry building foundation is located along the riverbank from Station 40+40 to 40+67. Erosion of the foundation wall has created intermittent undermining of the structure up to 1' high by 1.5' deep. Located between Station 40+85 and the downstream fascia of the Elm Street Bridge, there is a 3' to 5' high stone masonry wall which is in a state of disrepair (see Photo 134).

Photo 133 Left embankment, upstream of John Street Alley Bridge. Scrap metal and concrete retaining wall from Station 39+50 to 40+40. Masonry building foundation from Sta 40+40 to Sta 40+67 exhibits intermittent 1' high by 1.5' deep areas of undermining.

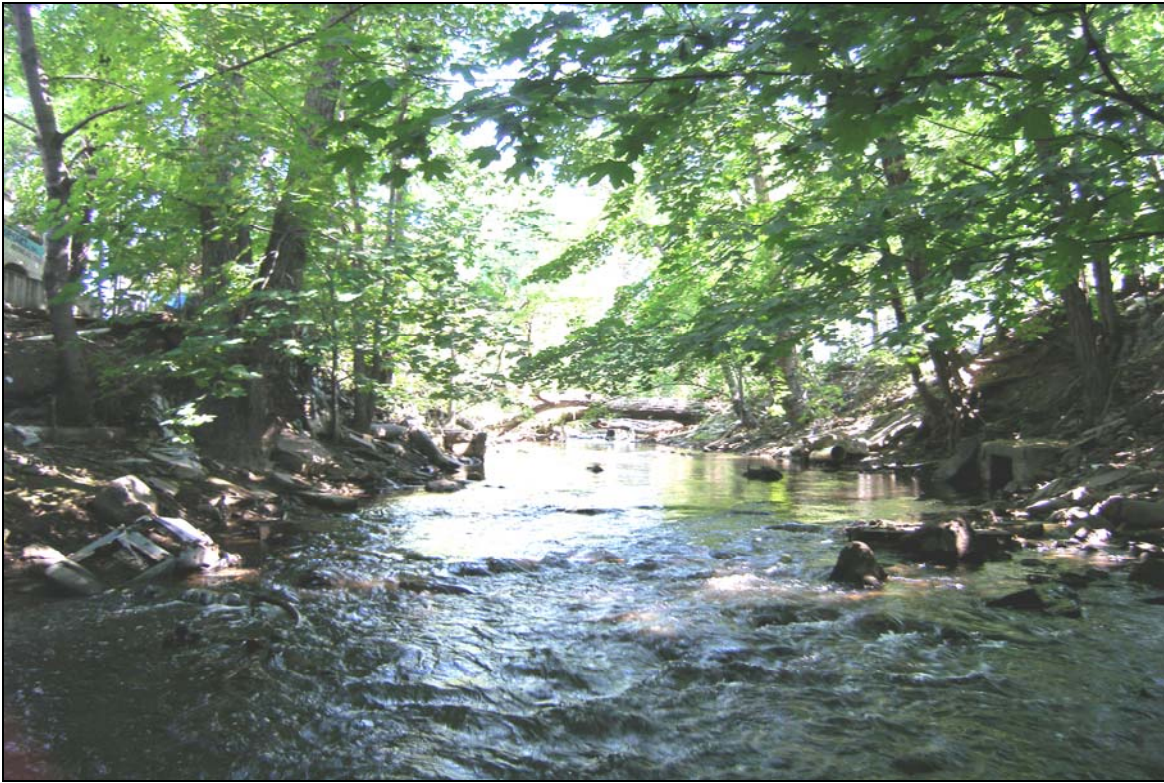
Photo 139 General view looking upstream from Station 42 + 30. Note the fallen timber across the river at Station 43 + 50.

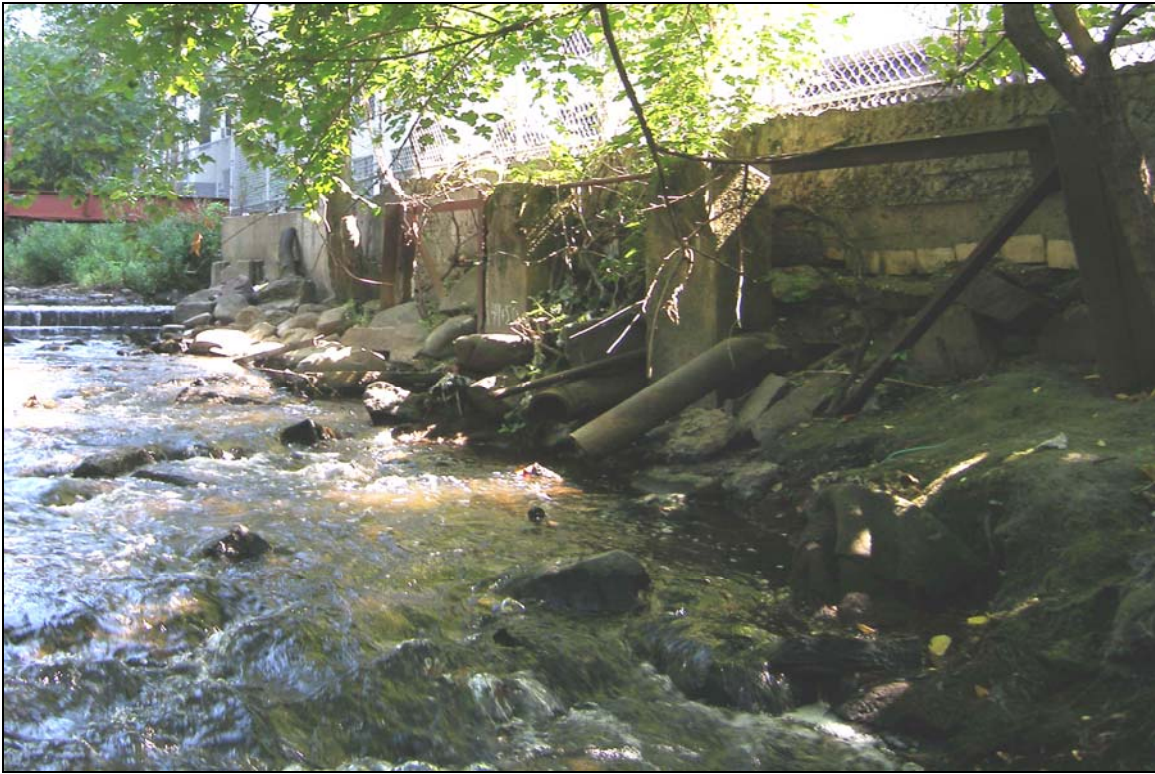
The right (east) embankment is comprised of destabilized riprap, loose earth, vegetation, and scattered debris from Station 42+30 to 43+80. As seen in Photo 141, a 1.5' to 3' high concrete retaining wall has been constructed between Stations 43+80 and 44+73. The wall retains fill for a parking lot which has been built adjacent to the riverbank.

Photo 141 Right embankment, Station 43+80 to 44+73 (upstream limit of inspection). 1.5' to 3' high concrete wall retains fill for parking lot built adjacent to riverbank.

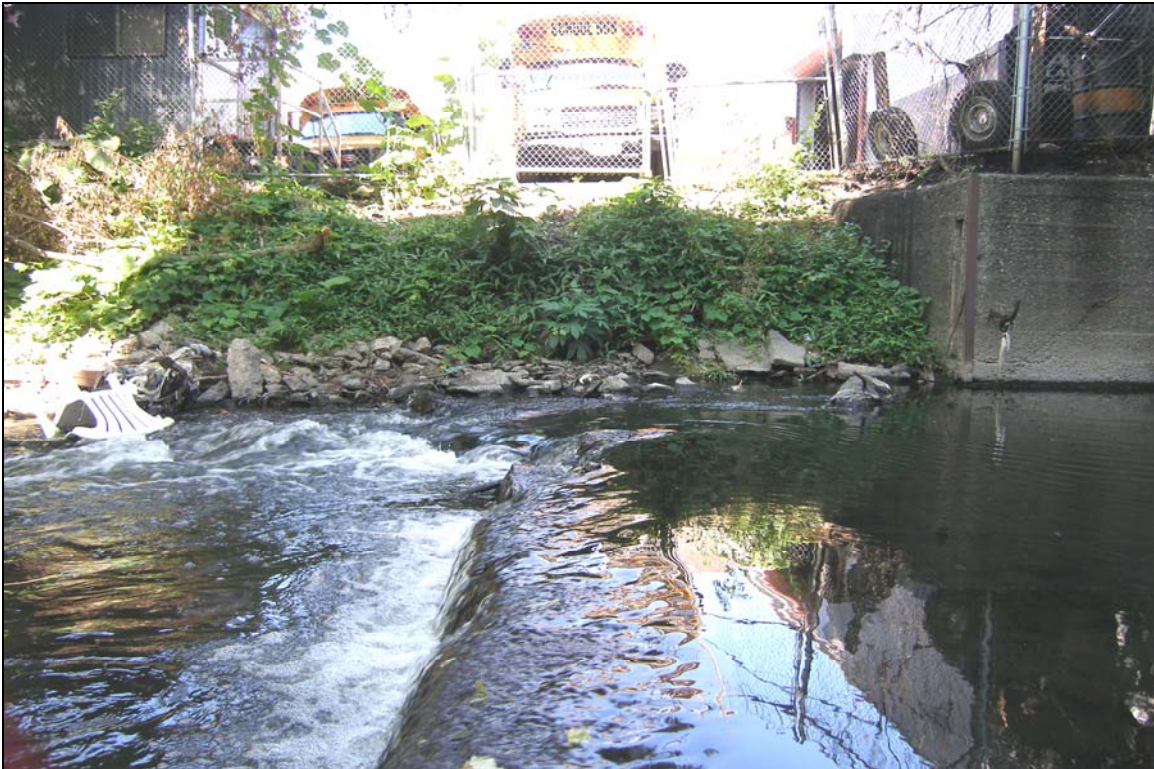
A general view looking upstream from Station 44+25 is shown in Photo 142. Located at Station 44+73, the upstream limit of inspection, there is a 1.5' high by 37' long concrete spillway. General views of the east and west sides of the spillway are shown in Photos 143 and 144, respectively. As seen in Photo 144, the westernmost 9.6' of the spillway exhibits one hundred percent deterioration.

Photo 144 West embankment, Station 44+73. General view of west half of 1.5' high concrete spillway. Note westernmost 9.6' of spillway is missing.
